ESTERO INFRASTRUCTURE INVENTORY PROJECT

JANUARY 2016

PREPARED FOR THE VILLAGE OF
ESTERO, FL

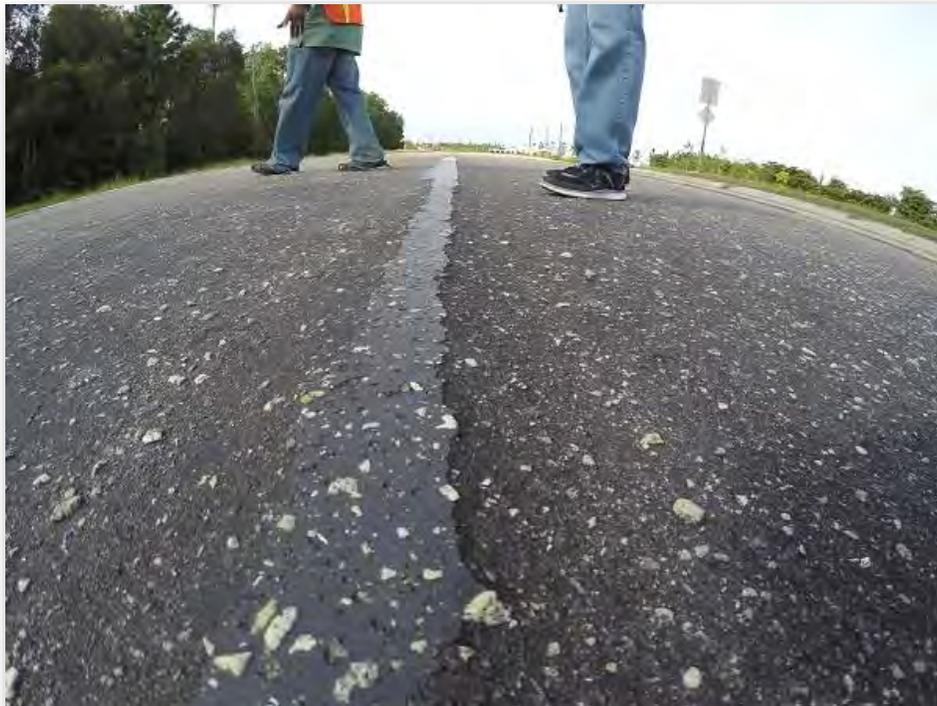
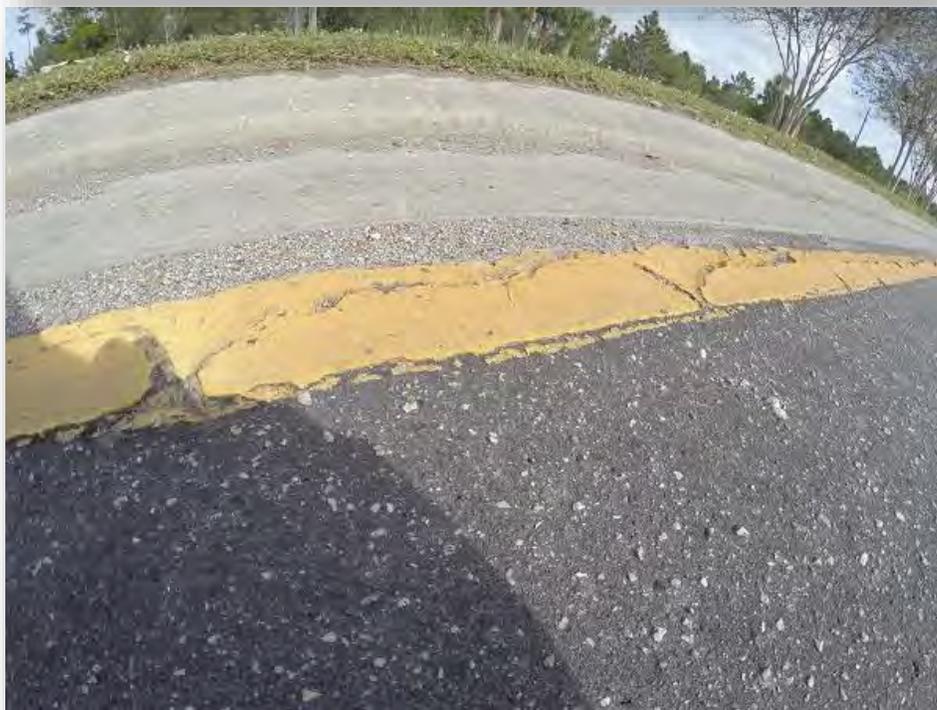
Street Name	Distance (ft)	Distress/concern	Recommendations / Actions
Estero Parkway	9,504	Severe raveling throughout the entire road. It is quite possible the road was never completed. Pavement appears to be very thin and is not flush with curbing (~1 inch). Light to moderated cracking.	Immediate attention is recommended. Re-pave at the earliest possible.
Poinciana Avenue	661	Severe raveling throughout the entire road. Road base can be seen through the cracks, depressions from erosion on the shoulder, as well as potholes and patching throughout.	Immediate attention is recommended. Re-pave at the earliest possible.
Trailside Drive	2,166	Moderate, type II block cracking is present throughout the entire road.	Immediate attention is recommended. If re-paving is not an option at this time, at the minimum, monitor crack propagation in the next year or so. Re-evaluated in the next year to ensure that condition does not worsen.

Figure 3: Severe Raveling & Road Not Flush with Curbing - Estero Parkway

Trailside Drive (Figure 6). It is recommended to repave these roadways within the next year. Additional information about each of these roadways is also provided in Appendix A.

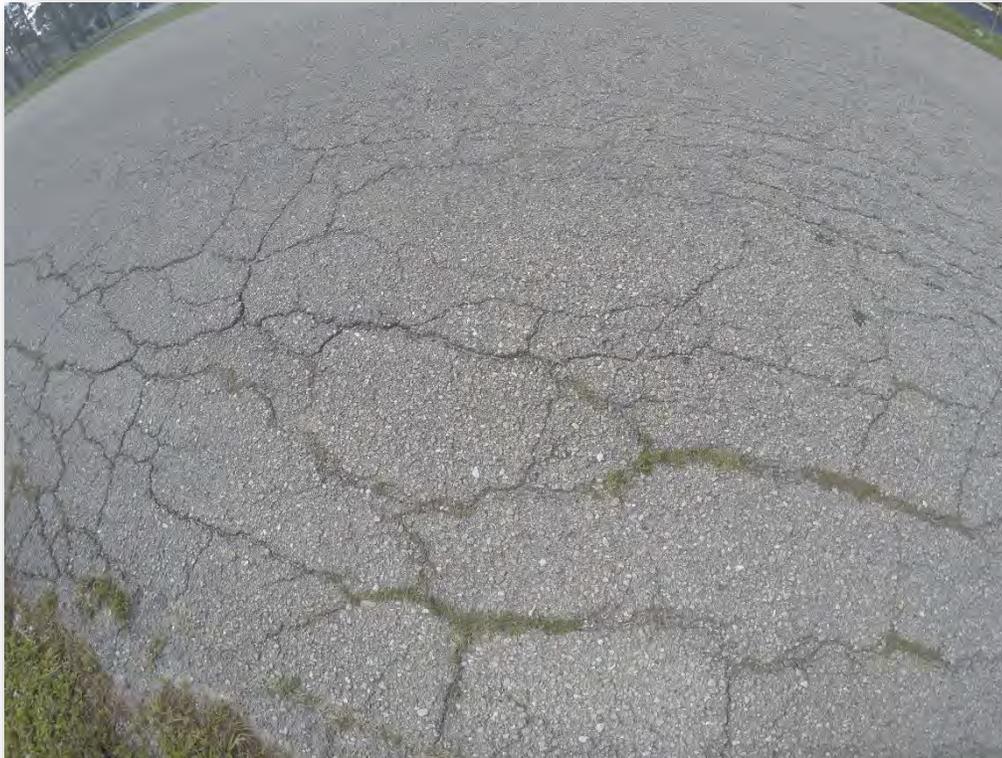
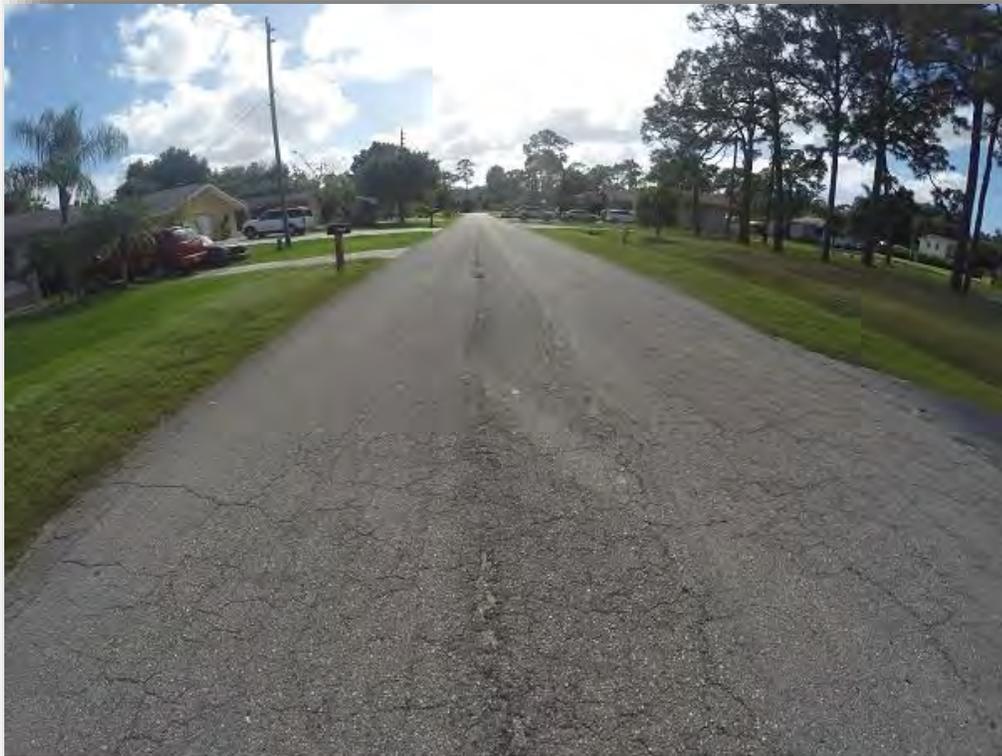
Figure 4: Exposed Base and Type III Alligator Cracking - Poinciana Avenue

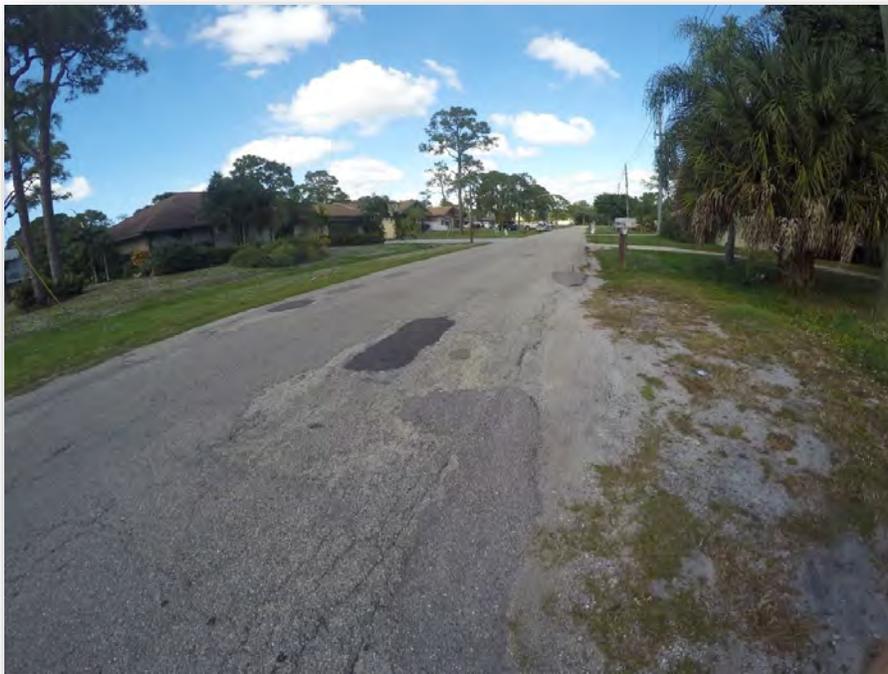
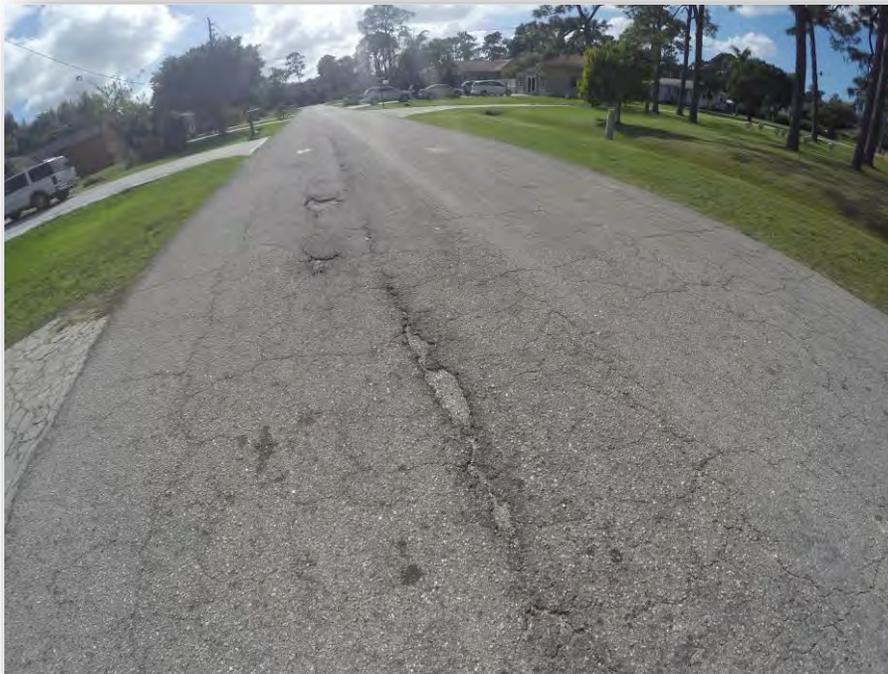
Figure 5: Potholes and Large Patches – Poinciana Avenue

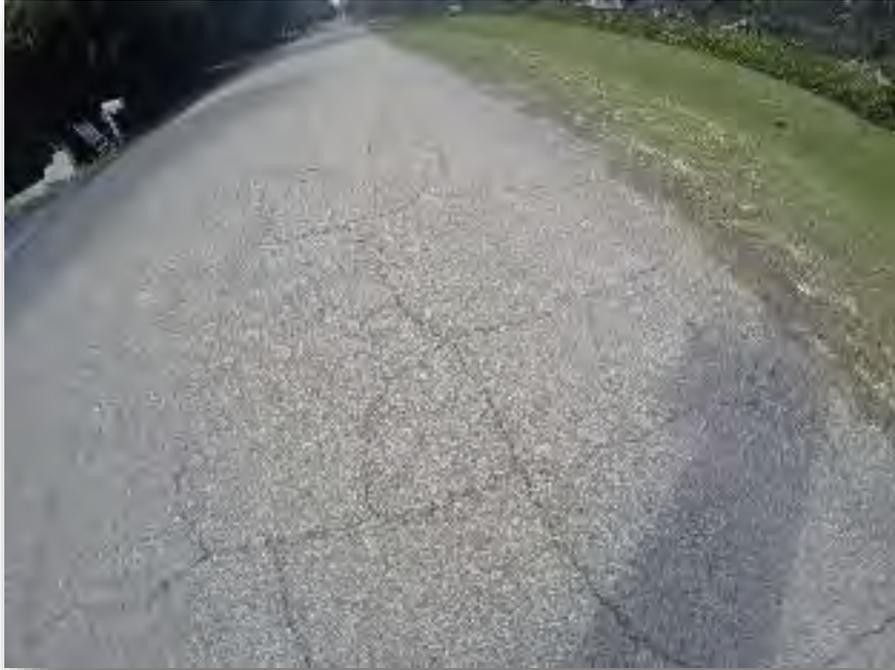
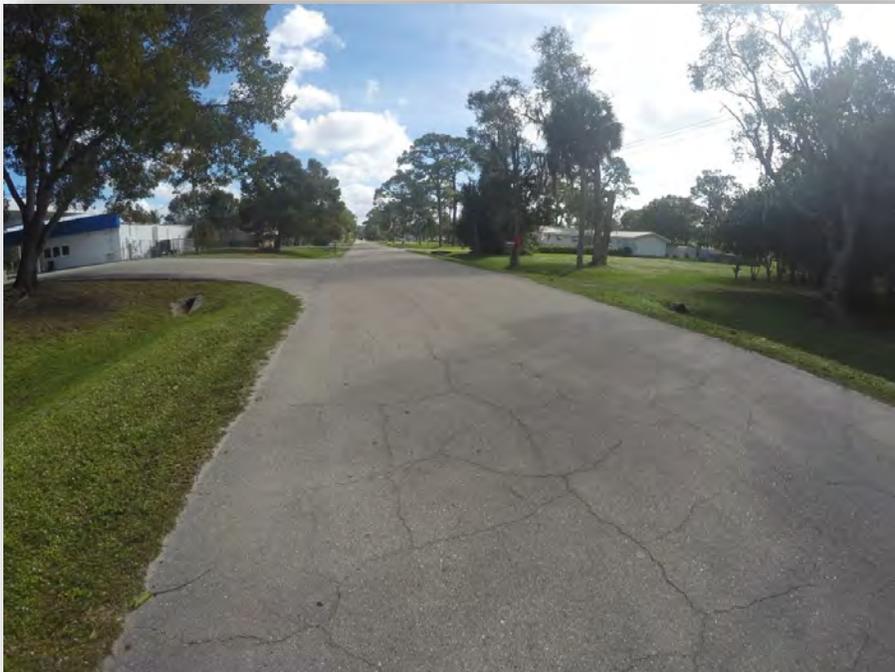
Several potholes, extensive cracking, and/or moderate raveling were observed on Estero Parkway, Poinciana Avenue, and Trailside Drive. These streets cover about 12 lane miles of pavement (see Table 2 below). These roads are categorized as in poor condition. Immediate attention is recommended. The conditions of these roadways may deteriorate very rapidly, which may result in a much more expensive solution to rehabilitate them. For example, one hundred percent (100%) of the total surface area on Estero Parkway has extensive raveling (Figure 3). At some locations the base materials are exposed. Extensive cracking and patching were observed in Poinciana Avenue (Figures 4 and 5). Some type II block cracking was observed on about the entire pavement of

Figure 6: Type II Block Cracking Throughout - Trailside Drive

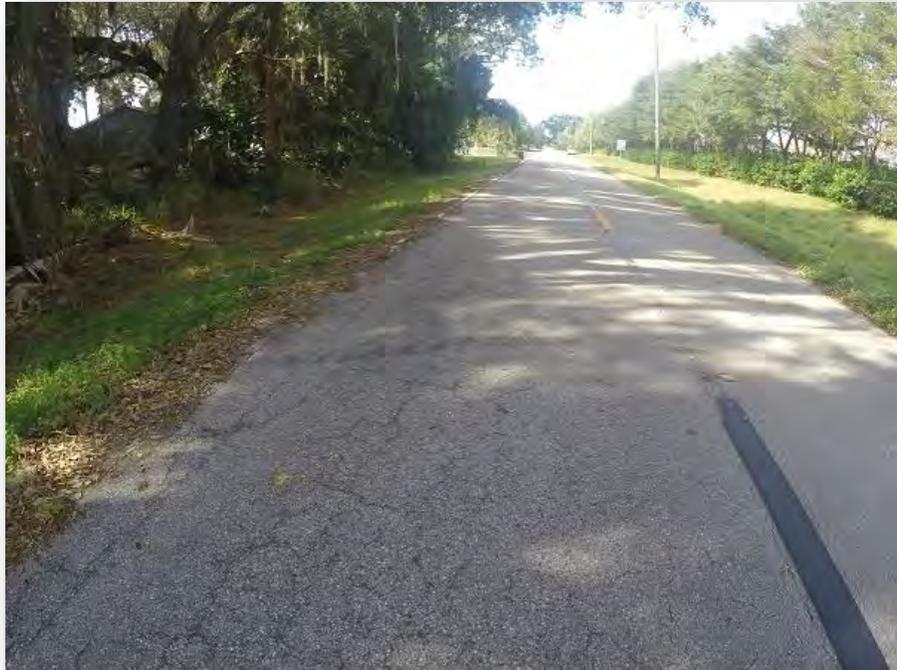
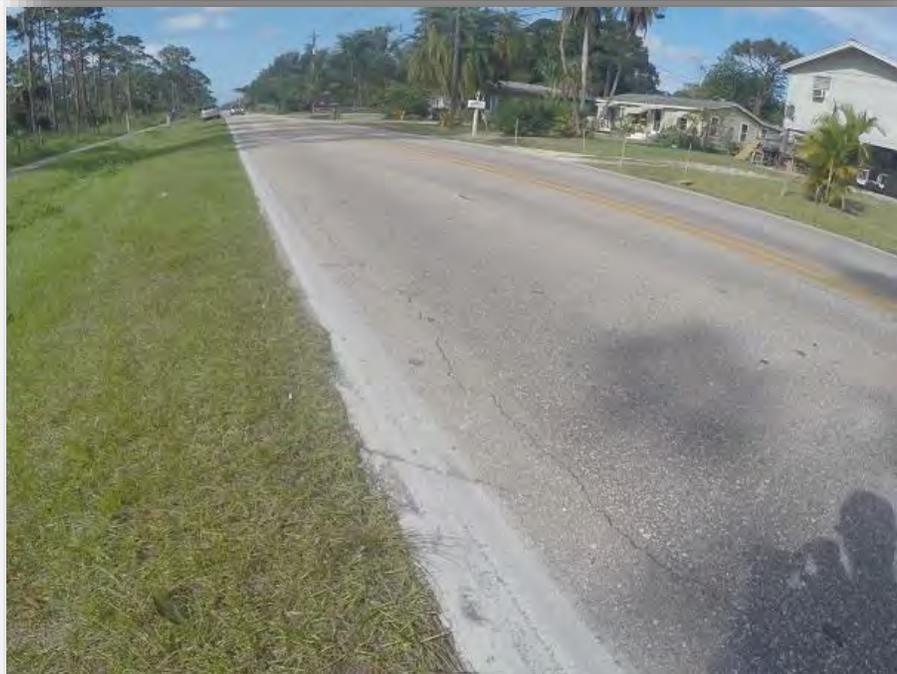
It is important, however, to also highlight Broadway Avenue (about 5 lane miles), Sandy Lane (about 1.5 lane miles); and Charing Cross Circle (about 1.25 lane miles). These three roadways contain some type II/III cracking and light-to-moderate raveling that may need additional attention. These are highlighted in yellow on the table. The distresses cover about forty percent (40%) of the surface area on these three roadways. Longitudinal and alligator cracking especially in the wheel path or centerline was present on Broadway Avenue (West side of US 41) (Figure 7) and Sandy Lane (Figure 8 & 9). About ten percent (10%) of back slope of drainage exits on the side of these roads. Although the cause of the distress observed on Broadway Avenue and Sandy Lane is beyond the scope of this work, it appears that the drainage provides inadequate lateral support which may in turn accelerate the conditions on these roads.

Figure 7: Alligator and Longitudinal Cracking in Wheel Path - Broadway Avenue

Table 3 contains roadways in which cracks have started to propagate. These streets cover about 20 lane miles of pavement in the Village. Additional information about these roadways are provided in Appendix A. In general most of these roads listed in the table are in good-to-moderate conditions. However, these cracks in some instances cover roughly 25% of the surface area on these roads. These roads should be reevaluated in two to three years.

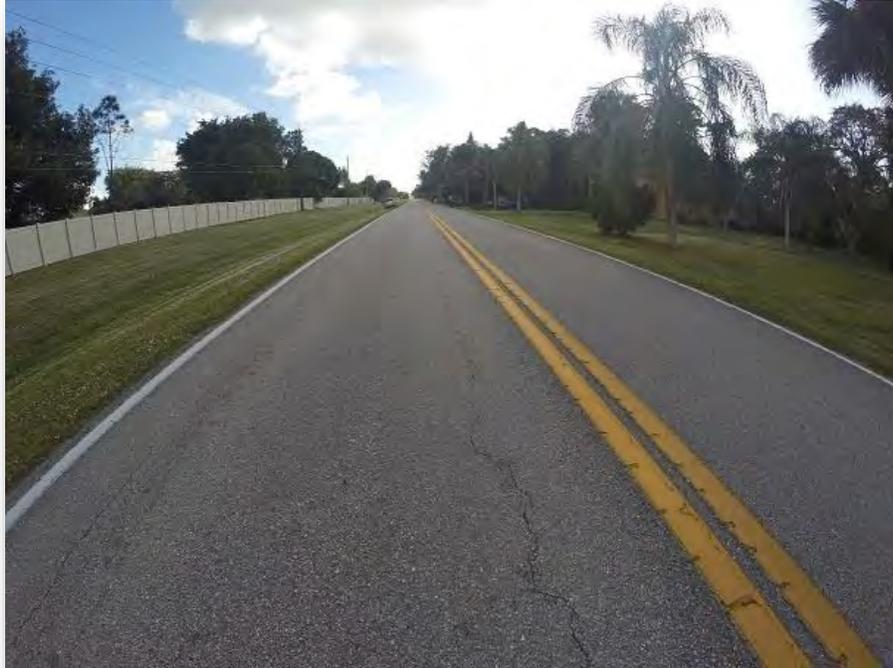
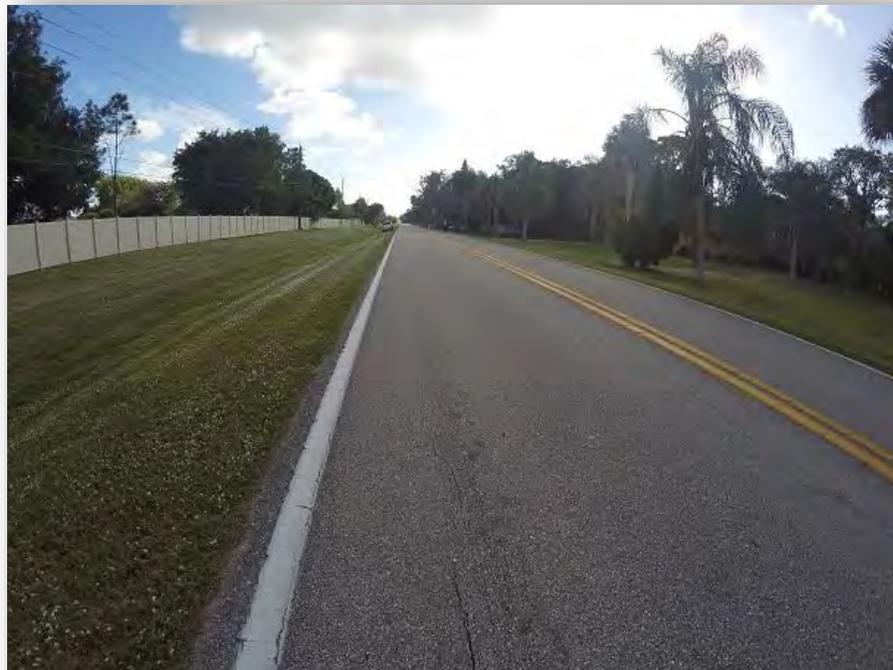
Figure 8 Longitudinal and Alligator Cracking in Wheel Path - Sandy Lane

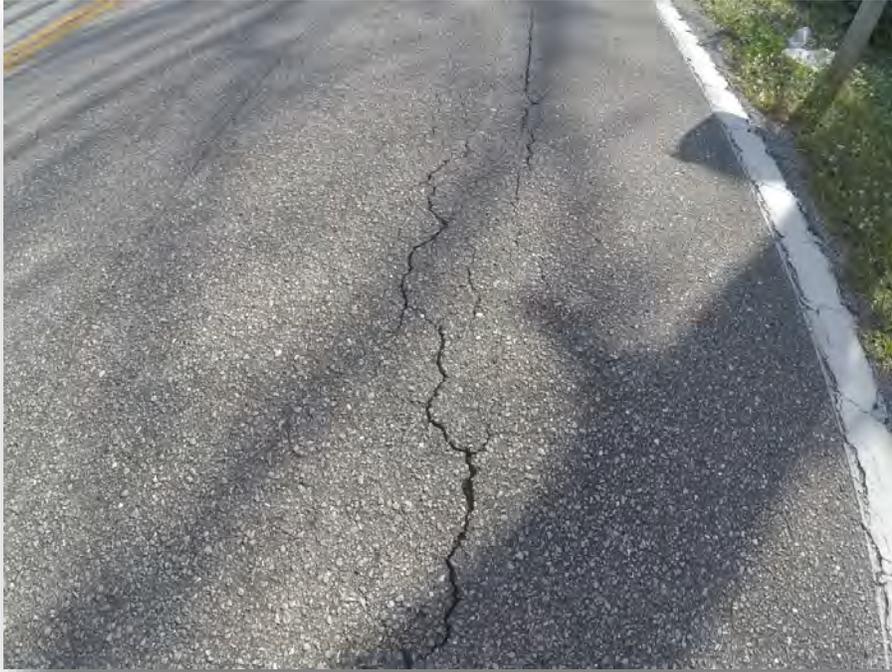
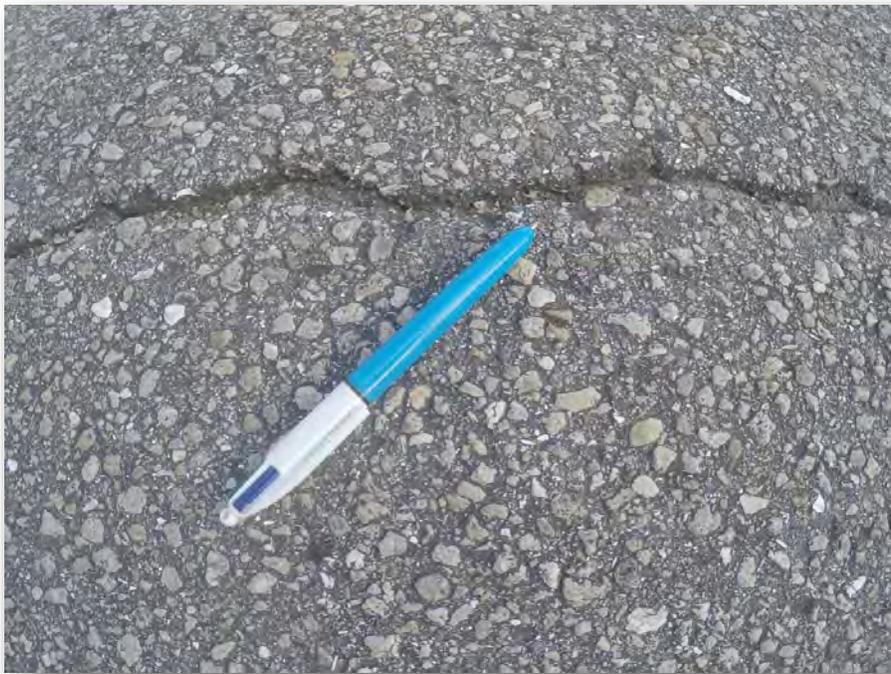
Figure 9: Type III Cracking Along Wheel Path – Sandy Lane

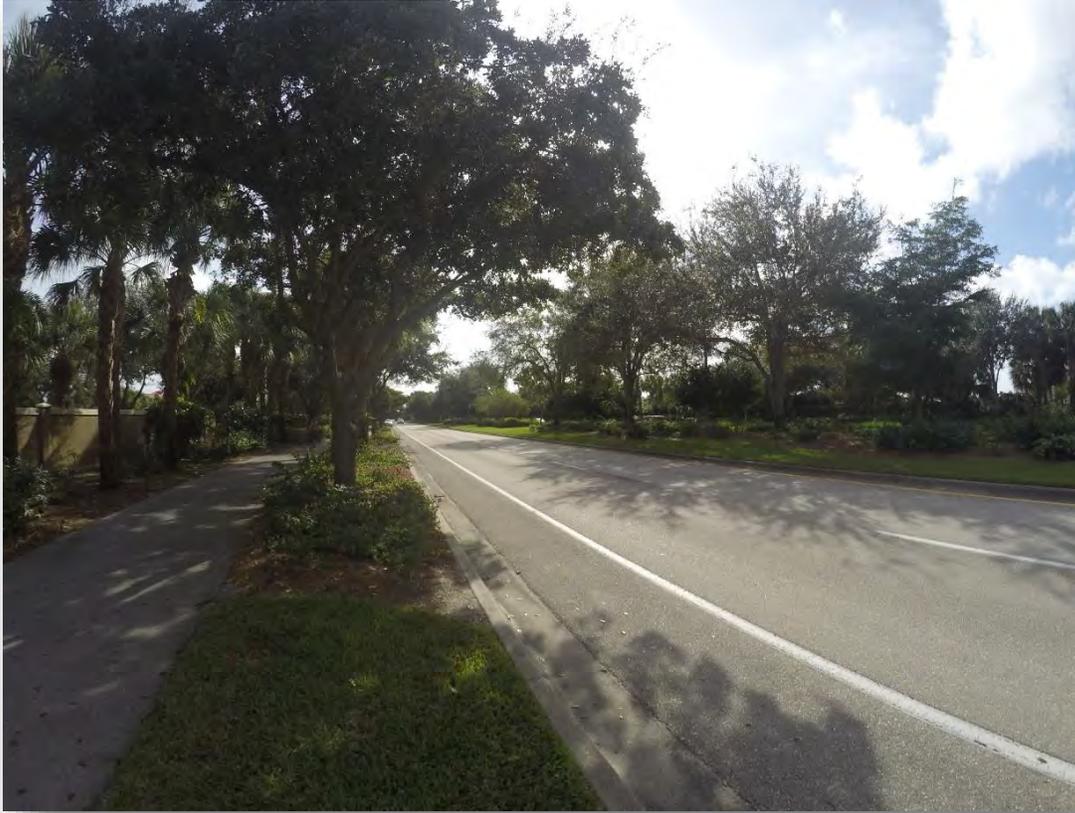
The rest of the roadways (Table 4) are in very good shape with only minor hair and/or very light raveling (see, for example, Coconut Road in Figure 10). These streets cover about 66 lane miles of pavement in the Village. Three Oaks Parkway showed some minimal cracking in between the wheel path (Figure 11). In addition only two (2) to five (5) percent of these distresses cover the surface area on these roads. As a result, no action is required on these streets.

Figure 10: Road in Very Good Condition - Coconut Road

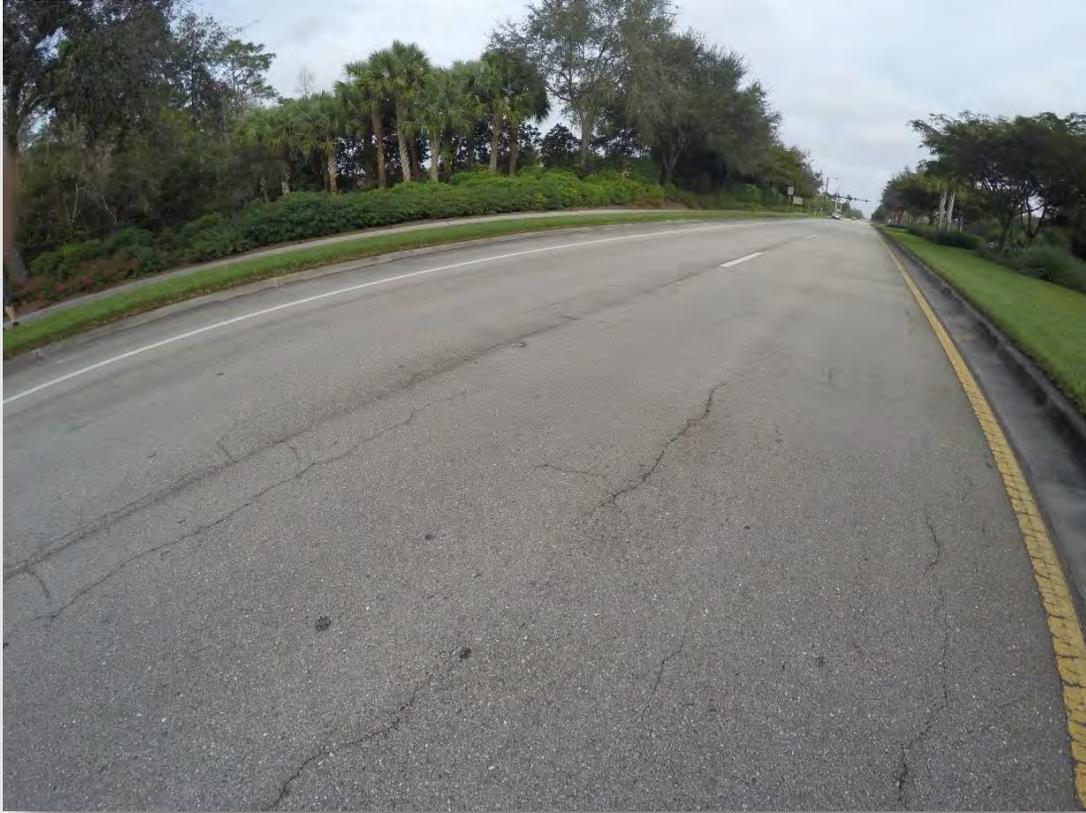
Figure 11: Minimal Cracking in Between Wheel Path - 3 Oaks Parkway

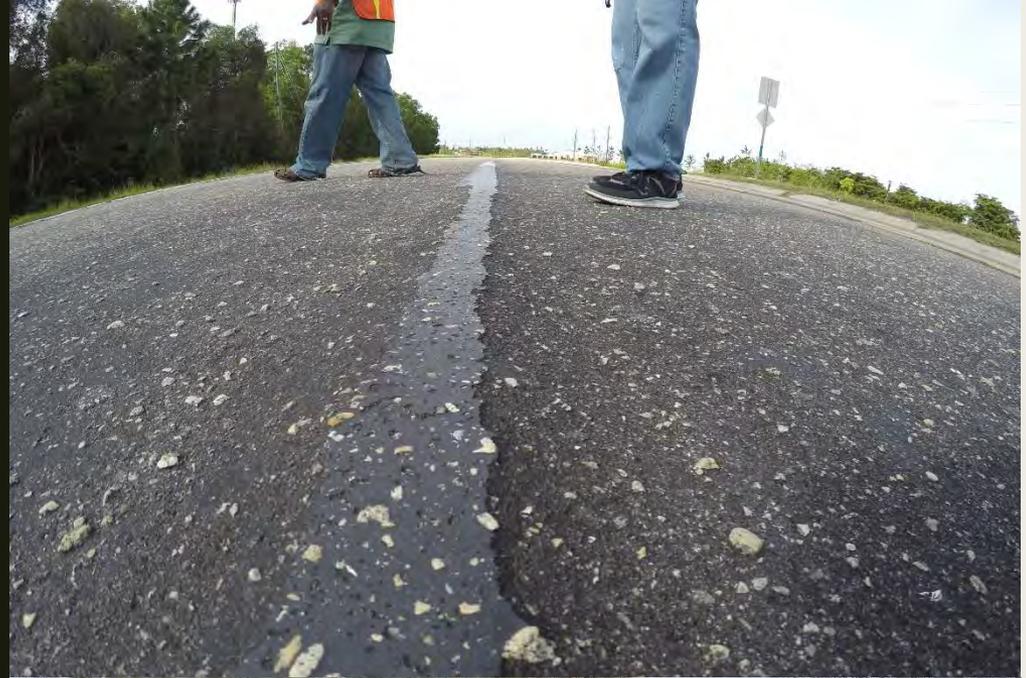
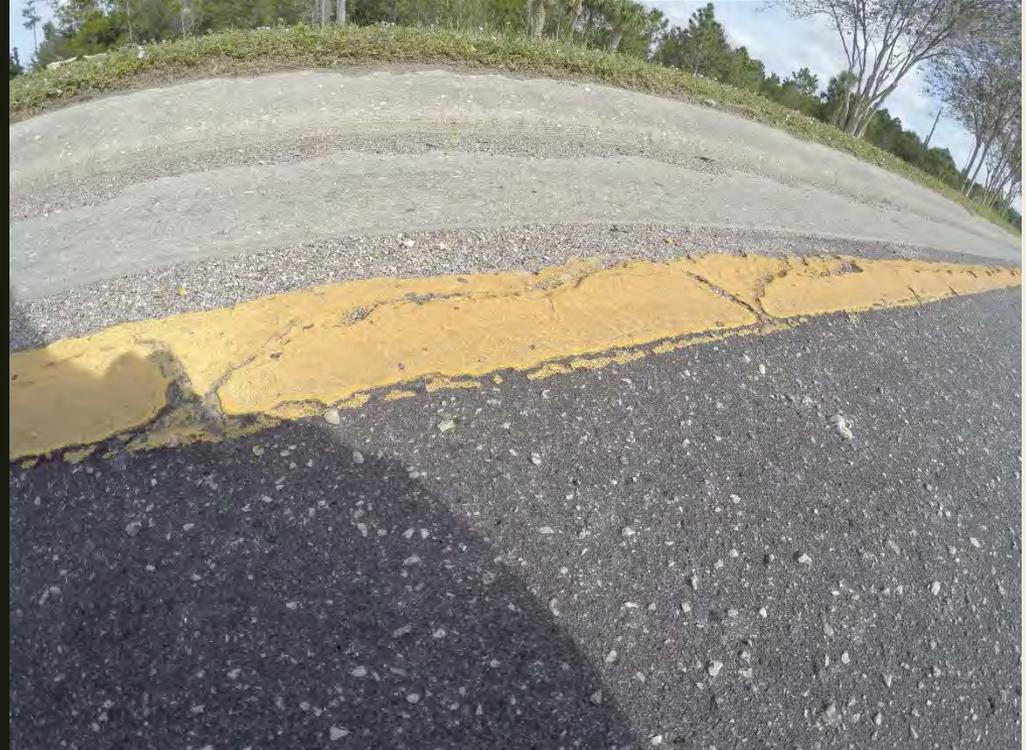
Estero Parkway

- Very thin pavement layer
- Pavement layer not flush with curbing
- Base materials exposed
- Resurfacing/ Rehabilitation in 2-3 YRS

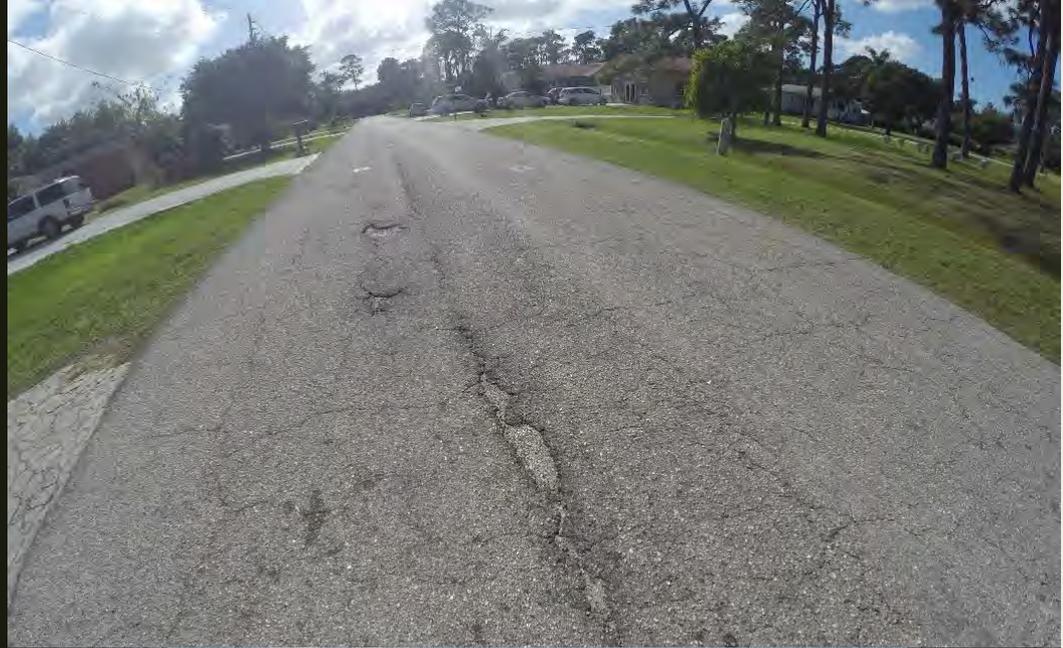
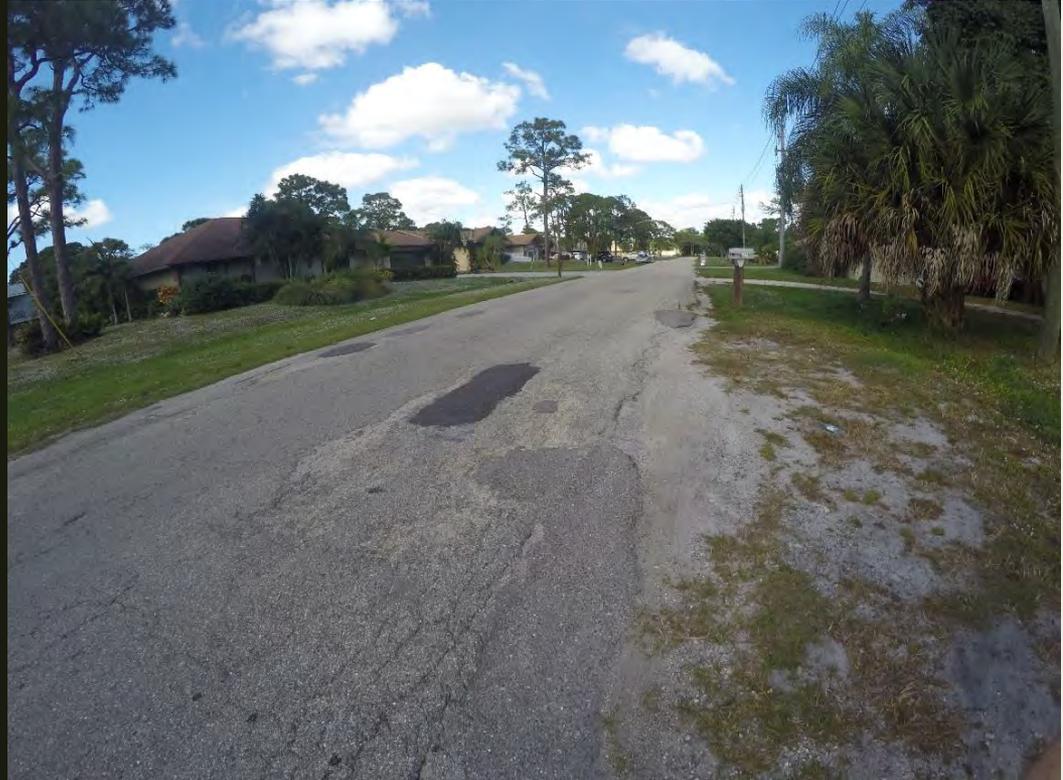
Poinciana Avenue

- Base materials exposed
- Resurface/ Rehabilitate in the next 1-2 YRS

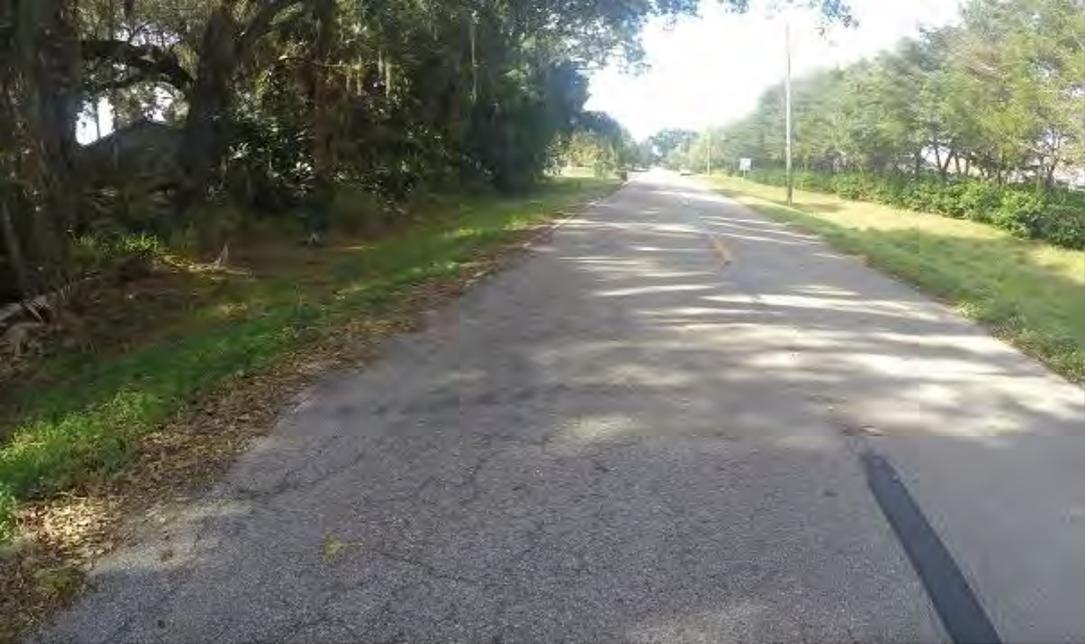
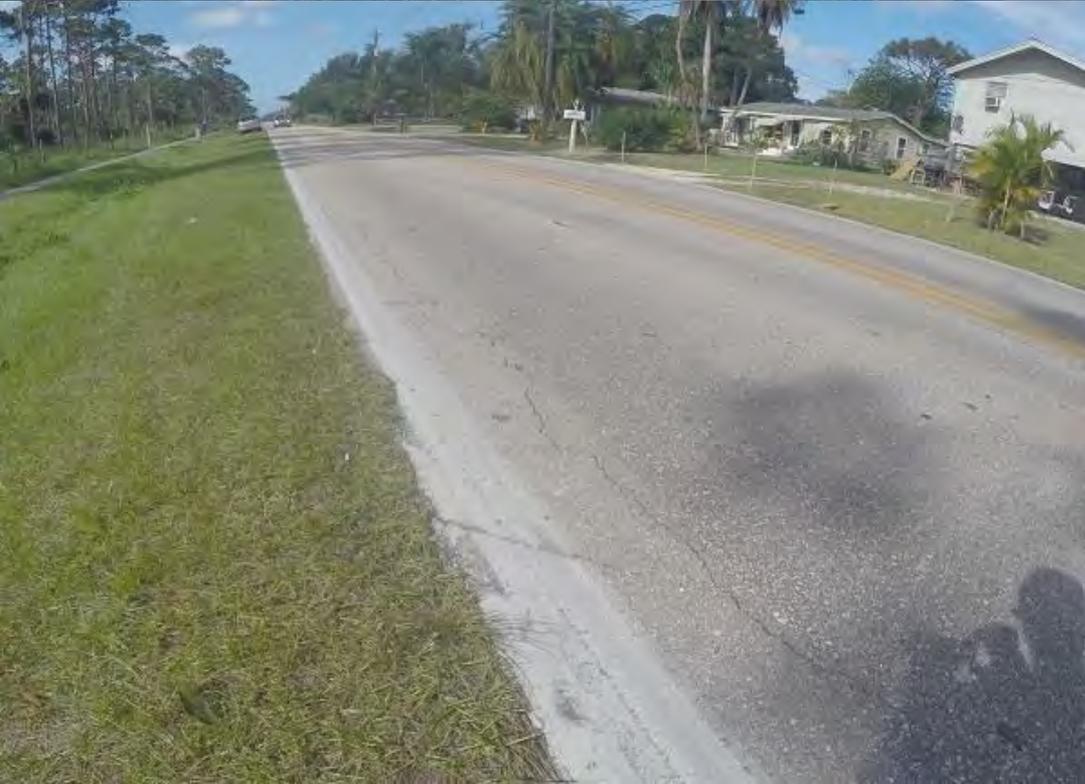
Broadway Avenue

- Light raveling West of US-41
 - Type IB and Type II longitudinal cracks along the centerline
