ESTERO INFRASTRUCTURE INVENTORY

Florida Gulf Coast University
January 20, 2016

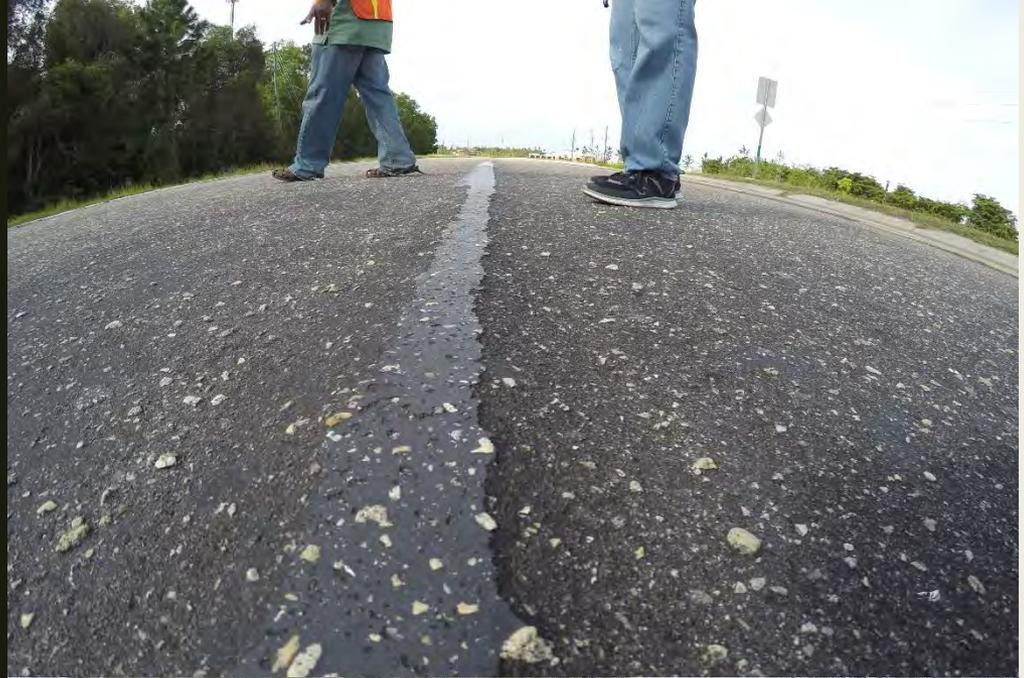
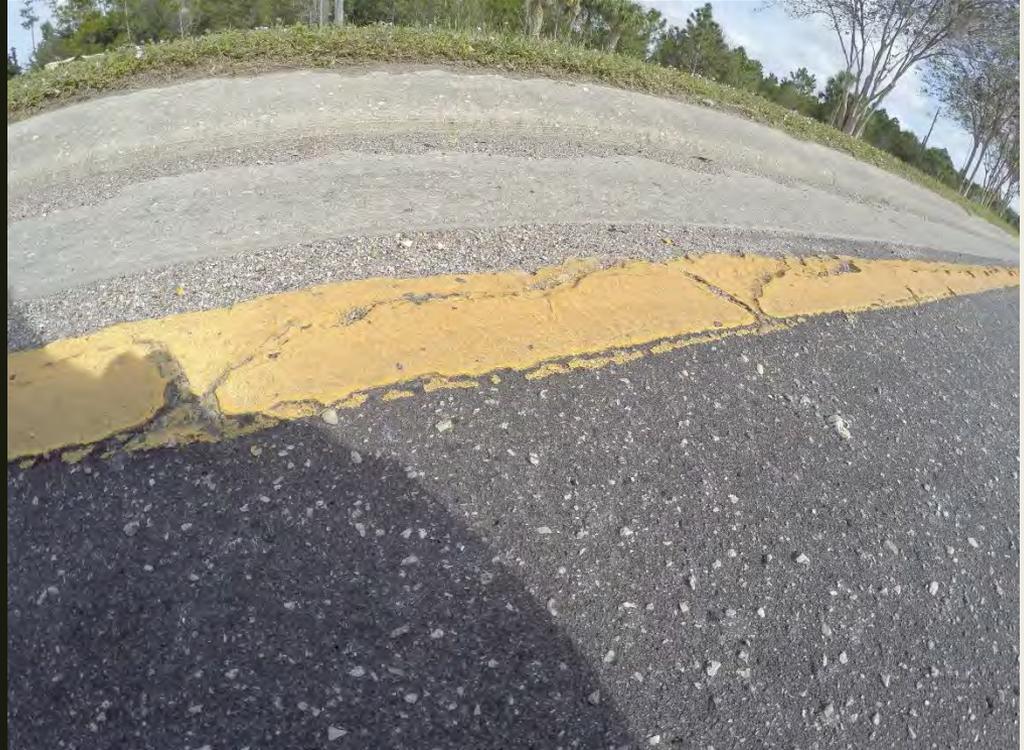
Estero Parkway

- Very thin pavement layer
- Pavement layer not flush with curbing
- Base materials exposed
- Resurfacing/ Rehabilitation in 2-3 YRS

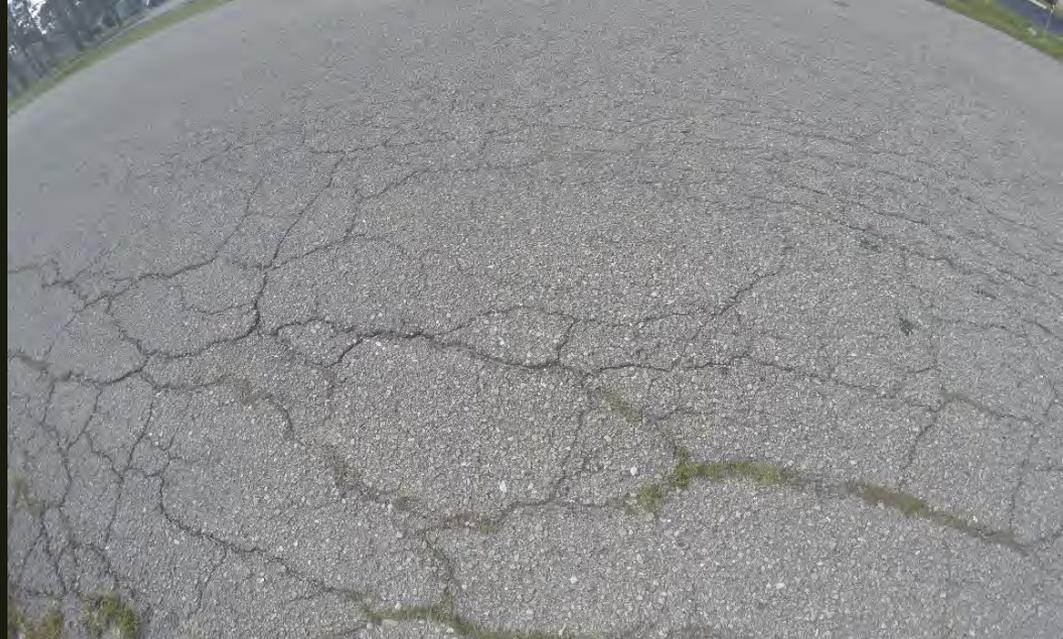
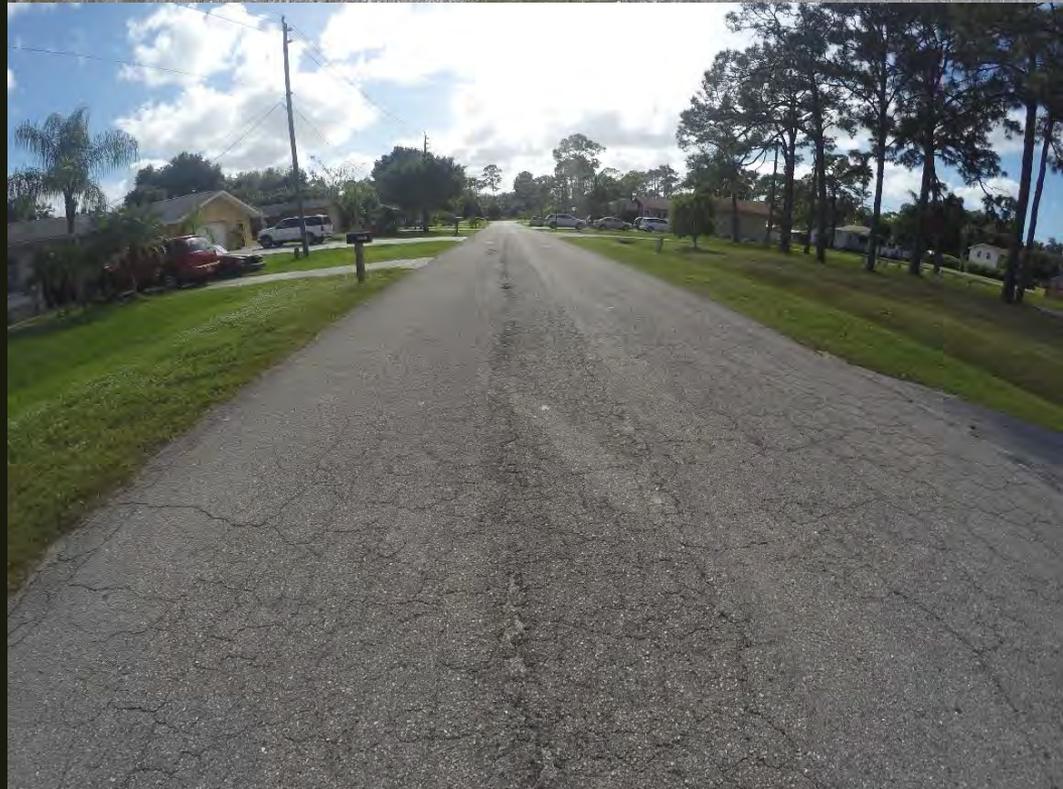
Trailside Drive

Resurface or monitor for 1 YR
