ESTERO INFRASTRUCTURE INVENTORY

JANUARY 2016

PREPARED FOR THE
VILLAGE OF ESTERO, FL

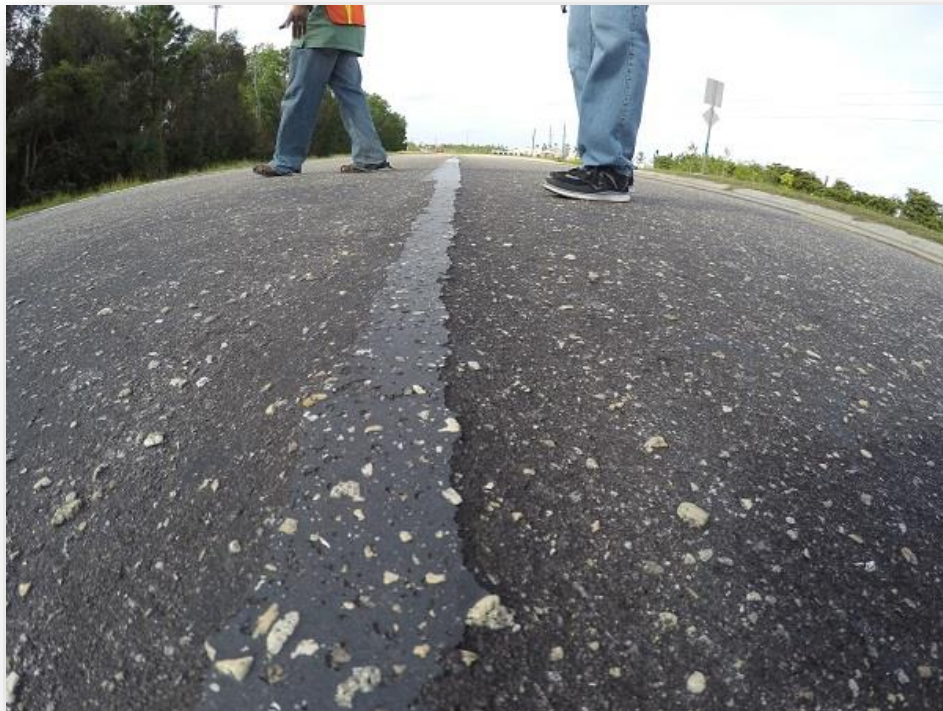
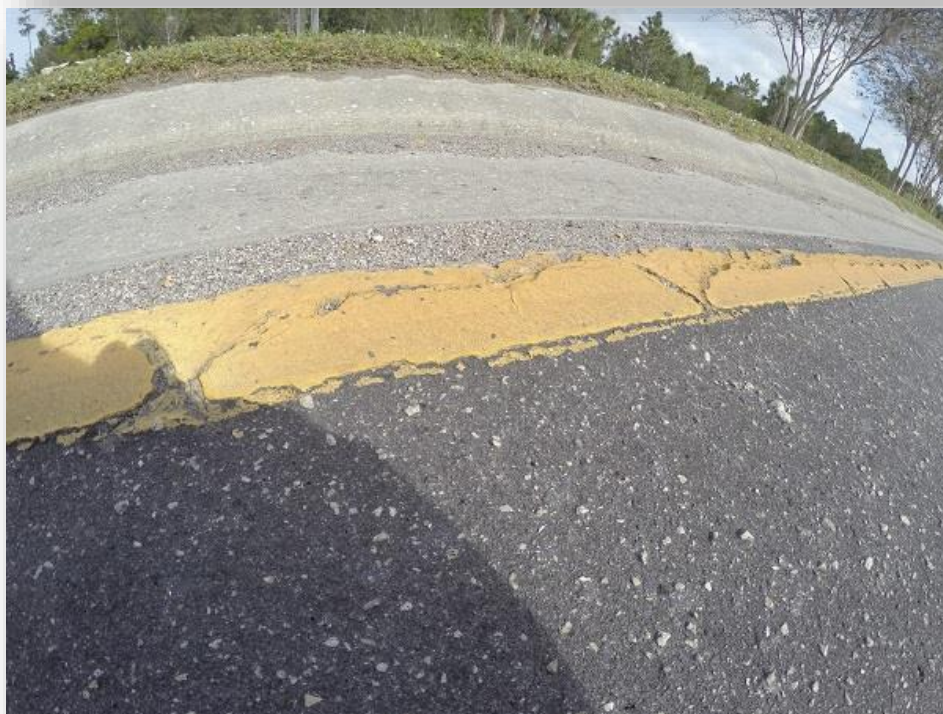
Figure 3: Severe Raveling & Road Not Flush with Curbing - Estero Parkway

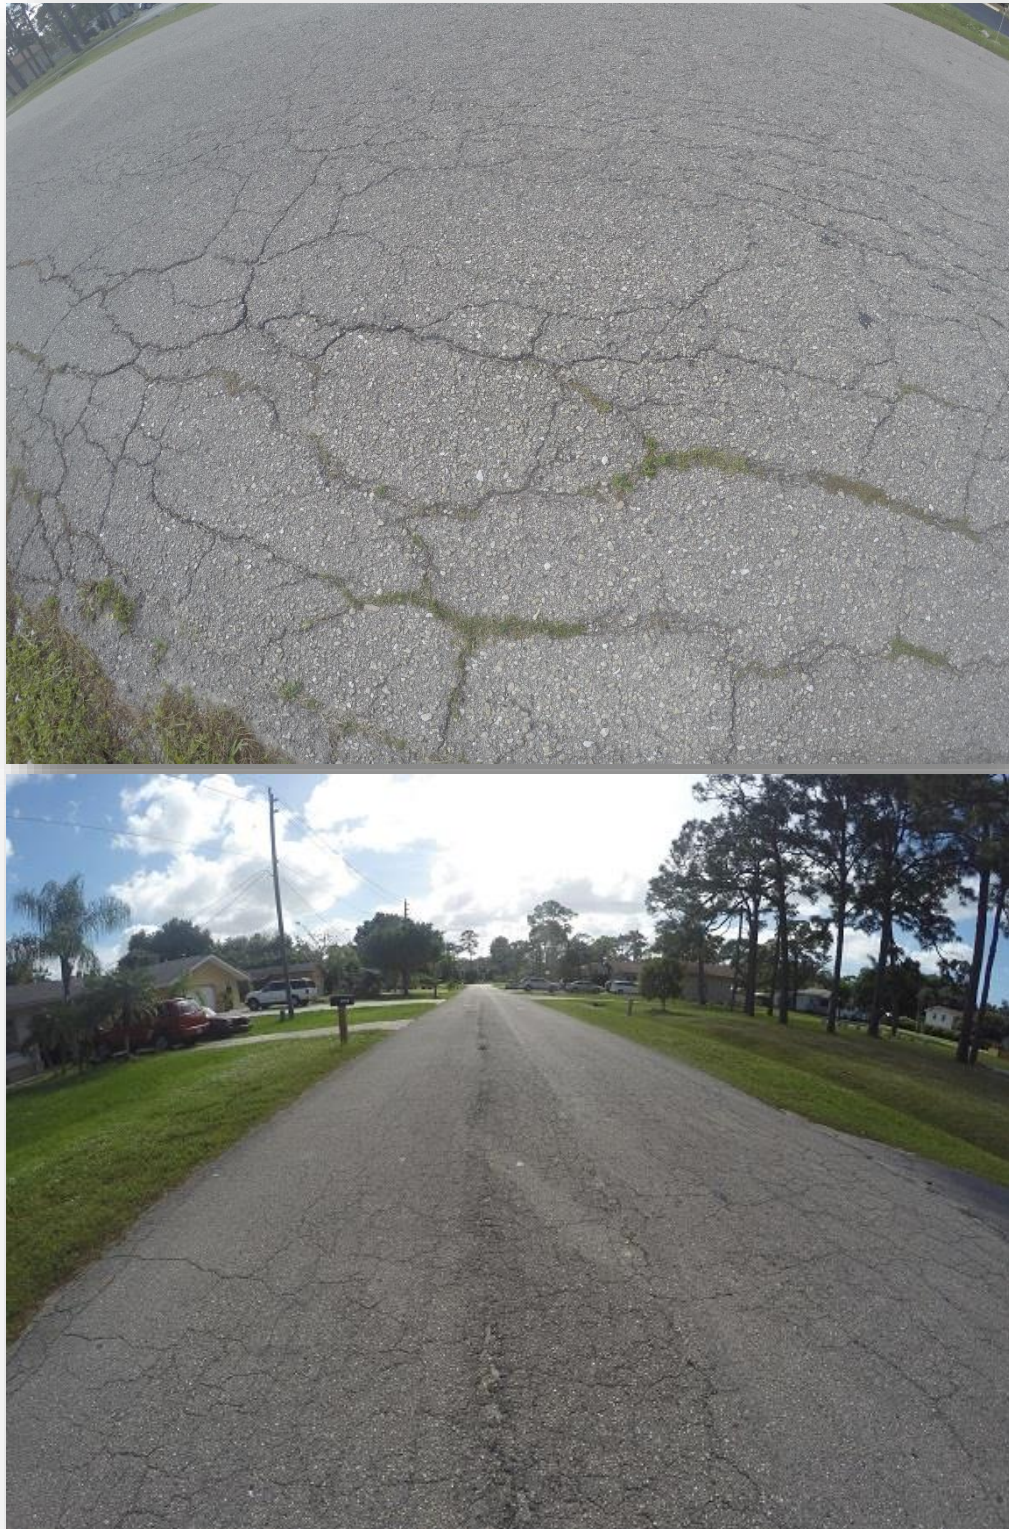
Figure 4: Exposed Base and Type III Alligator Cracking - Poinciana Avenue

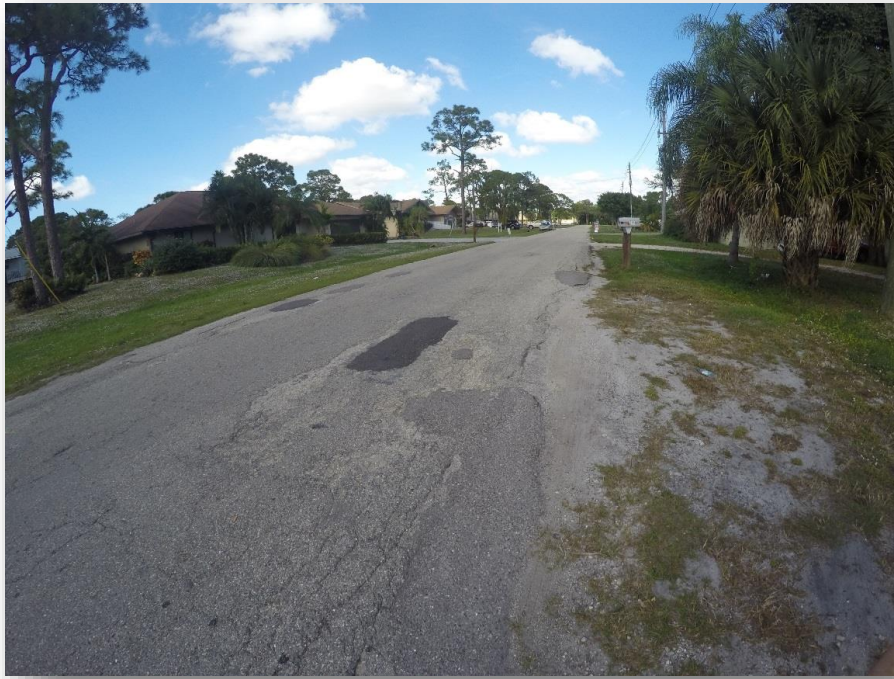
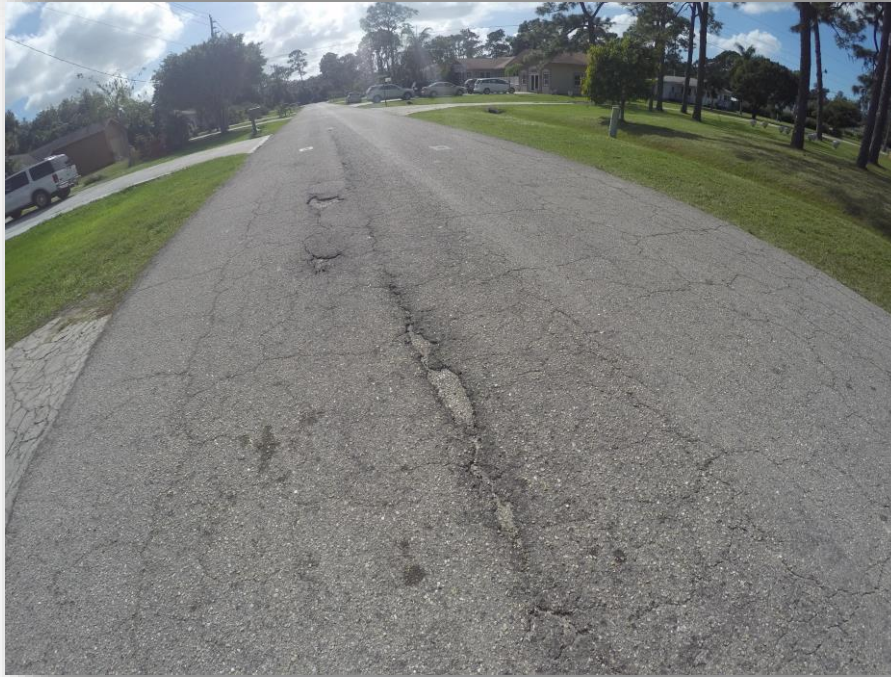
Figure 5: Potholes and Large Patches – Poinciana Avenue

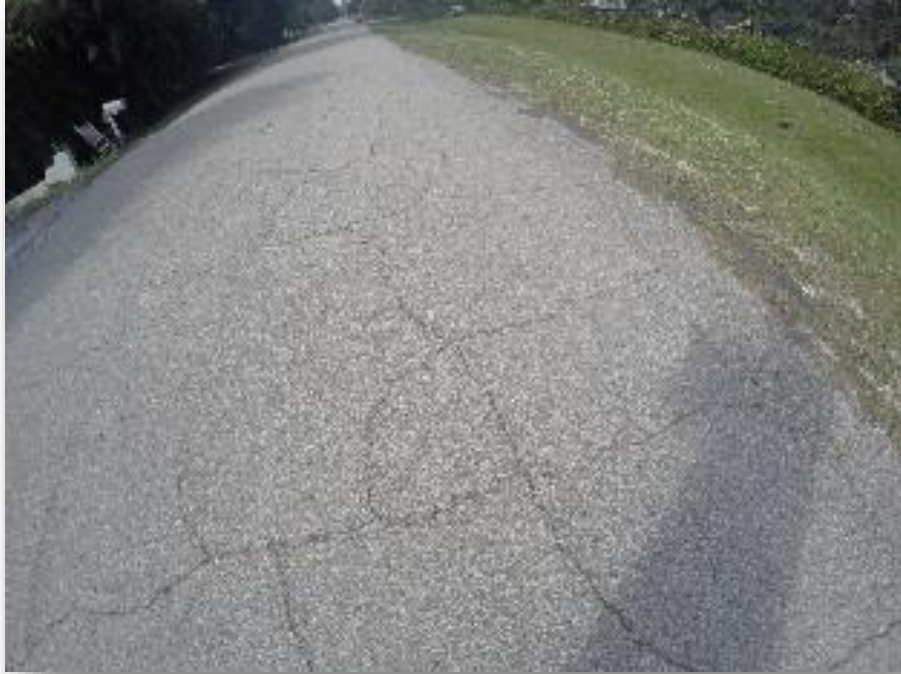
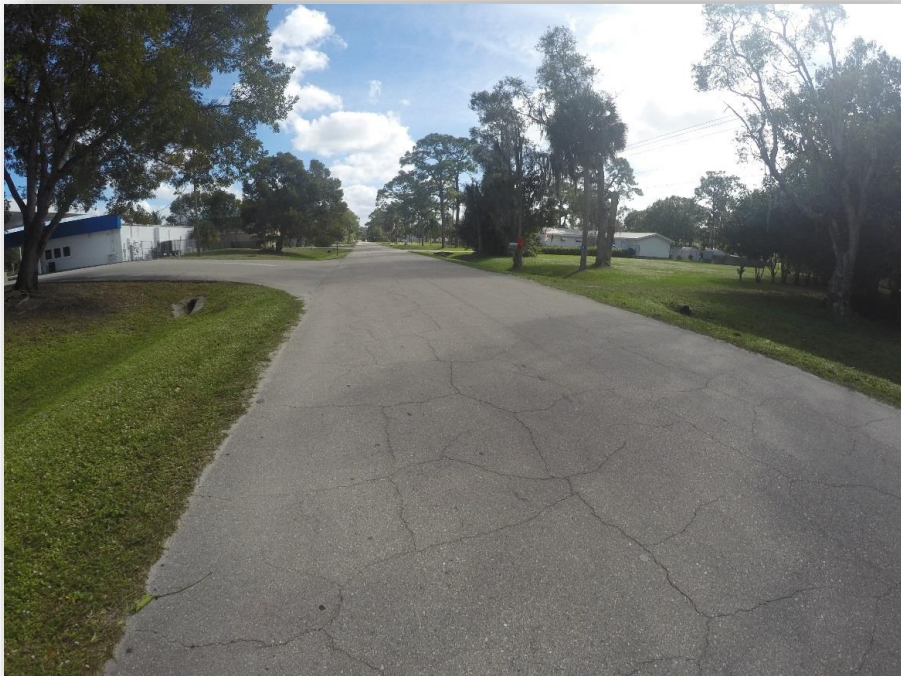
Figure 6: Type II Block Cracking Throughout – Trailside Drive

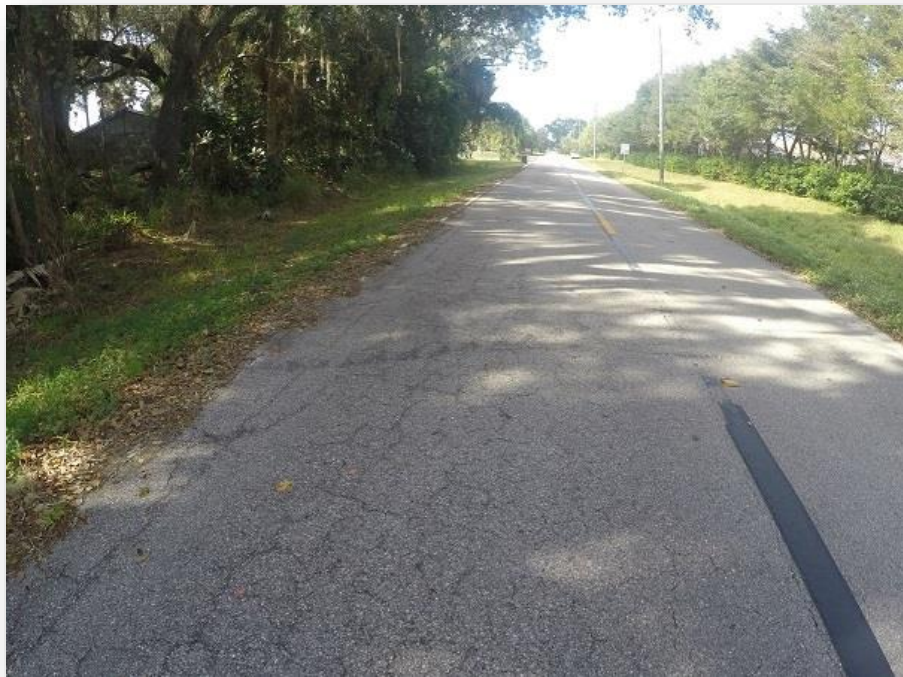
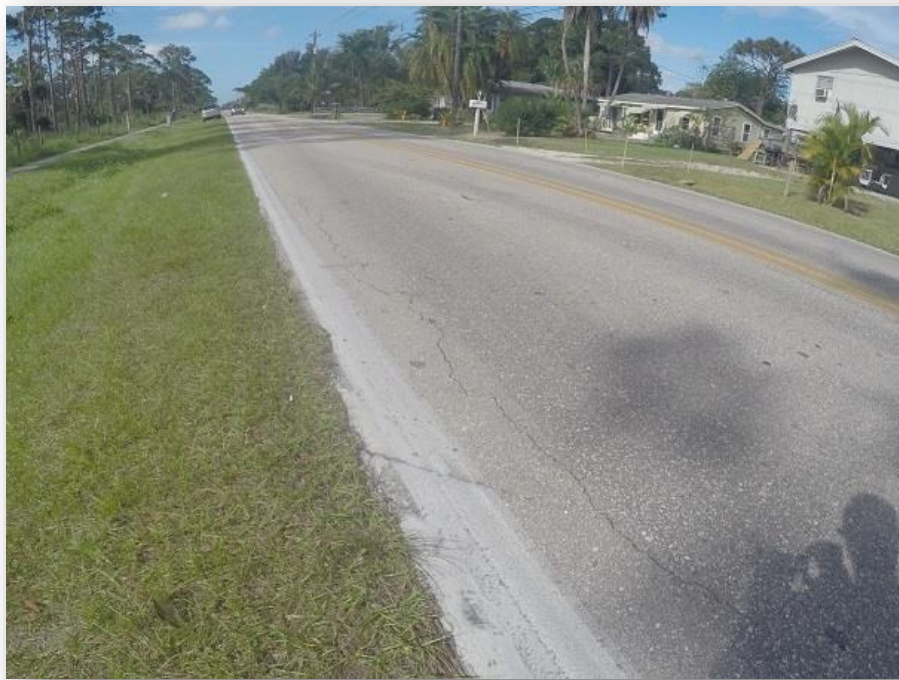
It is important, to also highlight Broadway Avenue (about 5 lane miles), Sandy Lane (about 1.5 lane miles); and Charing Cross Circle (about 1.25 lane miles). These three roadways contain some type II/III cracking and light-to-moderate raveling that may need additional attention. These are highlighted in yellow on the table. The distresses cover about forty percent (40%) of the surface area on these three roadways. Longitudinal and alligator cracking, especially in the wheel path or centerline, was present on Broadway Avenue (West side of US 41) (Figure 7) and Sandy Lane (Figure 8 & 9). About ten percent (10%) of back slope of drainage exits on the side of these roads. Although the cause of the distress observed on Broadway Avenue and Sandy Lane is beyond the scope of this work, it appears that the drainage provides inadequate lateral support which may in turn accelerate the deteriorating conditions on these roads.

Figure 7: Alligator and Longitudinal Cracking in Wheel Path - Broadway Avenue

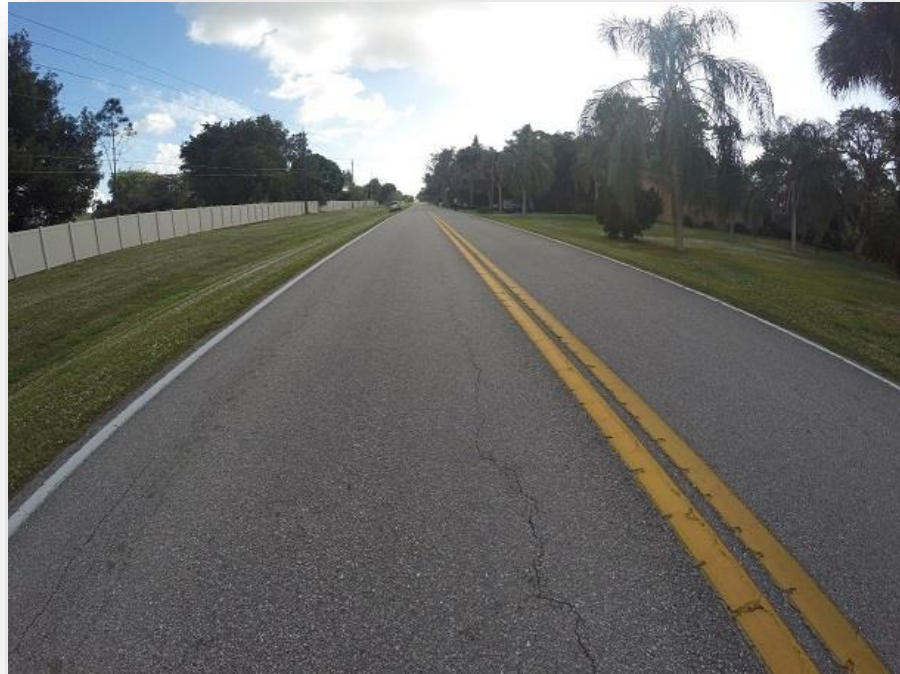
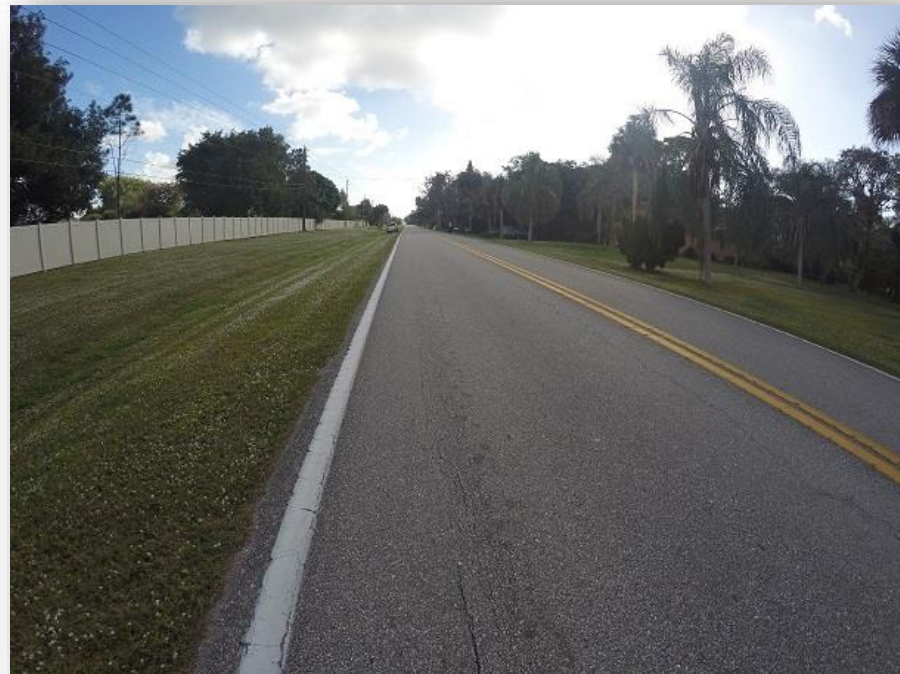
Figure 8 Longitudinal and Alligator Cracking in Wheel Path - Sandy Lane

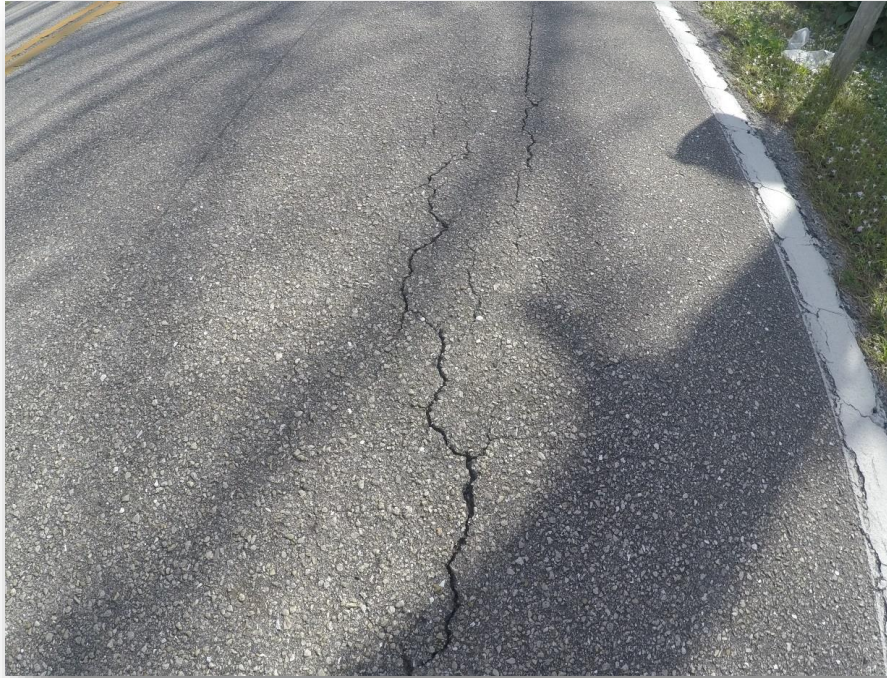
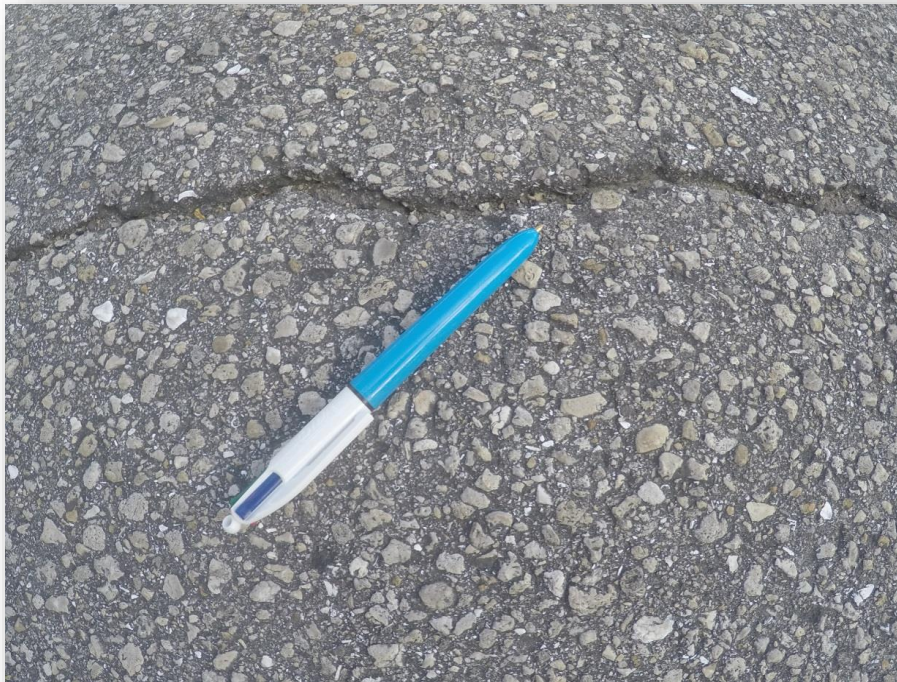
Figure 9: Type III Cracking Along Wheel Path – Sandy Lane

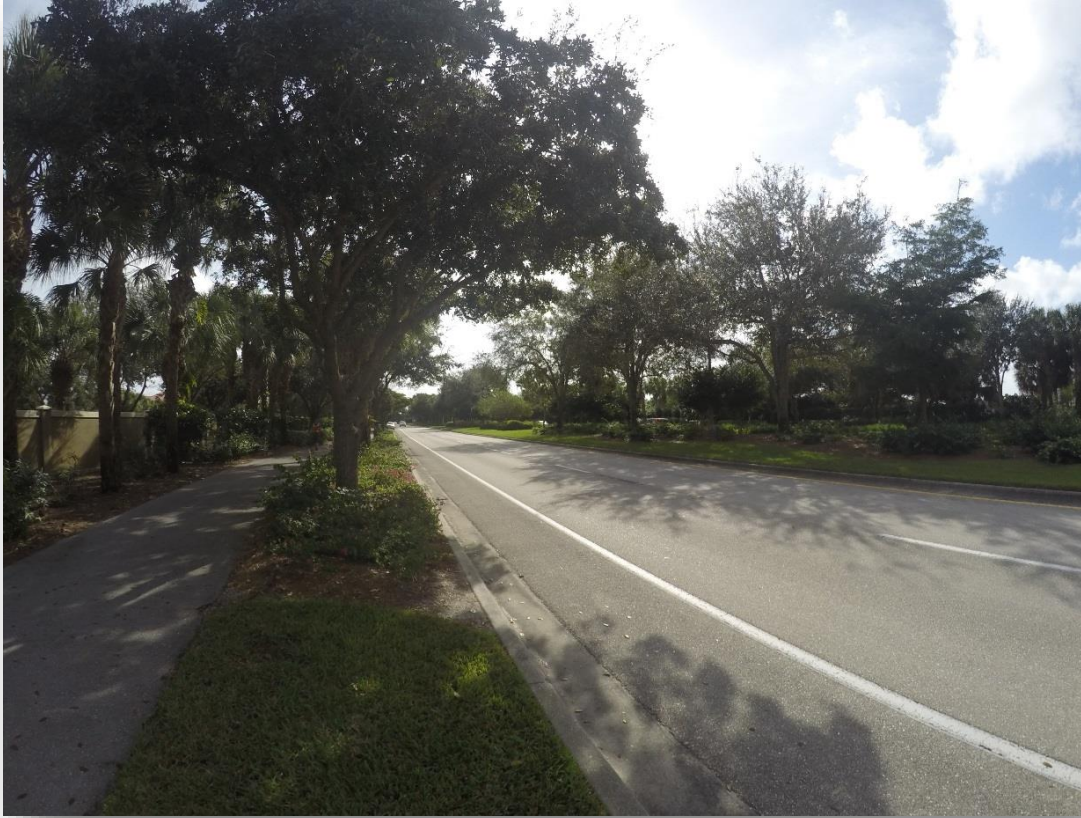
The rest of the roadways (Table 4) are in very good shape with only minor hair and/or very light raveling (see, for example, Coconut Road in Figure 10). These streets cover about 66 lane miles of pavement in the Village. Three Oaks Parkway showed some minimal cracking in between the wheel path (Figure 11). In addition only two (2) to five (5) percent of these distresses cover the surface area on these roads. As a result, no action is required on these streets.

Figure 10: Road in Very Good Condition - Coconut Road

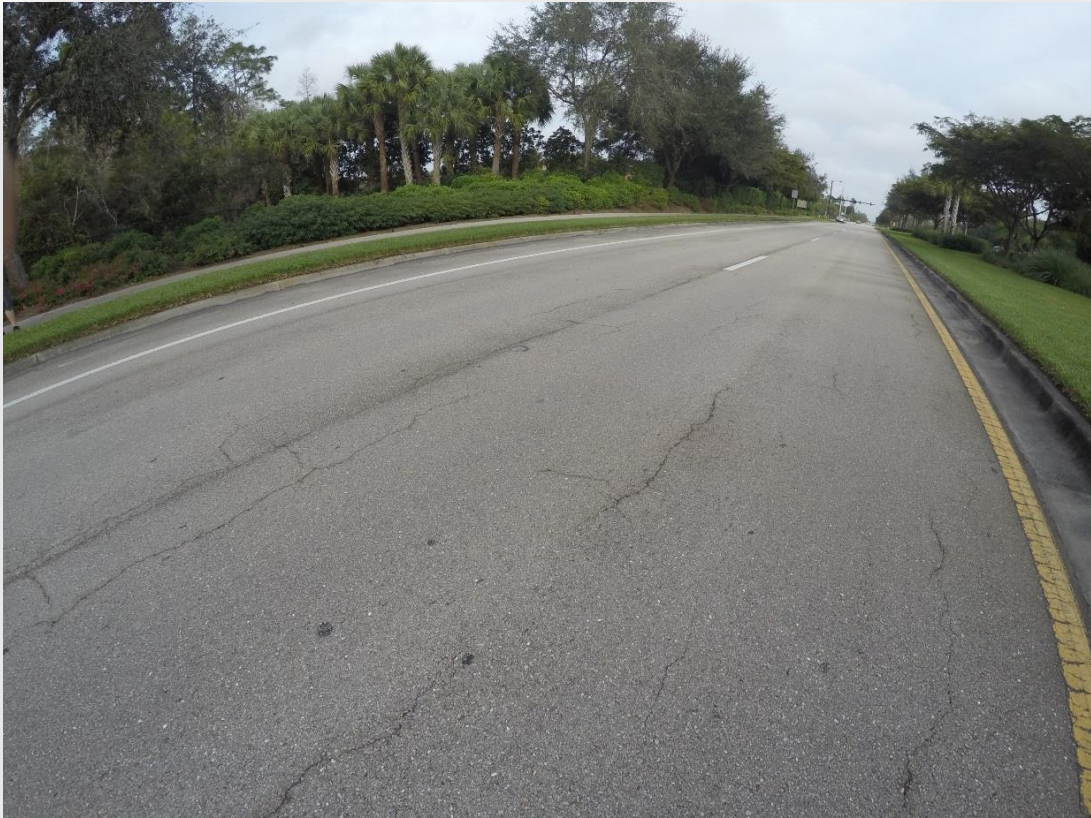
Figure 11: Minimal Cracking in Between Wheel Path - 3 Oaks Parkway
