**The Village of Estero
9401 Corkscrew Palms Circle
Estero, FL 33928**

DATE: May 26, 2020
SOLICITATION NO.: RFB 2020-06

SUBJECT: ADDENDUM NUMBER: Two (2)

REFERENCE: Estero on the River Structure Demolition

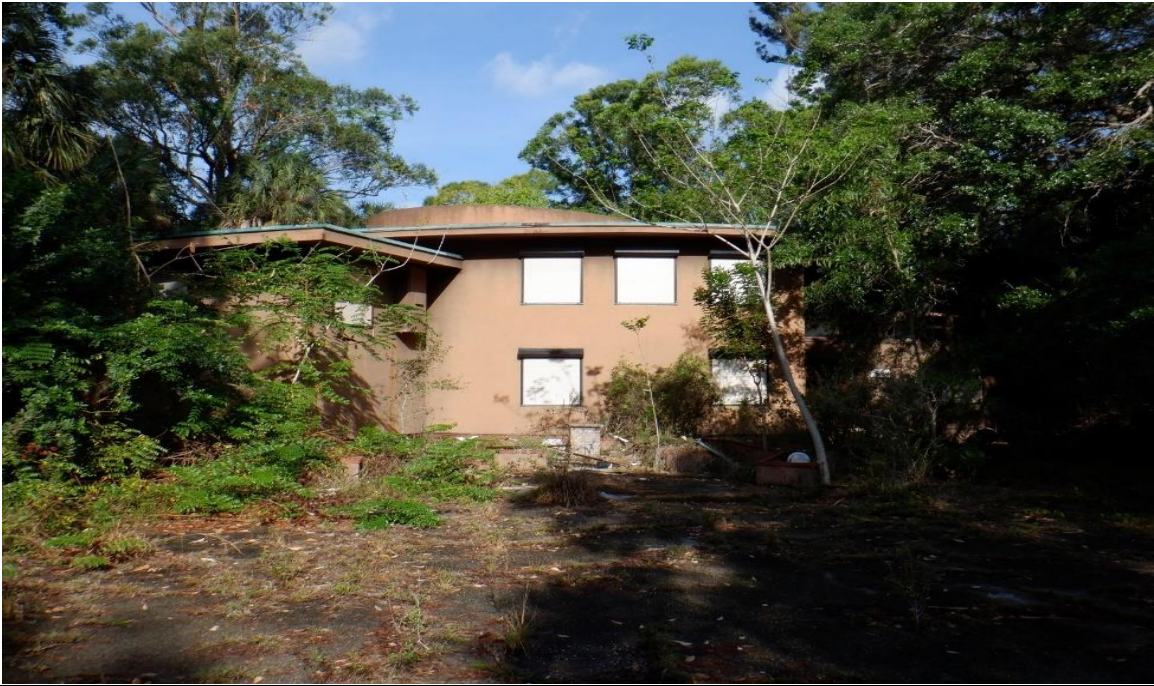
Photo 1: Structure 1 – 8661 Corkscrew Road 33928 – Front of two (2) story building.

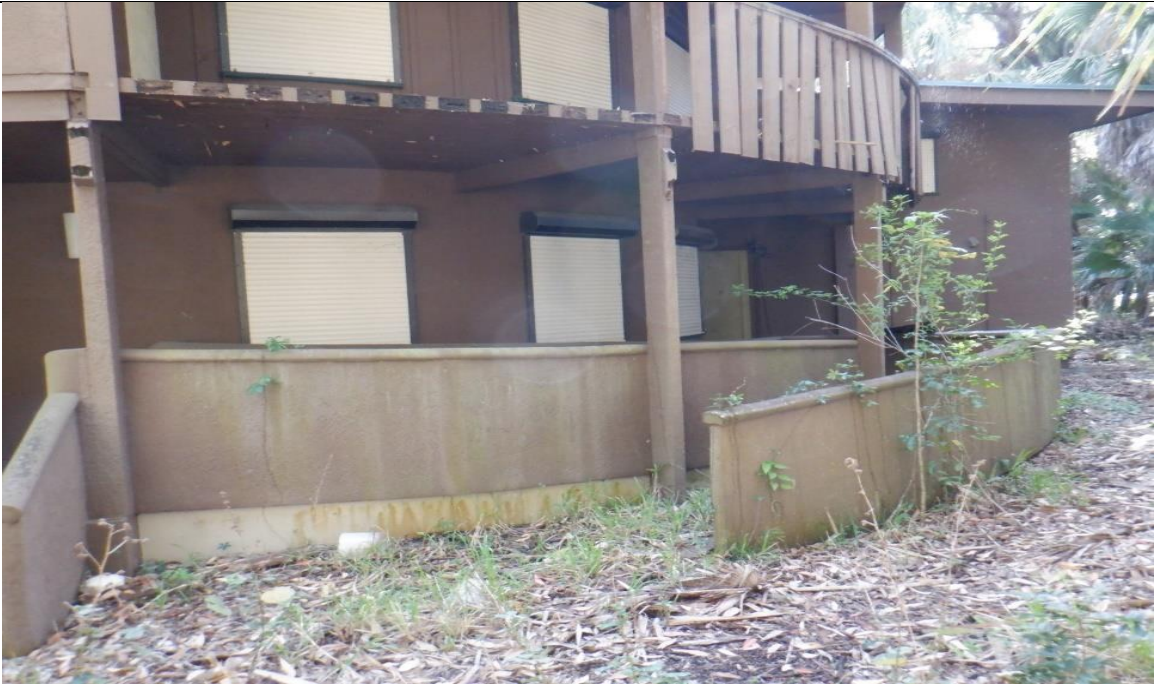
Photo 2: Structure 1 - 8661 Corkscrew Road 33928 – Rear of two (2) story building.

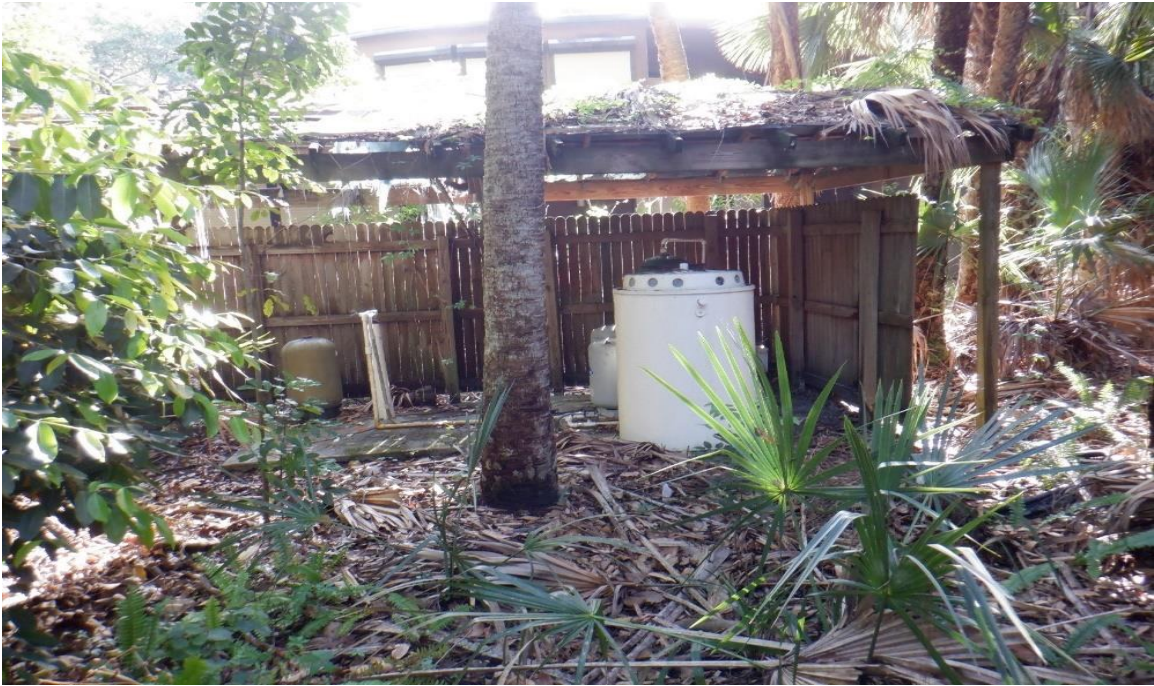
Photo 3: Structure 1 - 8661 Corkscrew Road 33928 – Woodshed for well and water equipment.

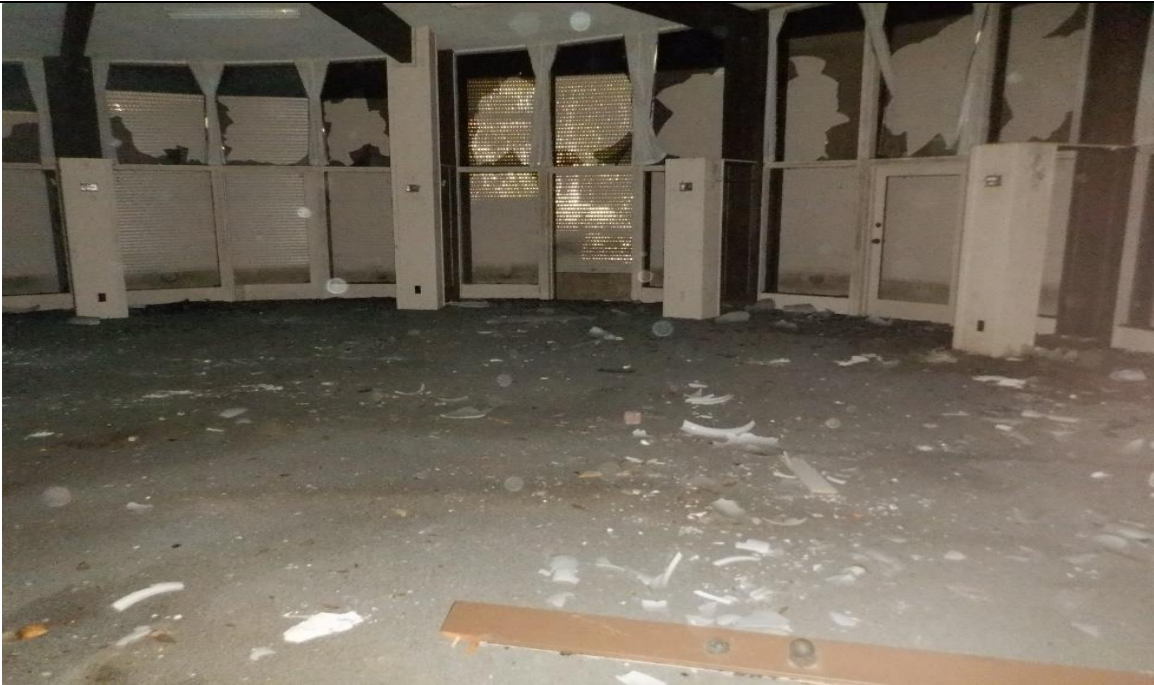
Photo 4: Structure 1 - 8661 Corkscrew Road 33928 – Interior of two (2) story building.

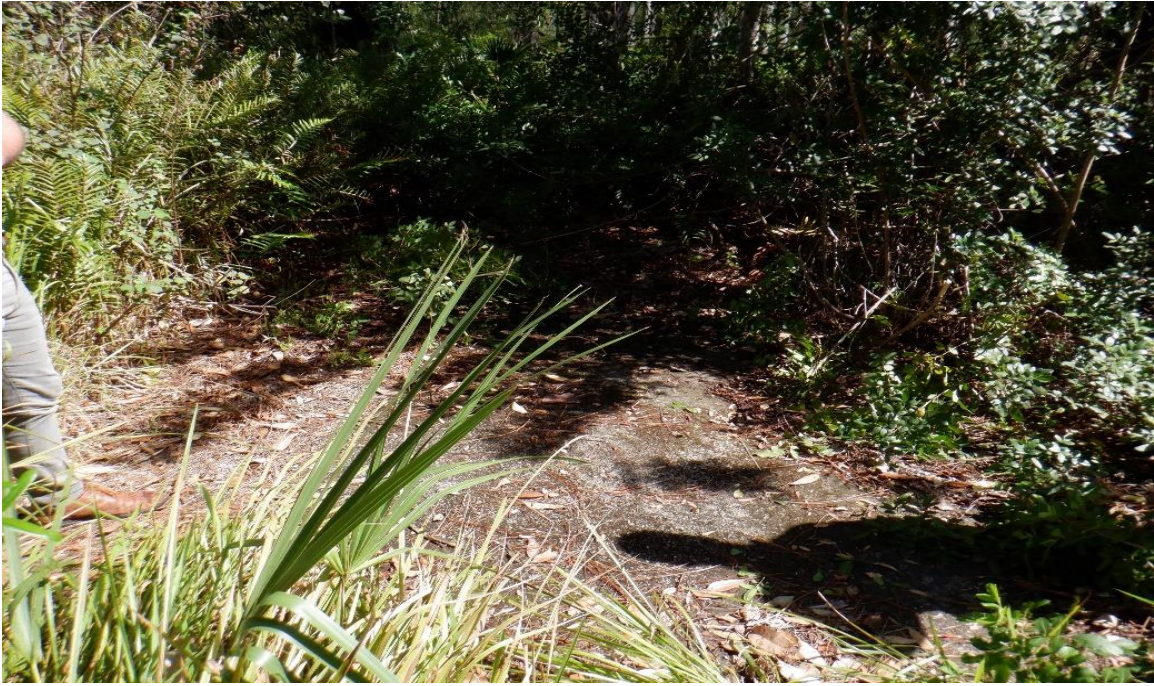
Photo 5: Structure 2 – Concrete slab approximately 100 ft²

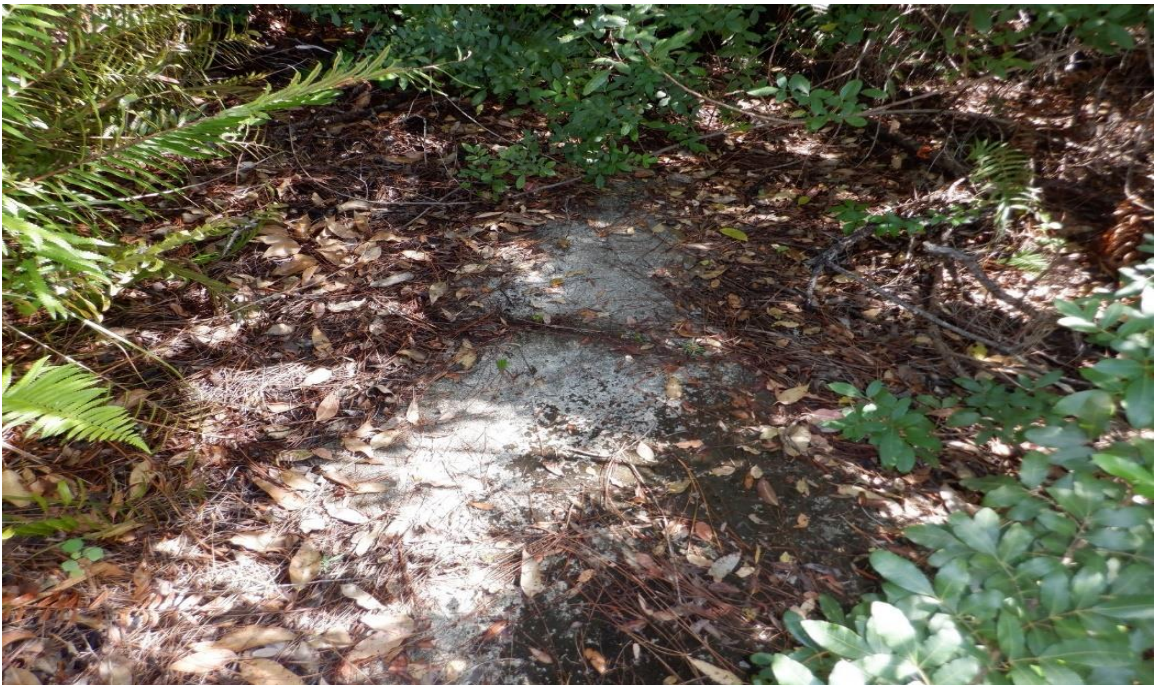
Photo 6: Structure 2 – Concrete slab approximately 100 ft²

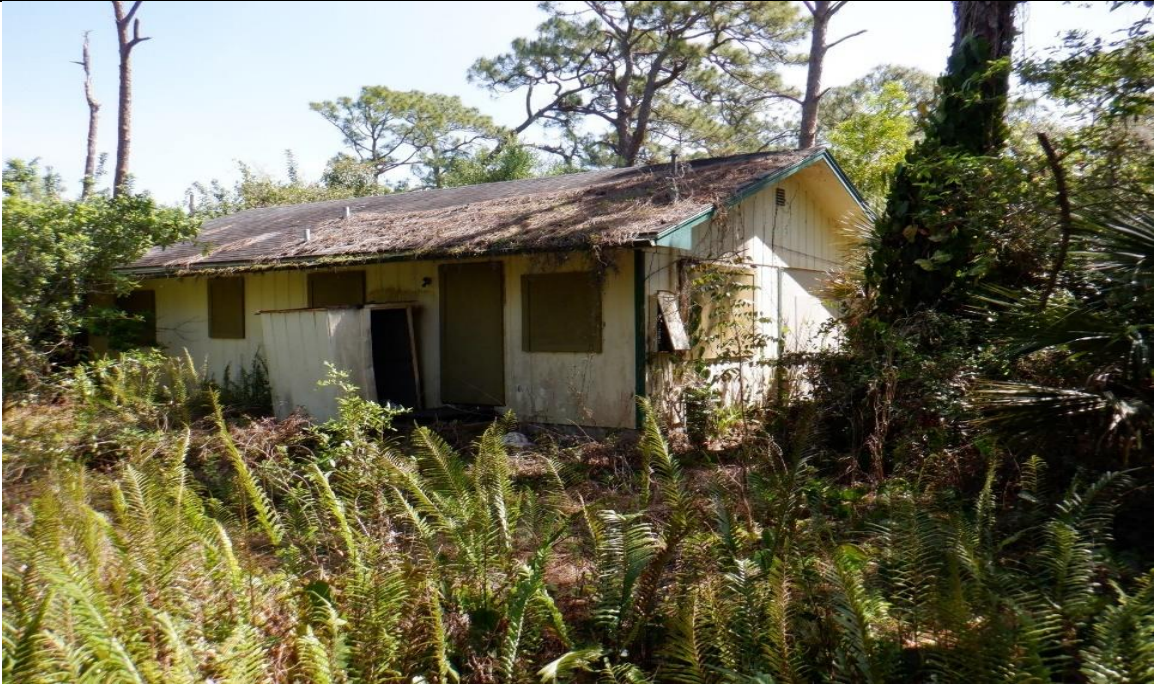
Photo 7: Structure 3 – 8741 Corkscrew Road 33928 – One (1) story wood framed house approximately 900 ft²

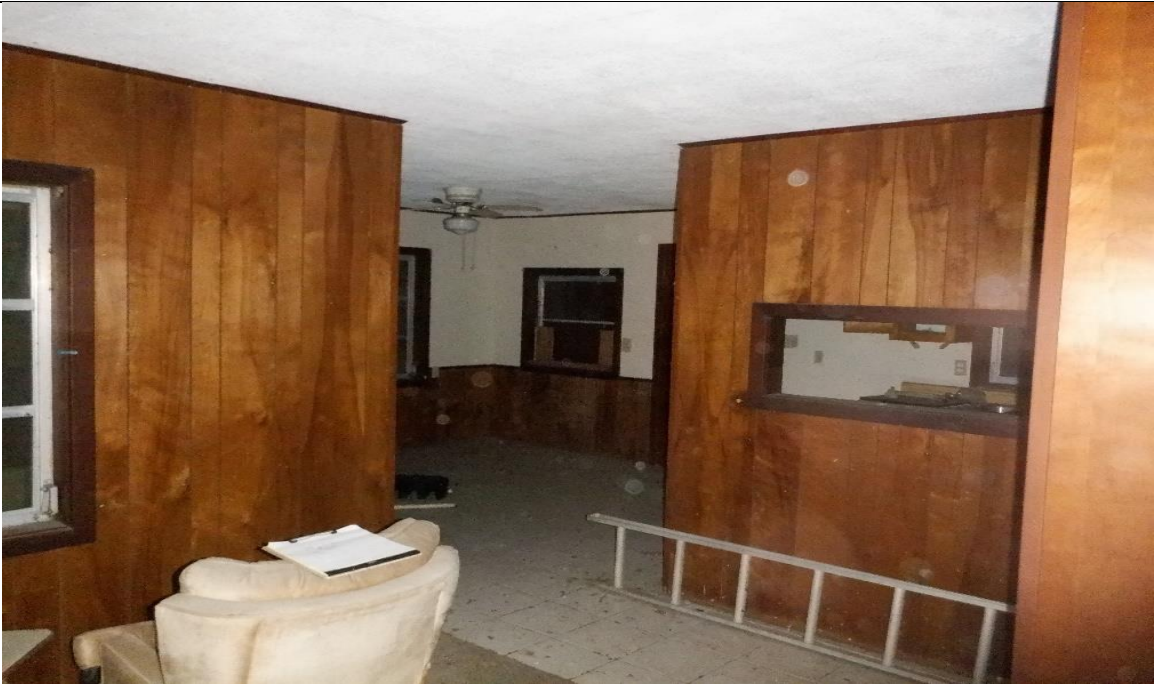
Photo 8: Structure 3 – 8741 Corkscrew Road 33928 – Interior view of the one (1) story wood framed house approximately 900 ft²

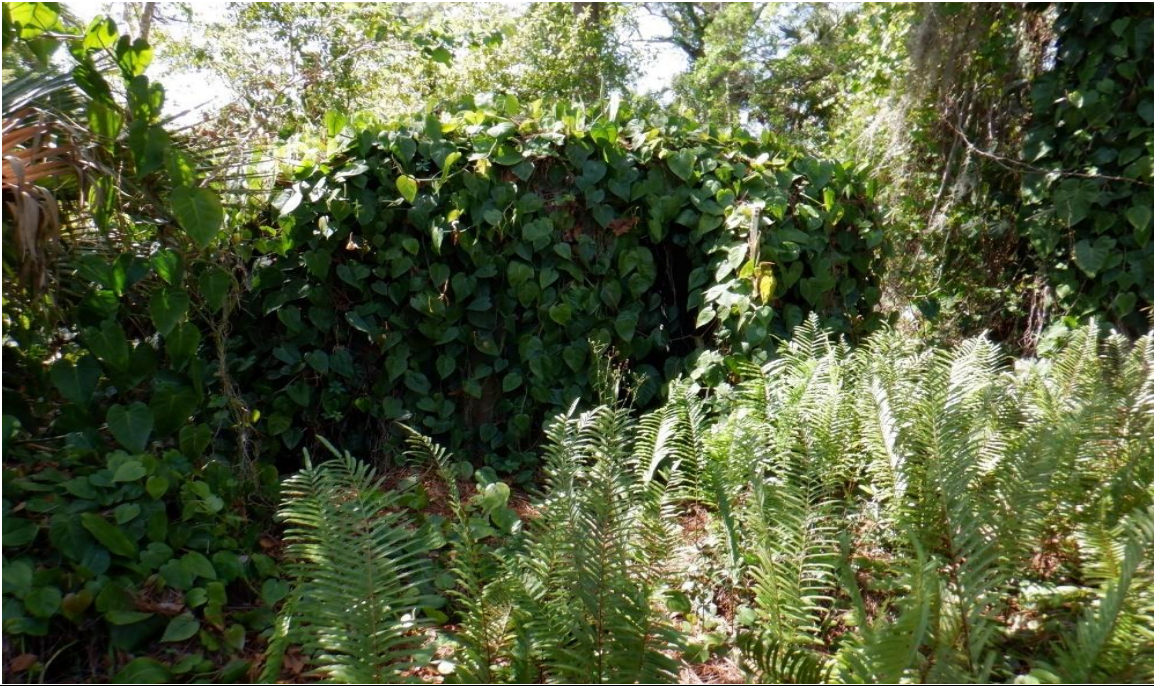
Photo 9: Structure 3 – 8741 Corkscrew Road 33928 – Hidden metal shed approximately 50 ft²

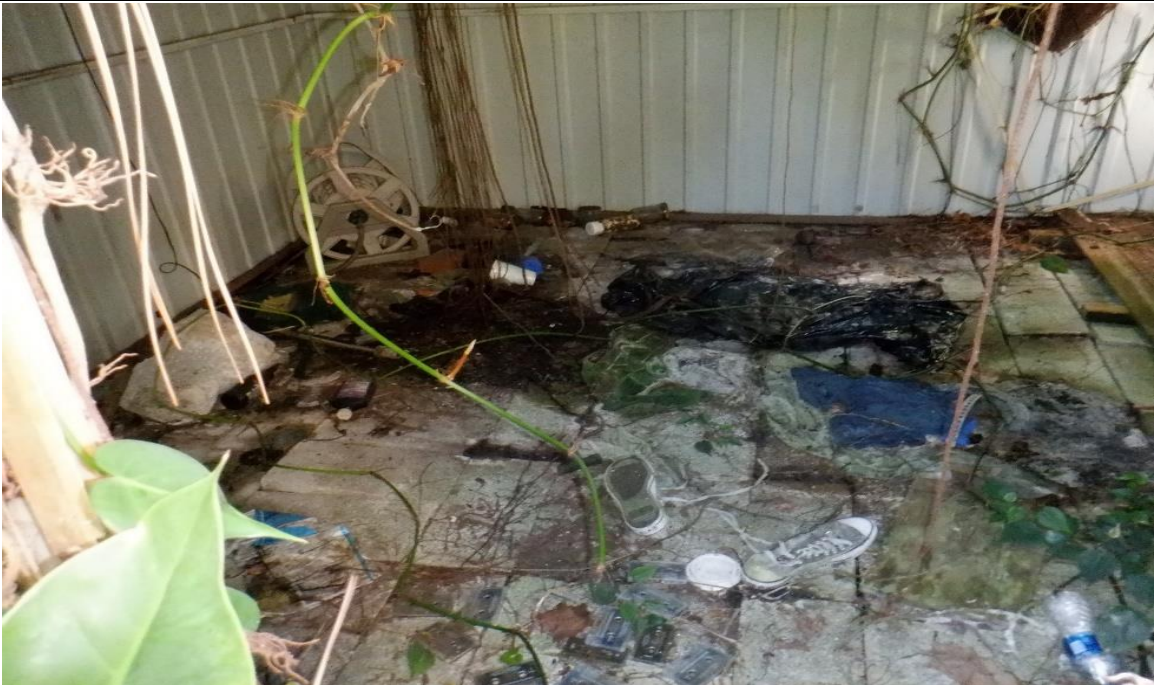
Photo 10: Structure 3 – 8741 Corkscrew Road 33928 - Interior view of hidden shed approximately 50 ft²

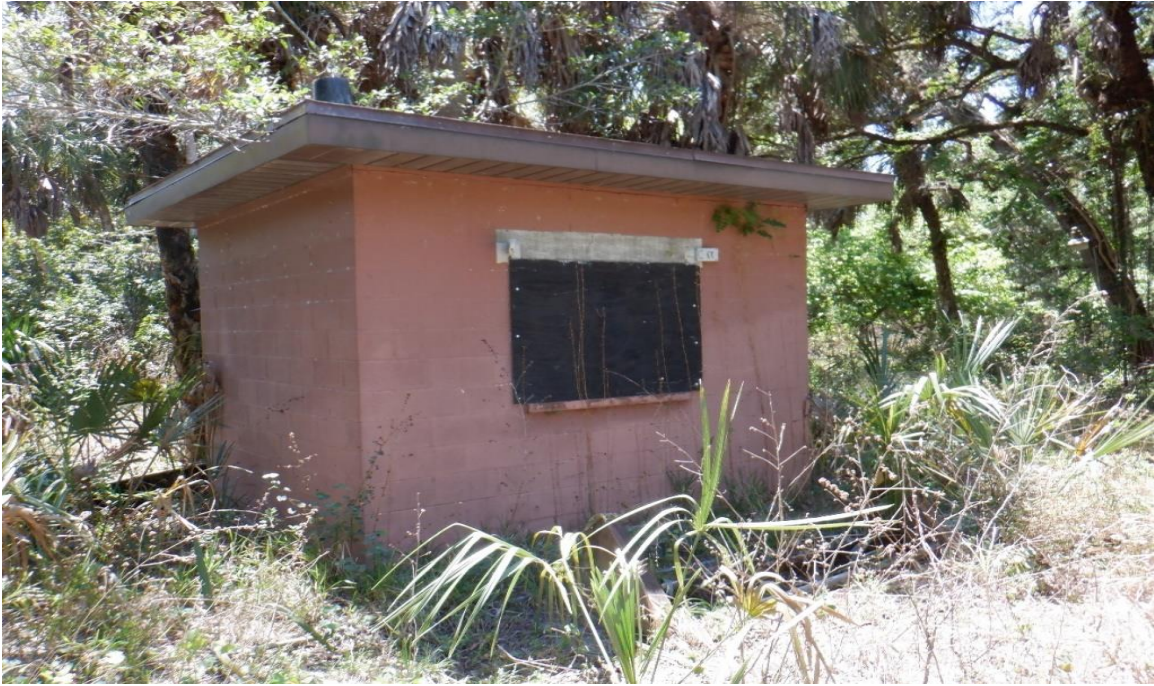
Photo 11: Structure 4 – Concrete Block Shed Pumphouse approximately 50 ft²

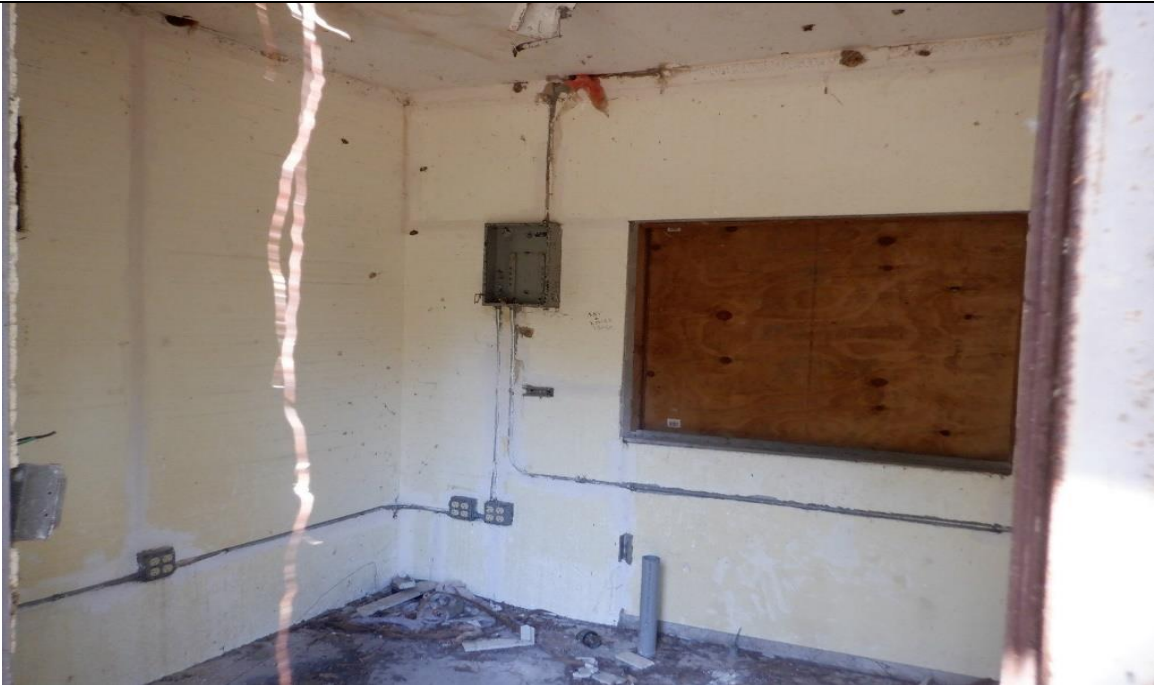
Photo 12: Structure 4 – Interior view of Concrete Block Shed Pumphouse approximately 50 ft²

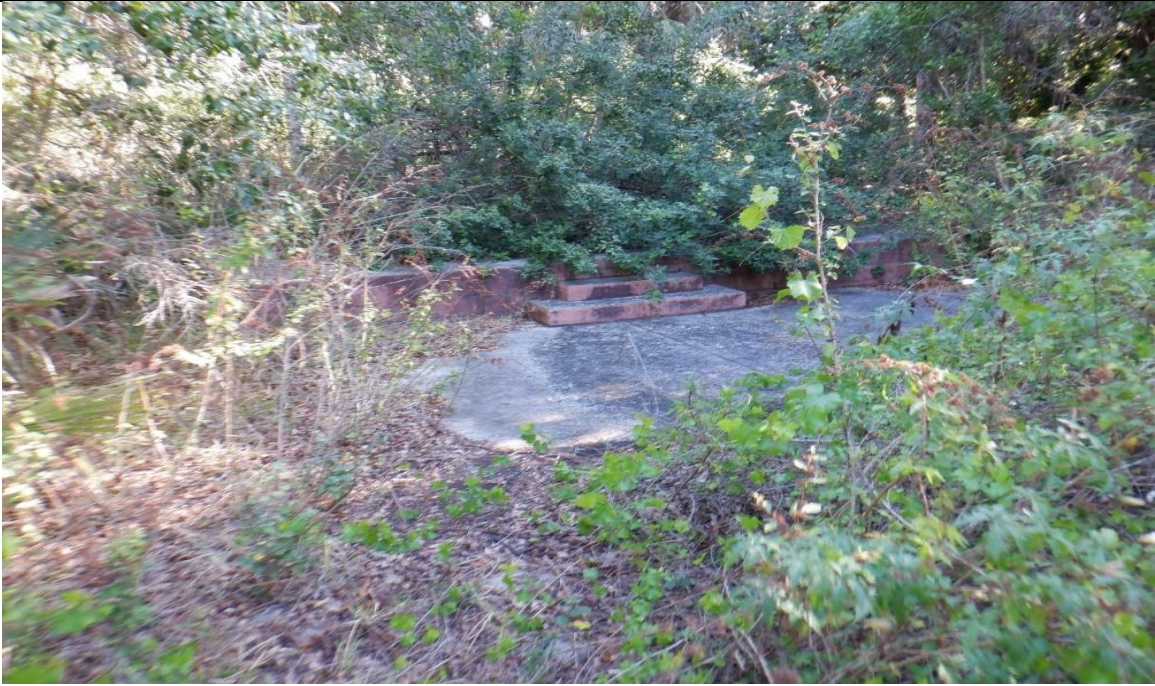
Photo 13: Structure 5 - Concrete Slab (Stage) approximately 625 ft²

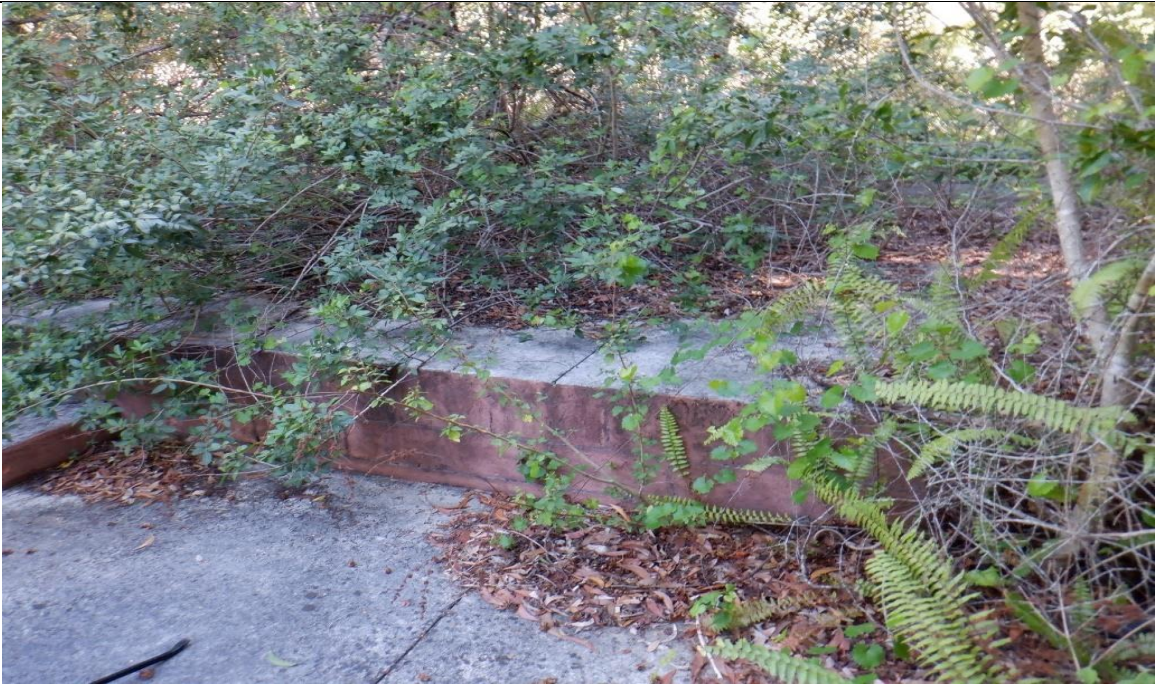
Photo 14: Structure 5 Concrete Slab (Stage) approximately 625 ft²

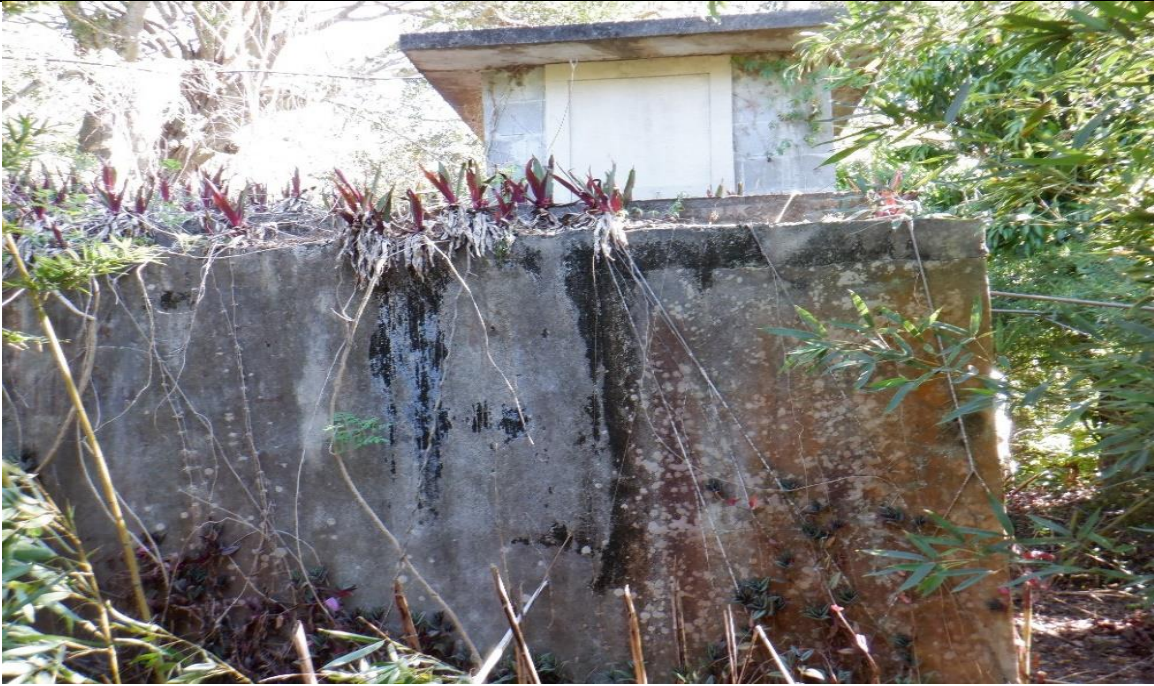
Photo 15: Structure 6 – Concrete aboveground bomb shelter approximately 400 ft²

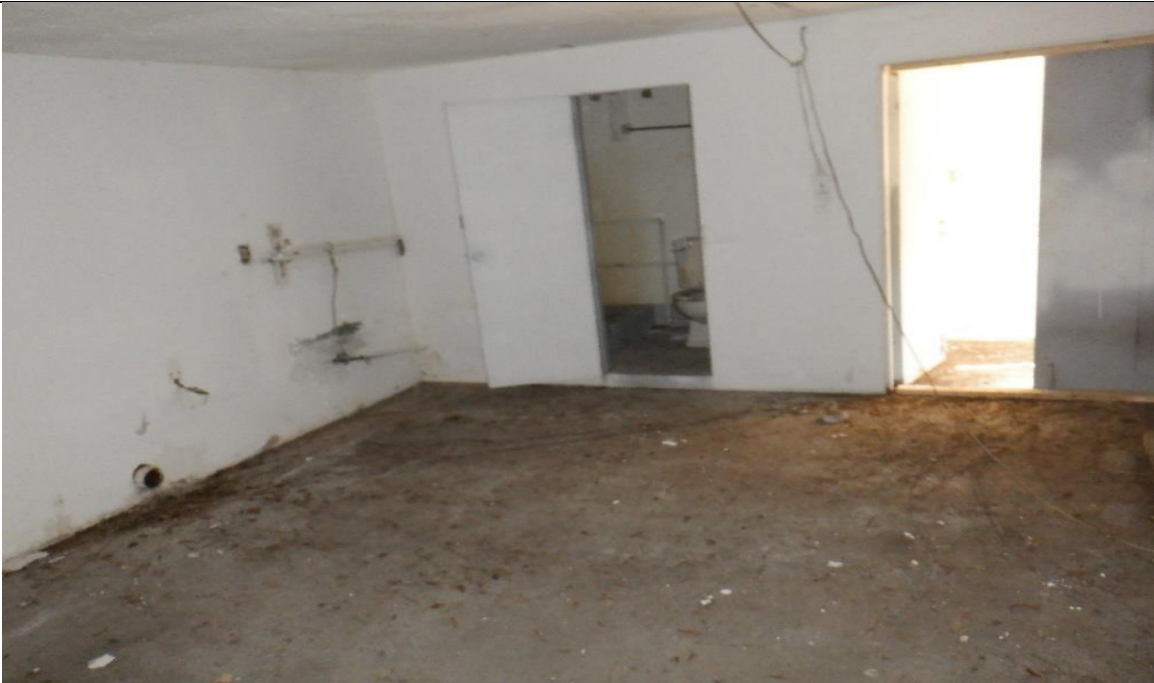
Photo 16: Structure 6 – Interior view of concrete aboveground bomb shelter approximately 400 ft²

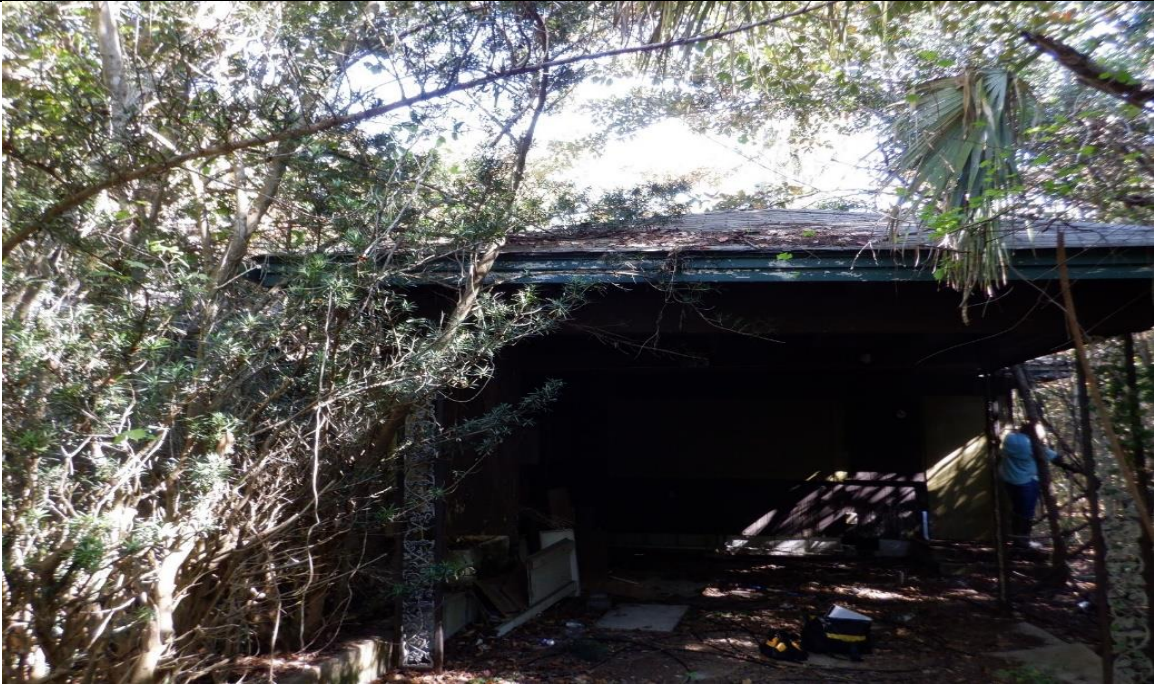
Photo 17: Structure 7 – 8761 Corkscrew Road 33928 – One (1) story wood framed house & concrete slab garage.

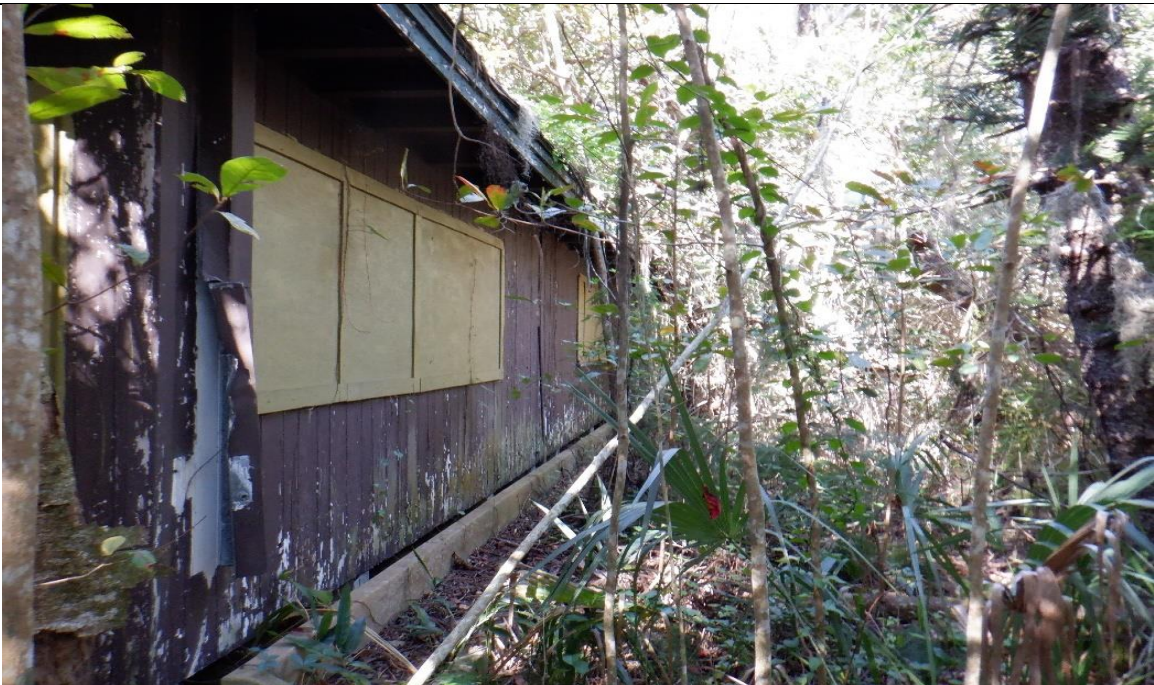
Photo 18: Structure 7 - 8761 Corkscrew Road 33928 – Side view of the one (1) story wood framed house.

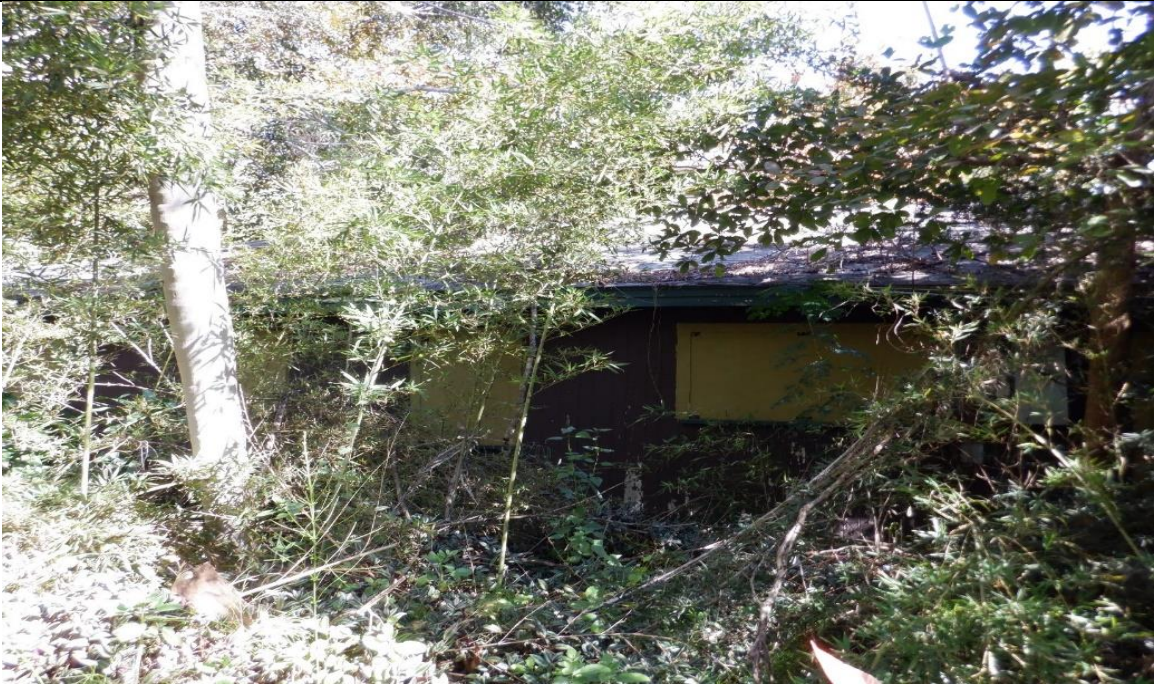
Photo 19: Structure 7 - 8761 Corkscrew Road 33928 – Front view of the one (1) story wood framed house.

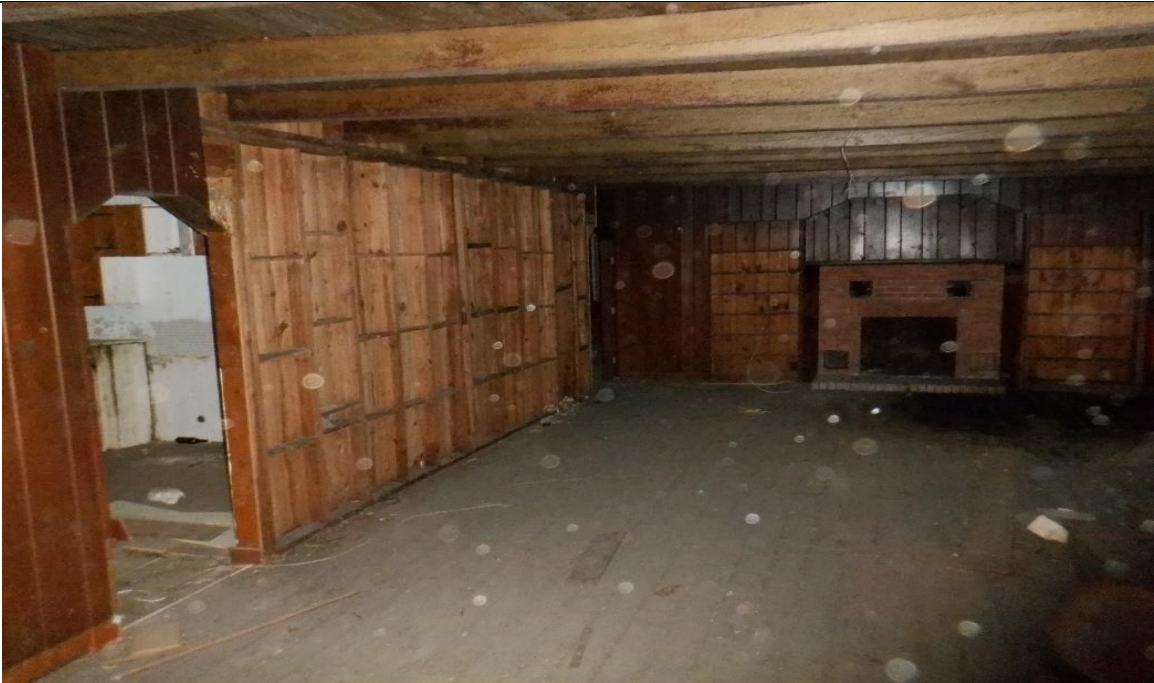
Photo 20: Structure 7 - 8761 Corkscrew Road 33928 – Interior view of the one (1) story wood framed house.

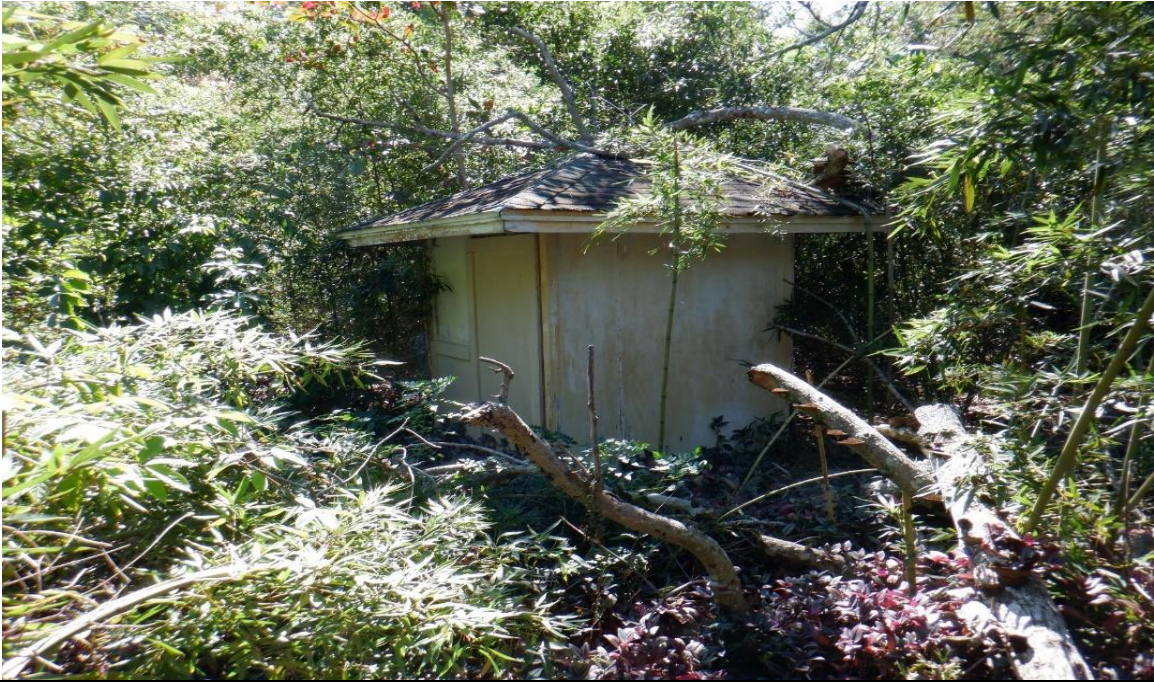
Photo 21: Structure 8 – Wood framed shed for well equipment.

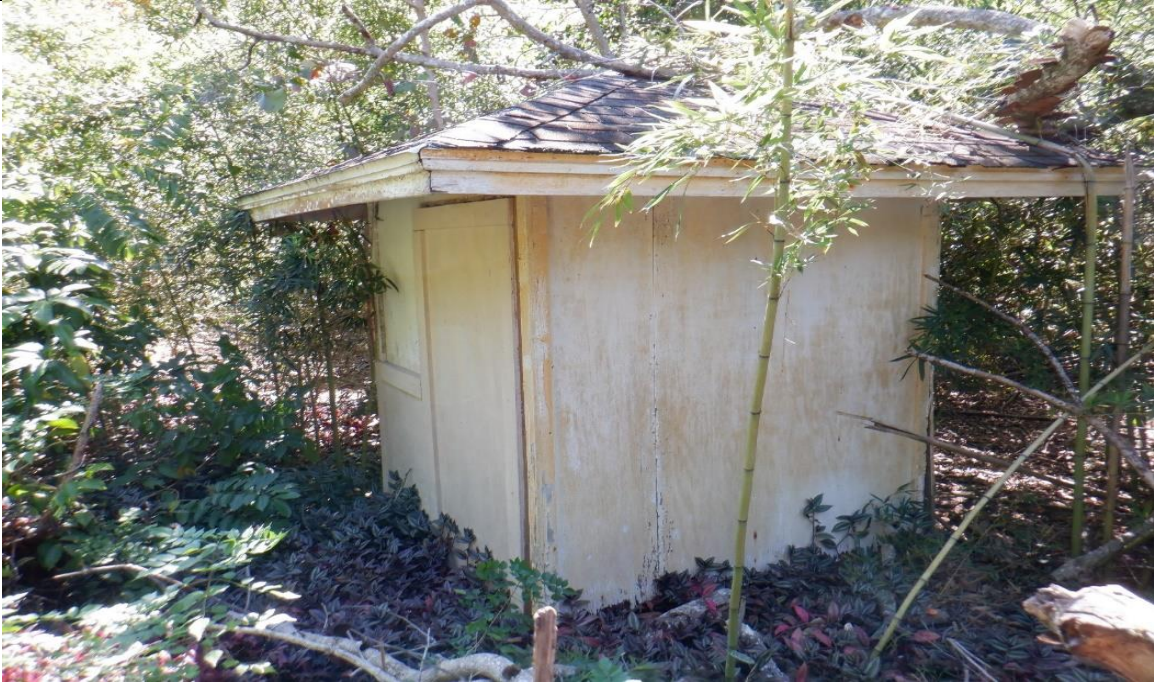
Photo 22: Structure 8 - Wood framed shed for well equipment.

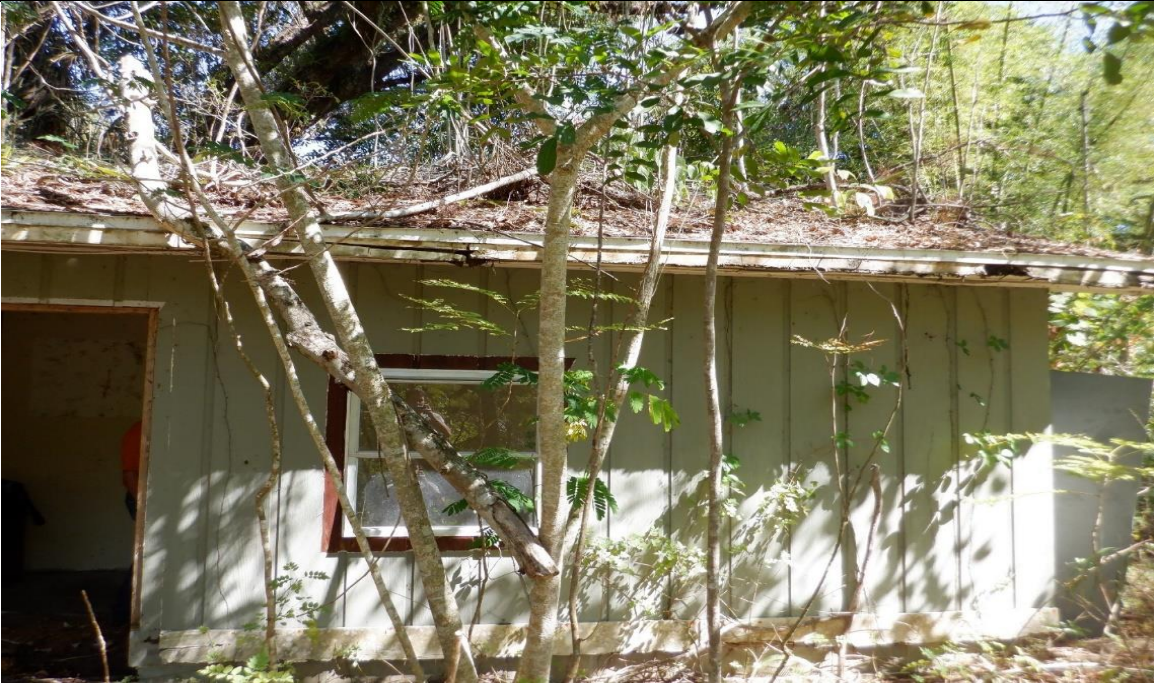
Photo 23: Structure 9 – One (1) story residential structure, wood framed, and addition is on a concrete slab.

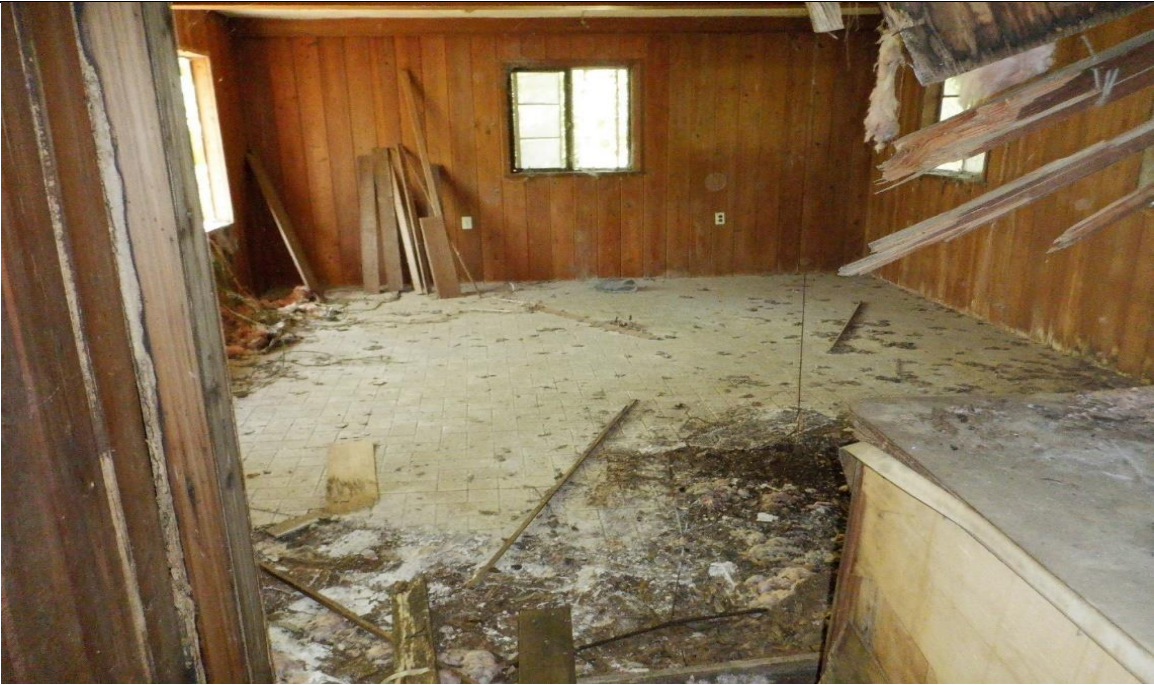
Photo 24: Structure 9 - Interior view of one (1) story residential structure.

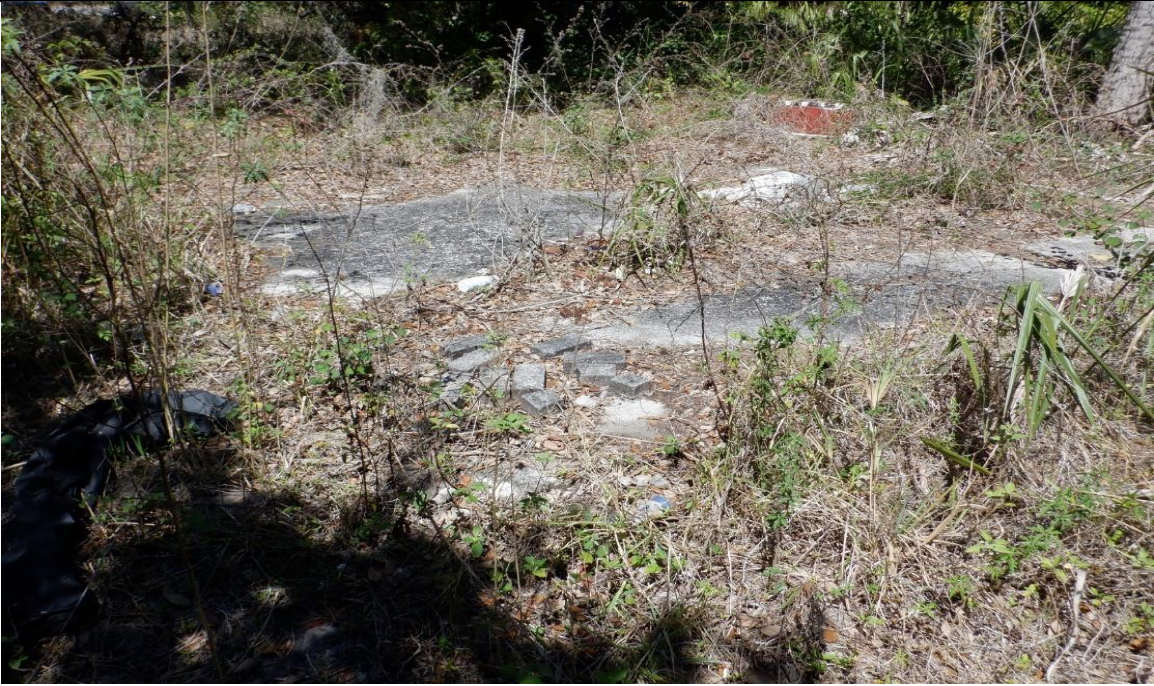
The pile of concrete off to the side of the path is part of Structure #10.

Photo 25: Structure 10 - Concrete slab approximately 500 ft²

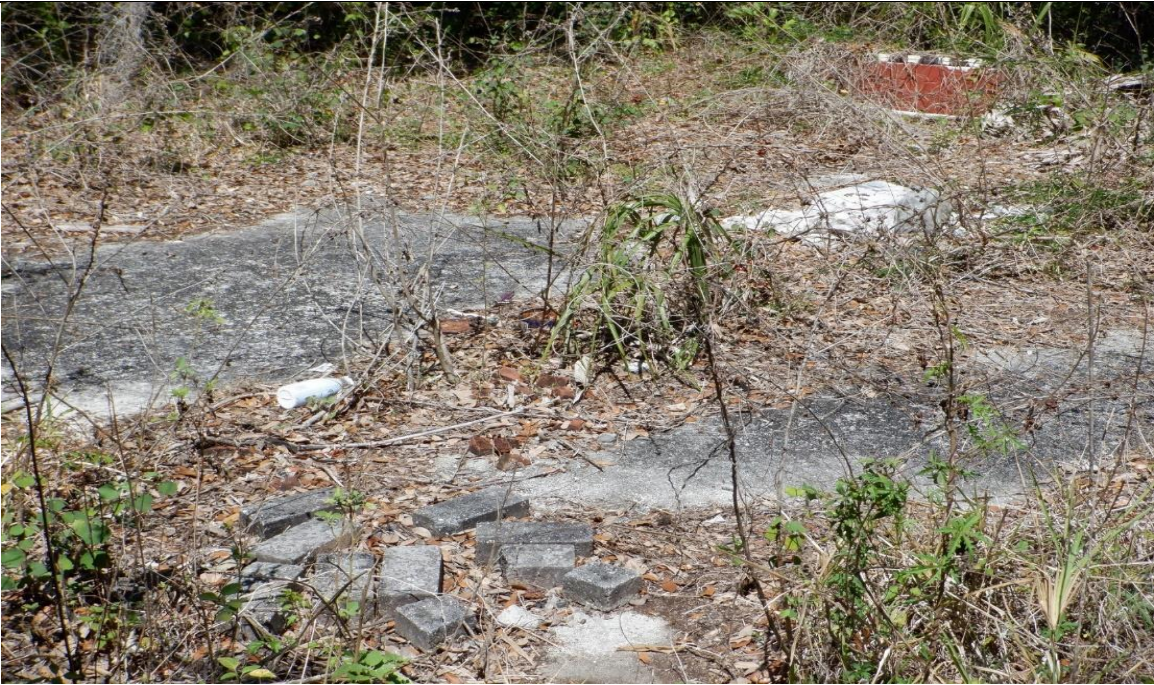
Photo 26: Structure 10 - Concrete slab approximately 500 ft²

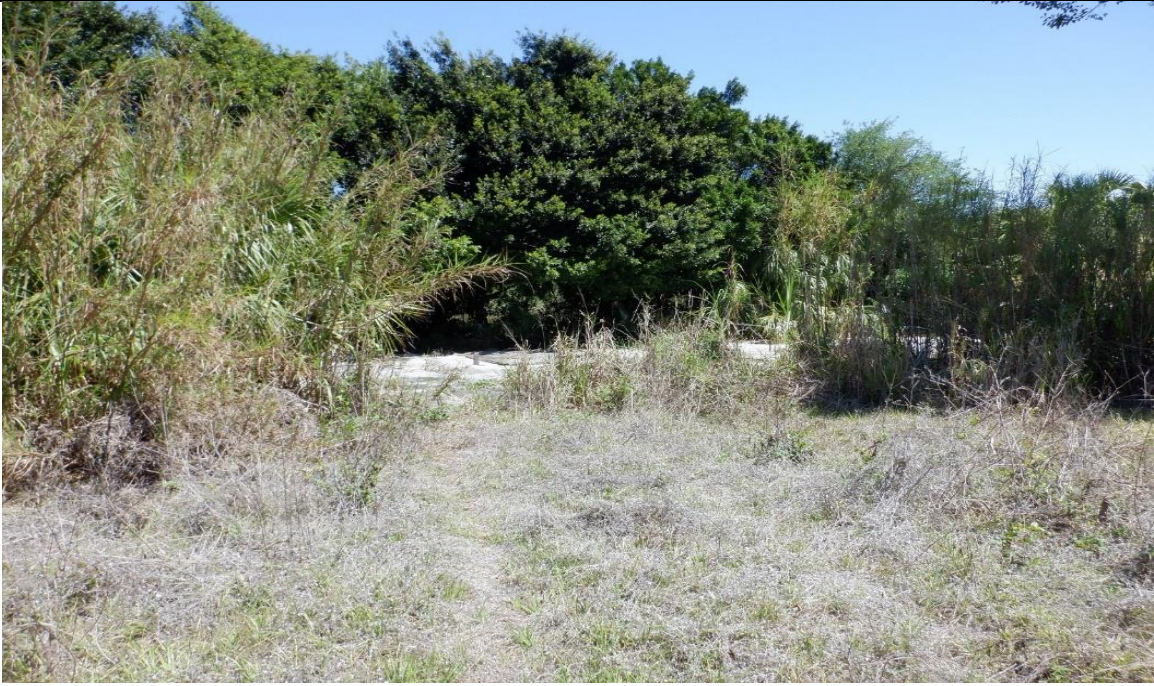
Photo 27: Structure 11 – 20911 Highlands Avenue 33928 – Concrete slab approximately 1,300 ft²

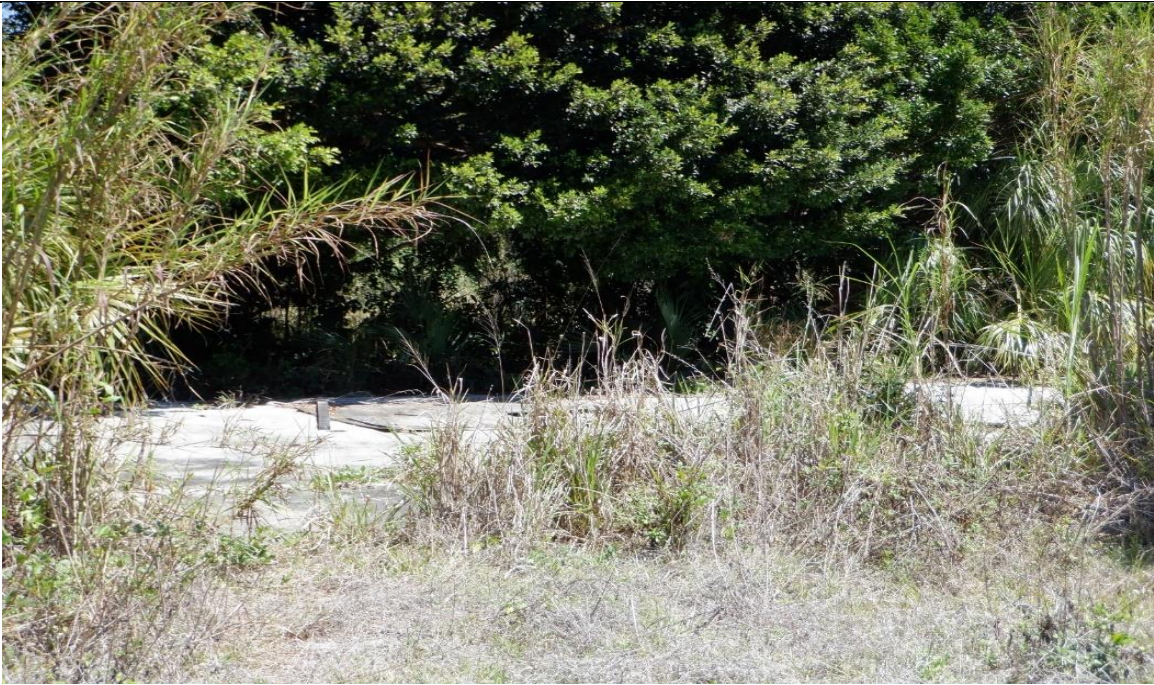
Photo 28: Structure 11 - 20911 Highlands Avenue 33928 – Concrete slab approximately 1,300 ft²
