**The Village of Estero
9401 Corkscrew Palms Circle
Estero, FL 33928**

DATE: May 26, 2020
SOLICITATION NO.: RFB 2020-06

SUBJECT: ADDENDUM NUMBER: Two (2)

REFERENCE: Estero on the River Structure Demolition

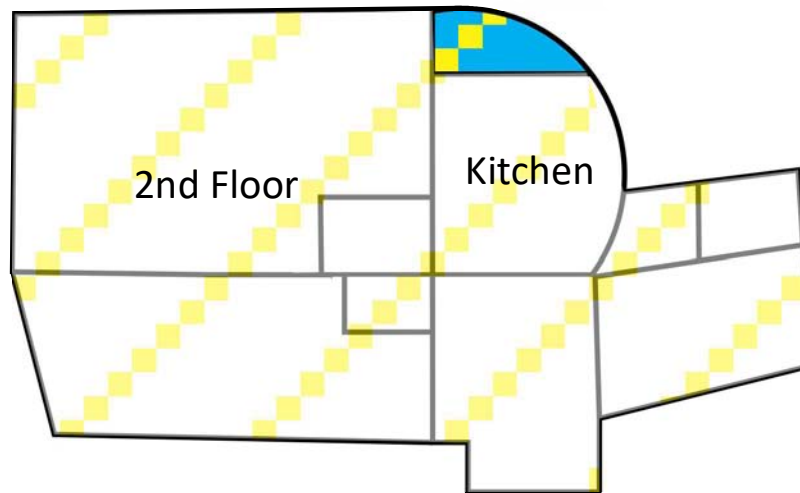
ACM Location Map

-   =HM-C: Rolled Vinyl Flooring, Yellow Pebble Pattern
-   =HM-I: Sink Insulation, Pink
-   =HM-K: Built-up Roofing, Black
-   =HM-O: Rolled Vinyl Flooring, Yellow Floral Pattern

AMRC recommends that materials identified as Asbestos-Containing Materials (ACM), while in place, be maintained through an Operations and Maintenance (O&M) program until they must be disturbed or removed as a result of renovation or demolition. If these materials become significantly damaged and/or require extensive repair activities, access to the areas of damaged ACM should be restricted and the material should be removed by a Florida Licensed Asbestos Abatement contractor.

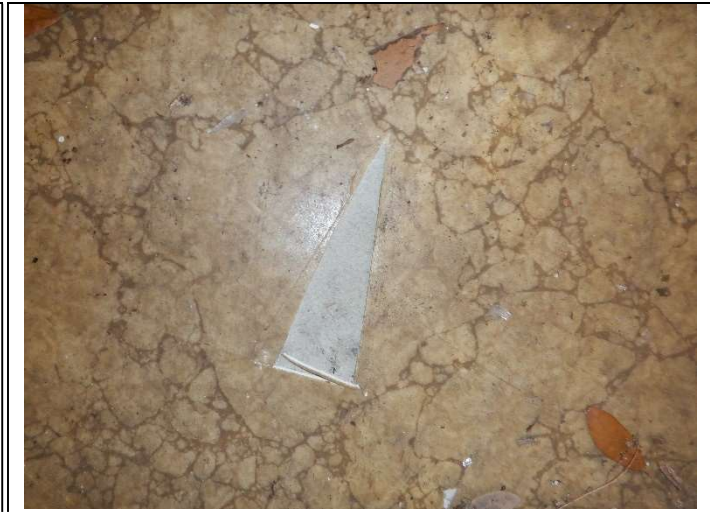
HM-C: Rolled Vinyl Flooring, Yellow Pebble Pattern

Category I non-friable materials may remain in the building during demolition if wet methods are utilized. All materials must be kept adequately wet during the demolition to prevent the release of asbestos fibers. In addition, the work practices for the demolition of a building containing asbestos must be in regulatory compliance with OSHA 1926.1101. A certified asbestos "competent" supervisor must perform or supervise the work. If during the demolition process visible emissions are observed, the asbestos-containing materials must then be abated. Category I non-friable materials identified within the structure included **rolled vinyl flooring, built-up roofing, 9" x 9" vinyl floor tile and 12" x 12" vinyl floor tile.**

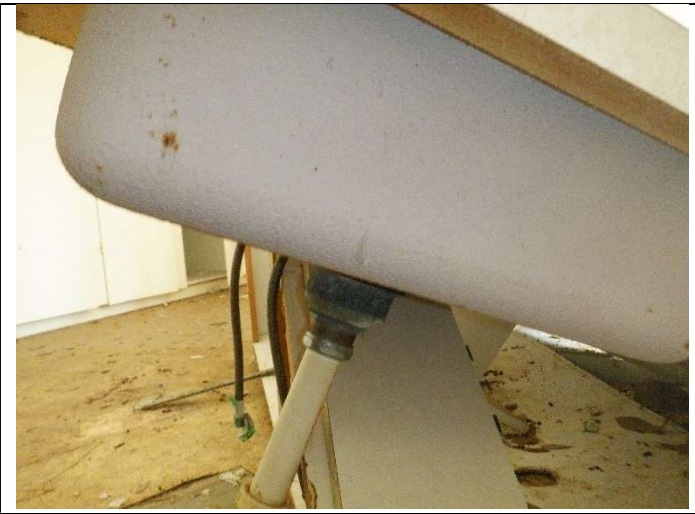
HM-I: Sink Insulation, Pink

Category II non-friable materials, such as **sink insulation and window glaze**, that are in good condition are typically not considered regulated NESHAP asbestos-containing materials. It is not until the material's condition begins to deteriorate or it is disturbed in a manner that will allow for the release of fibers, that control procedures are necessary. The materials designated as Category II non-friable include those that will become friable during traditional demolition activities. These materials must be removed by a Florida Licensed Asbestos Abatement Contractor prior to demolition of the structure. Category II non-friable materials identified within the structure include **sink insulation and window glaze**.

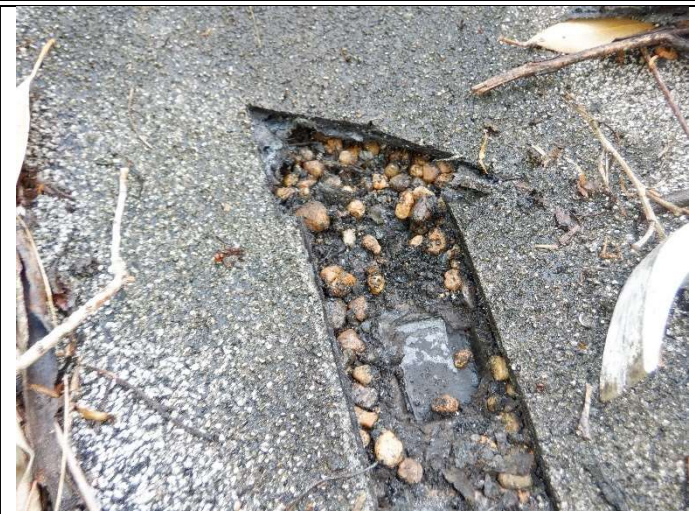
HM-K: Built-up Roofing, Black

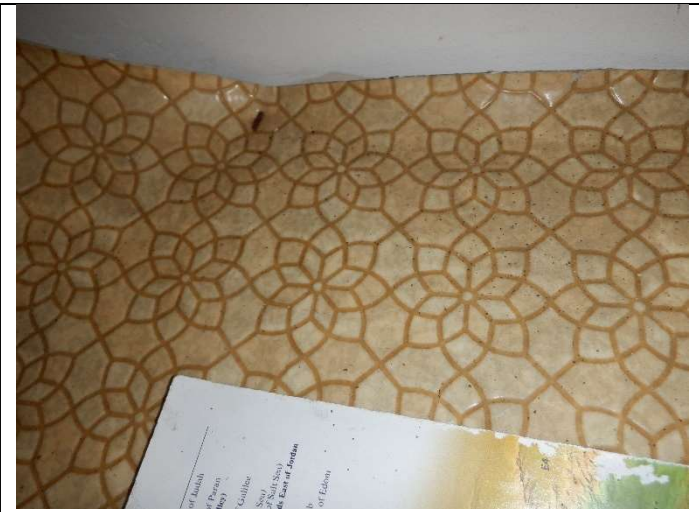
HM-O: Rolled Vinyl Flooring, Yellow Floral Pattern
