ESTERO INFRASTRUCTURE INVENTORY PROJECT

JANUARY 2016

PREPARED FOR THE VILLAGE OF
ESTERO, FL

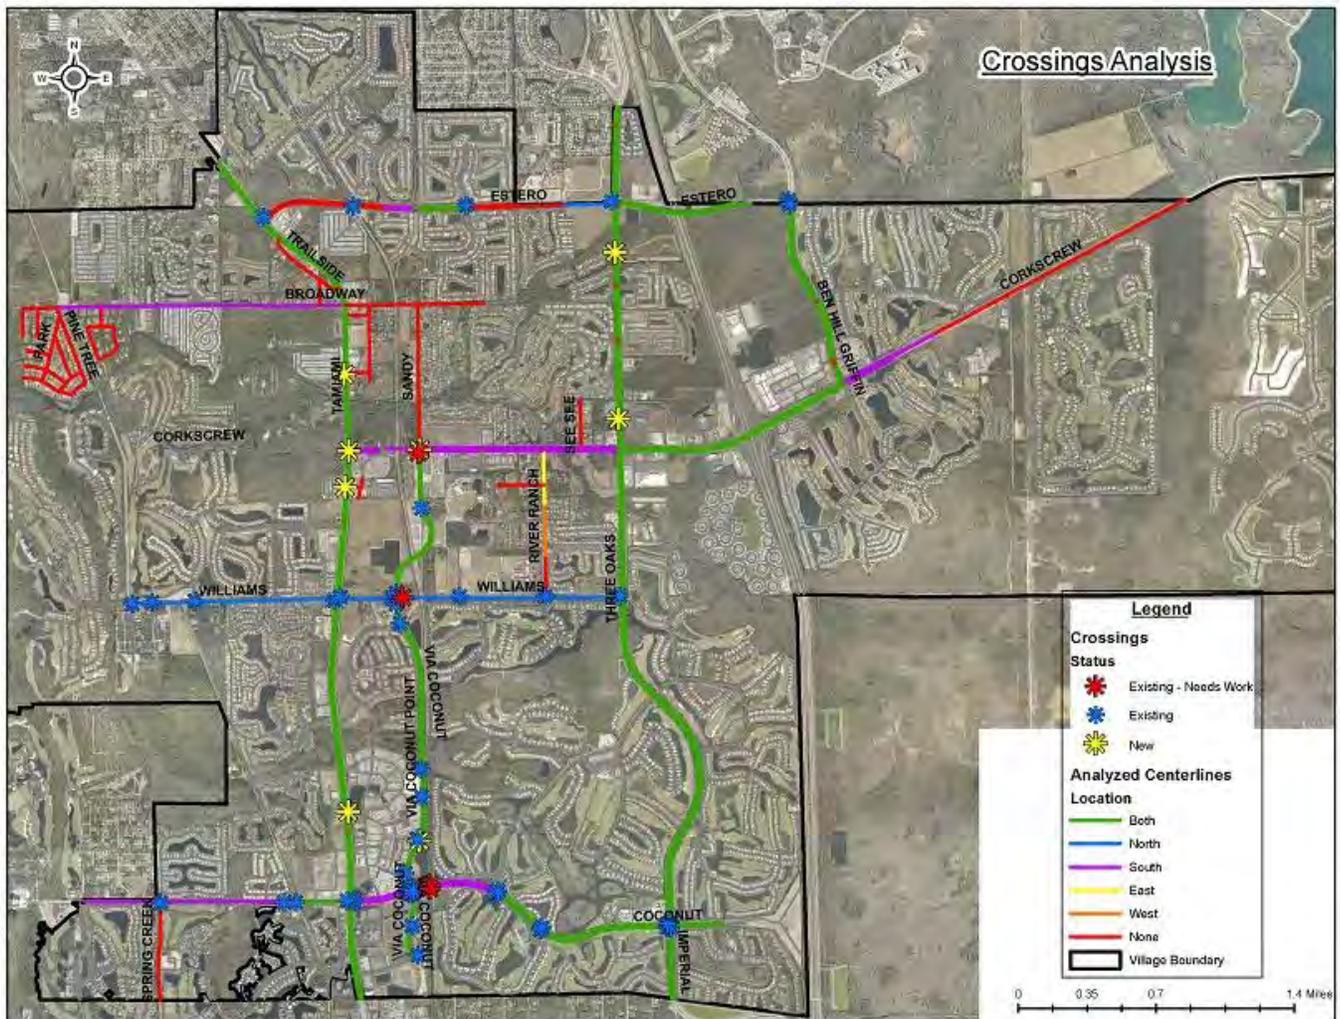
Figure 13: Sidewalks & Intersections & Crossings

The map that appears in Figure 13 shows the location of existing sidewalks and sidewalk gaps. The most significant are gaps that appear on Estero Parkway from US 41 to 3 Oaks Parkway (west of the Don Eslick Bridge). Many of the participants in the recommendations conference considered

In addition to the sidewalks, the Team mapped many of the intersections in Estero. Intersections are particularly important from a safety standpoint because they represent conflicts between pedestrians / bicyclists and automobiles. The primary issue with the existing intersections in the Estero community is their speed. This analysis and the recommendations found three intersections that were problematic. These are indicated on map (see Figure 13) as red asterisks. They are also listed below in Table 6.

The map that appears in Figure 13 graphically shows the sidewalk gaps and notable crossings in the community.

In addition to the existing intersections, there are several important new crossings that, if installed, could significantly increase the safety and walkability of the community. These are listed below in Table 7 as well as indicated in yellow asterisks on Figure 13. While several of these crossings are not in the jurisdiction of the Village of Estero, there may be opportunities to improve these intersections in the future.¹¹

Intersection	Issue	Recommendation
Williams Road Roundabout at Via Coconut Point	Speed of automobiles exiting roundabout places pedestrians at risk	Place crosswalks further away from the intersection to increase site line
Crossing Via Coconut Point at Corkscrew	Speed of automobiles turning south to Via Coconut Point present safety hazard for pedestrians crossing	Consider installing island to reduce the turning radius and offer a pedestrian refuge (see Figure 14 below).
Intersection of Via Coconut Point and Coconut Road	Speed of automobiles turning present safety hazard for pedestrians crossing	Consider installing island to reduce the turning radius and offer a pedestrian refuge (see Figure 14 below). Consider timing and operation of pedestrian light.
Intersection of US 41 and Corkscrew	Speed of automobiles turning present safety hazard for pedestrians crossing	Consider installing island to reduce the turning radius and offer a pedestrian refuge (see Figure 14 below)

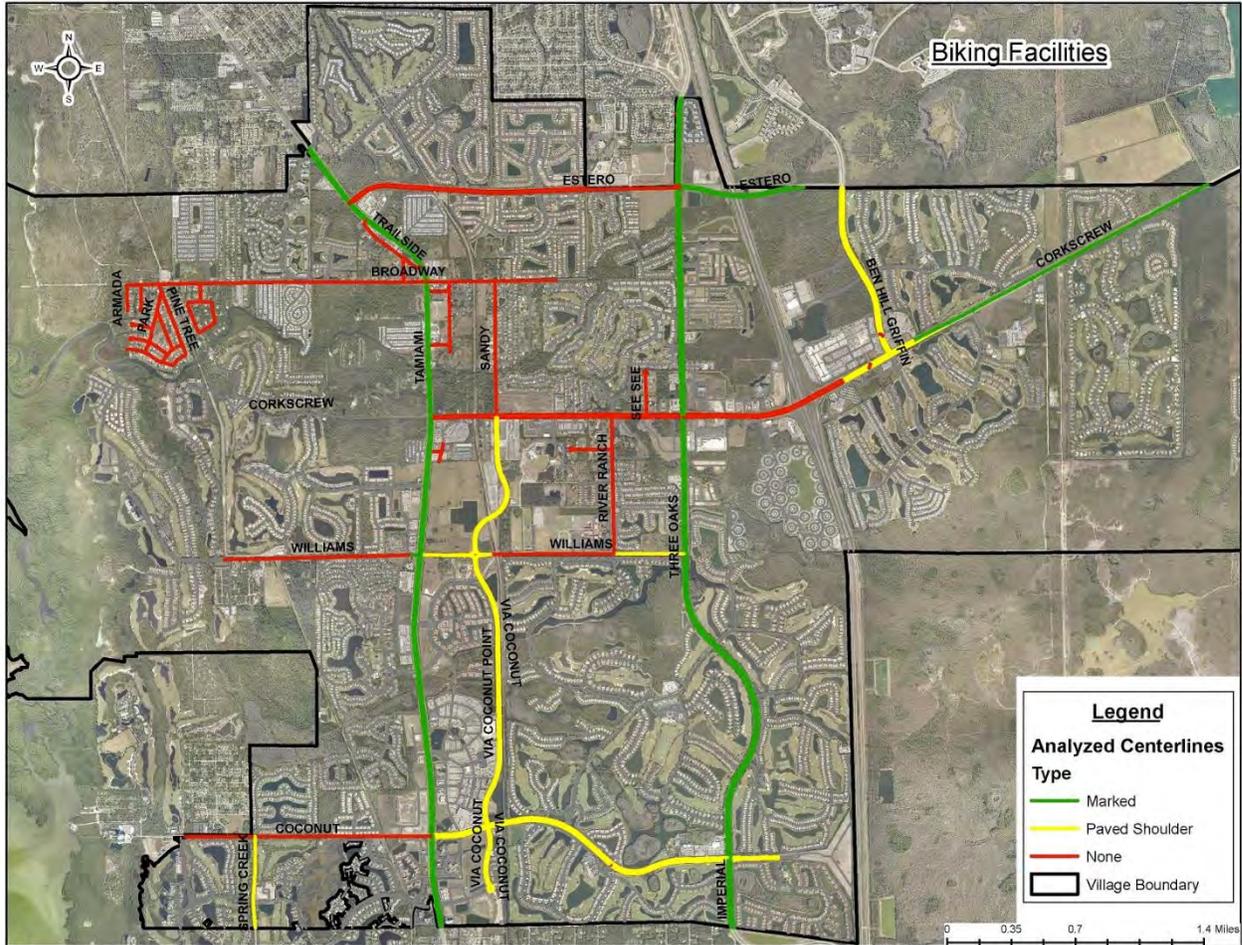
Figure 15: Estero Biking Facilities

As shown on Figure 15 below, there are many gaps in the biking facilities in the Village. There are a variety of benefits of fixing these gaps, including increased safety, usage, and reduction of vehicle miles traveled. In addition, there are connectivity benefits that could increase livability.

There are certain improvements that if made, could significantly add to a connected network. This would provide safer biking for residents in Estero. For example, a shared use path and a buffered bike lane along Estero Parkway connecting US 41 to 3 Oaks Parkway and the University Loop would significantly increase the entire network. This is also true for a bike lane on Williams that could

connect Via Coconut and 3 Oaks Parkway; creating a loop going east on Williams, south to 3 Oaks, west on Coconut, and north on Via Coconut back to Williams.

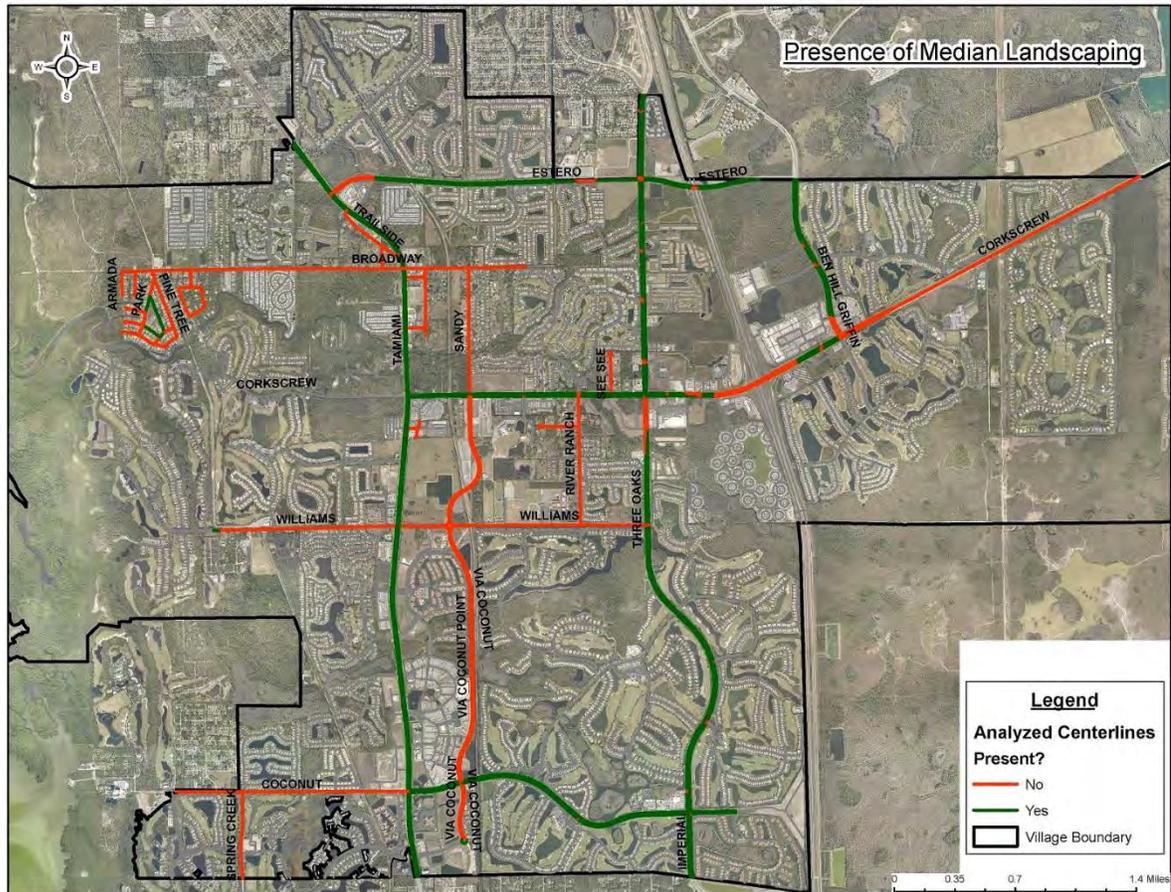
Figure 19: Median Landscaping

The median landscaping was mapped in a similar fashion as the other facilities. Figure 19 shows the presence of median landscaping in the Village.

The recommendations group prioritized landscaping for the medians with the criteria of lower cost, aesthetic value, and enhancement of the image of the Village as the main criteria. The availability of water was a main consideration. When water is available or nearby developers are willing, the landscaping can come at a reasonable cost. In addition, landscaped medians can work to calm traffic and therefore increase safety for all users of the roadways.

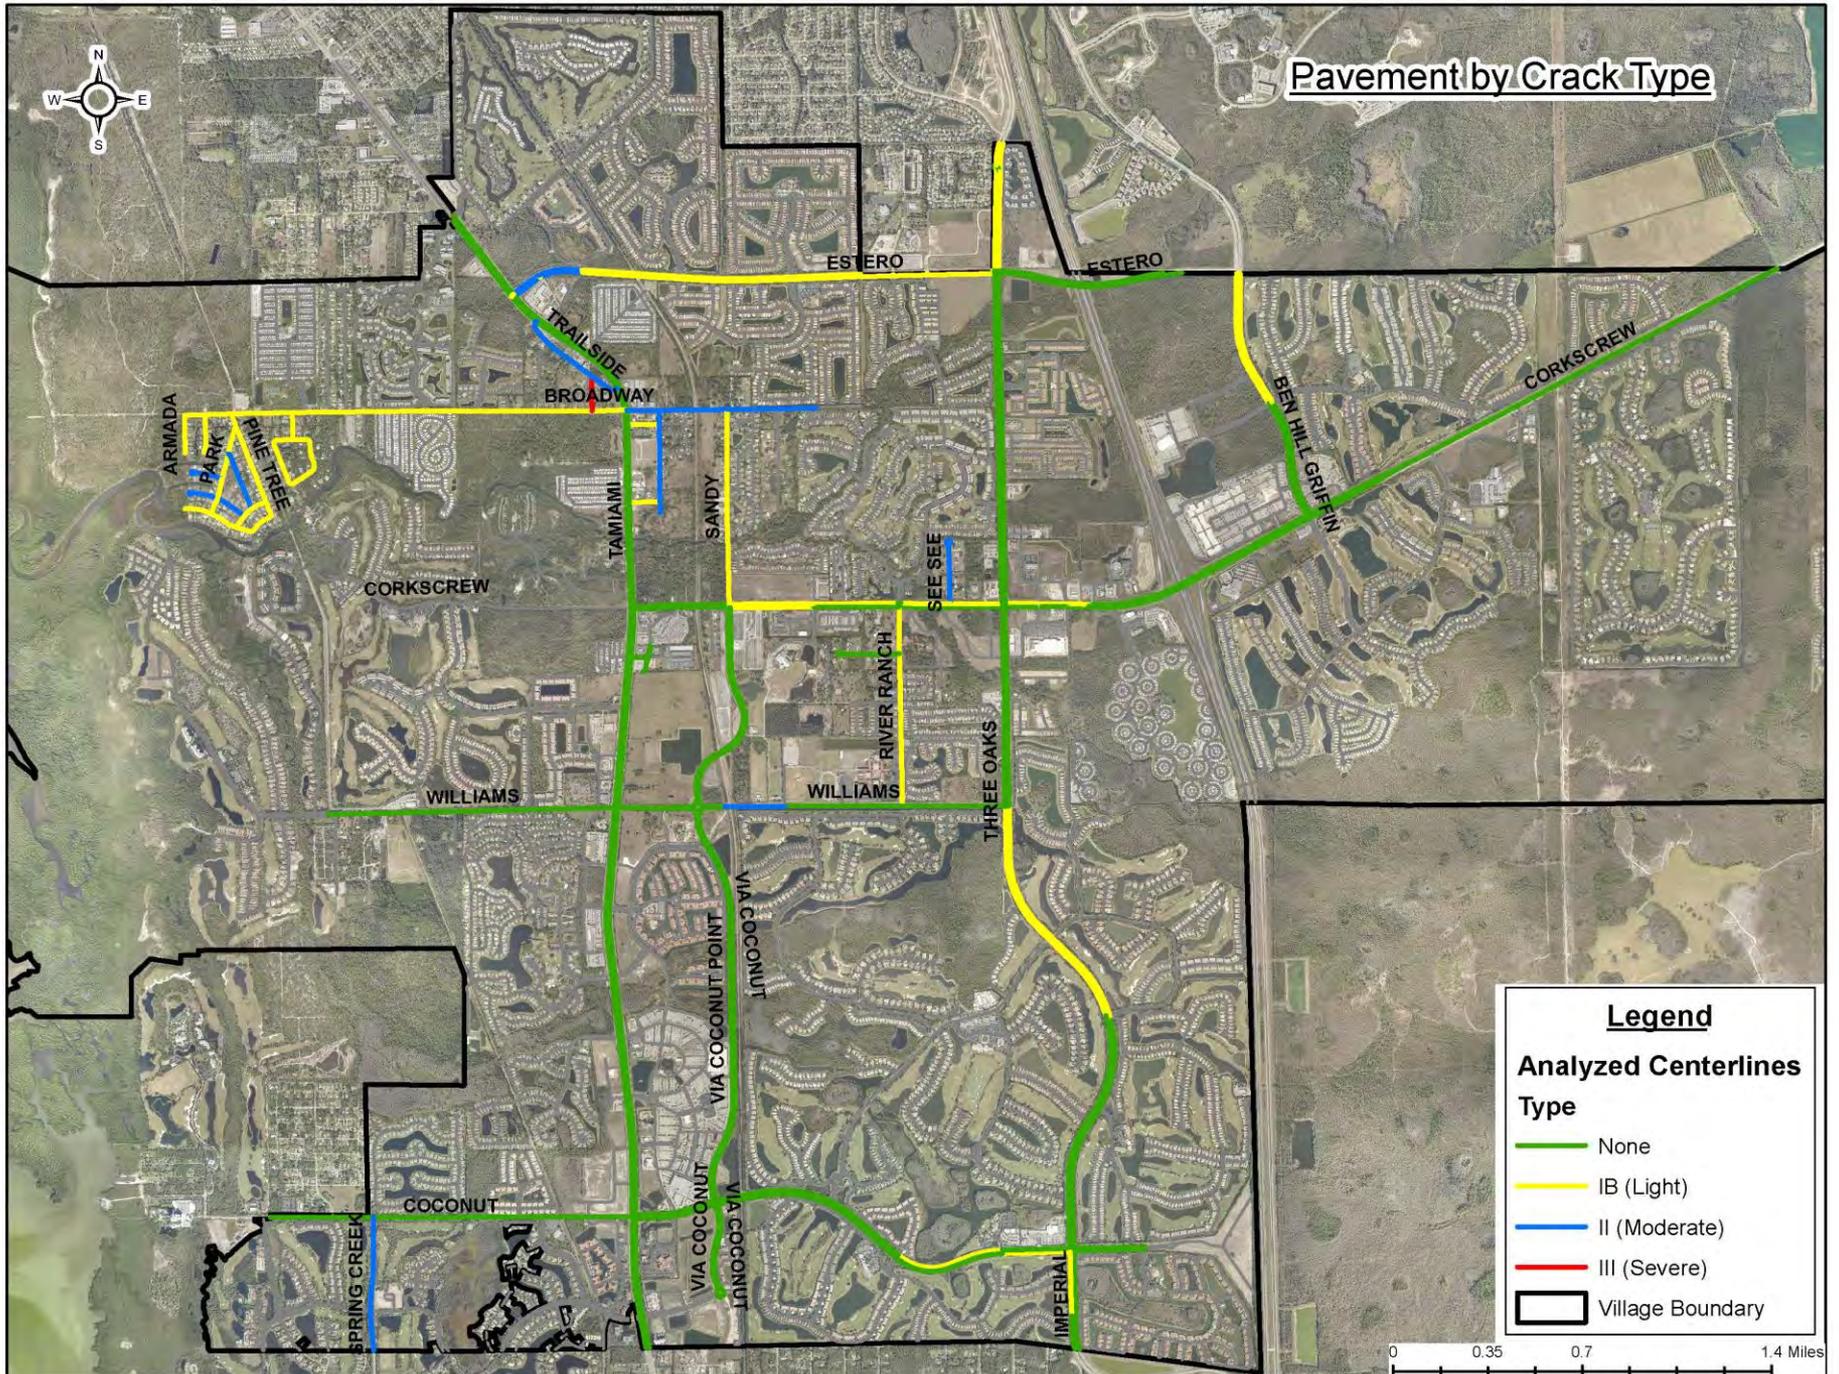
Pavement by Crack Type

- Light raveling West of US-41
 - Type IB and Type II longitudinal cracks along the centerline

- Approximately 12% of lane miles of total roads need immediate attention
- Approximately 20% of lane miles of total roads are of the type IB cracks that should be reevaluated in 2-3 years
- Approximately 68% of lane miles of total roads are in good condition where no immediate action needs to be taken

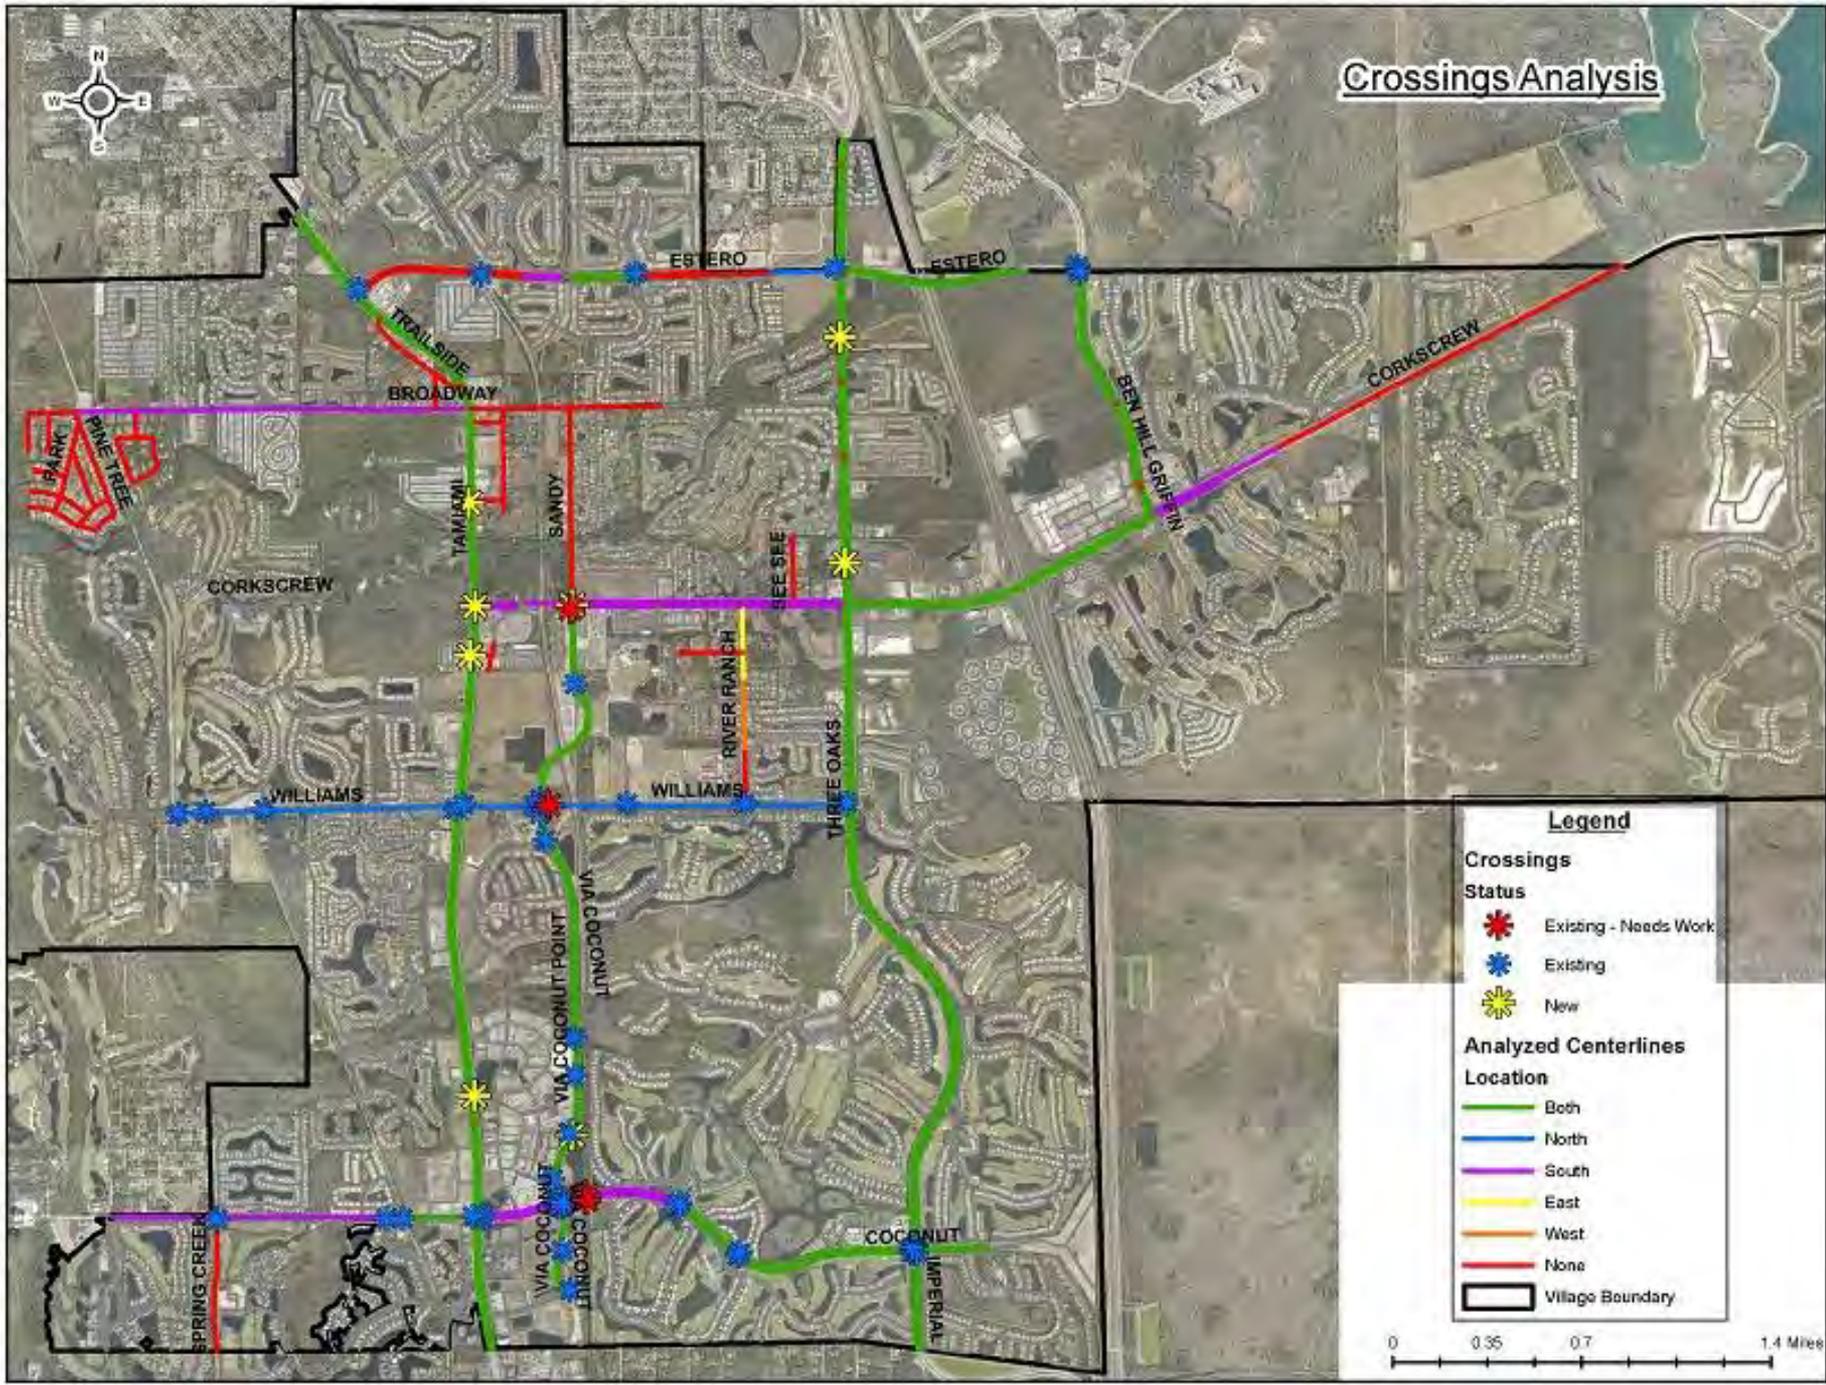
Crossings Analysis

Intersection	Issue	Recommendation
Williams Road Roundabout at Via Coconut Point	Speed of automobiles exiting roundabout places pedestrians at risk	Place crosswalks further away from the intersection to increase sight line
Crossing Via Coconut Point at Corkscrew	Speed of automobiles turning south to Via Coconut Point present safety hazard for pedestrians crossing

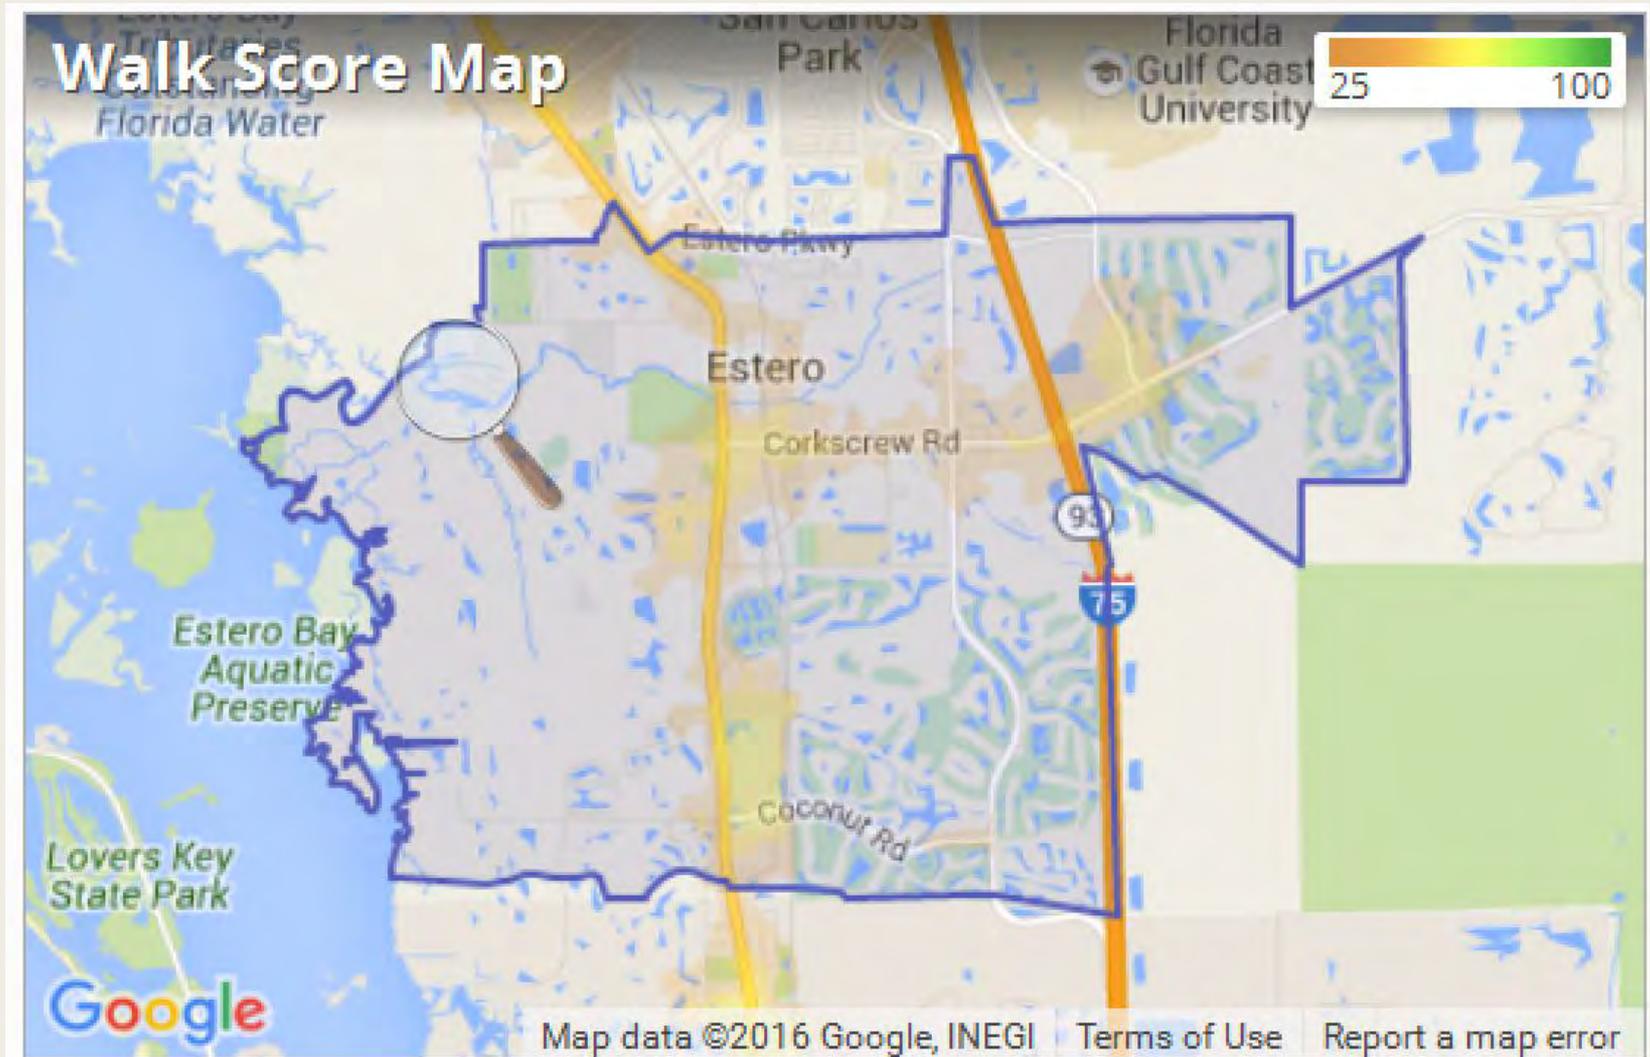
Walk Score “Heat Map”

- Increase safe conditions
- Calm traffic through intersection and lane treatments
- Increase connectivity
- Bridge gaps
- Develop a bike/ped master plan
- Recognize opportunities for improvements as new communities and the Village Center develop
 - *Add facilities*
 - *Increase safety of facilities*
- Use “heat map” to assist with prioritization process
