ESTERO INFRASTRUCTURE INVENTORY

Florida Gulf Coast University
January 20, 2016

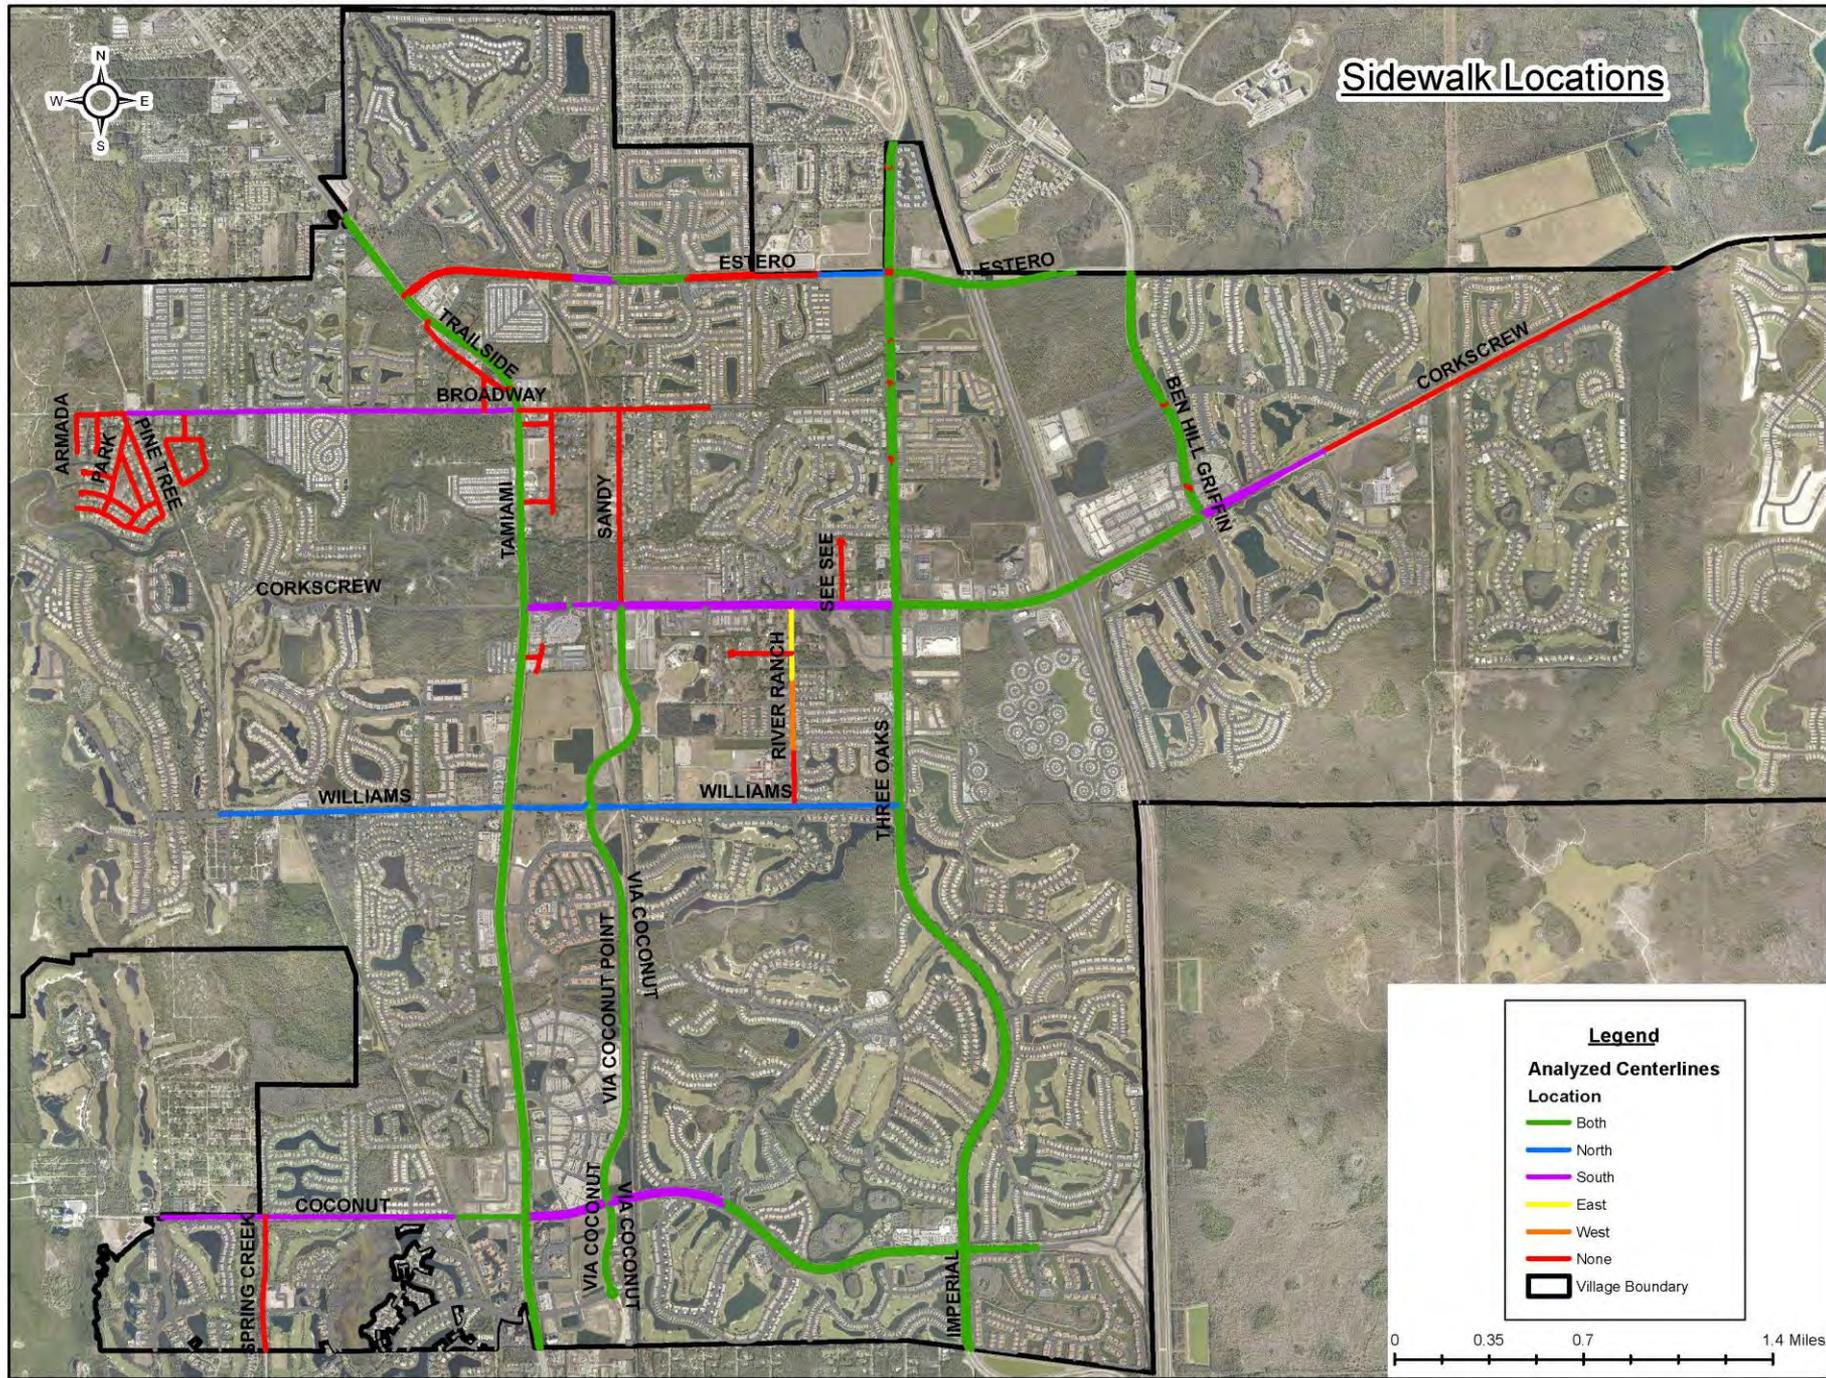
Sidewalk Locations

Road / Street	Criteria				Recommendation
	Connectivity	Usage	Safety	Access	
Estero Parkway (41 to 3 Oaks)	✓	✓	✓	✓	New 10' Shared Use Path
River Ranch Road (Corkscrew to Williams)	✓	✓	✓	✓	New Sidewalks to Repair Gaps
Connections to Estero Community Park <ul style="list-style-type: none"> • Via Coconut to Park • Estero Park to Block Ln • @ Corkscrew Road 	✓	✓	✓	✓	New Sidewalk New / Improved Sidewalk Wider sidewalk
Sandy Lane (Broadway to Corkscrew)	✓	✓	✓	✓	New Sidewalk Bike/Ped Bridge Over River
Corkscrew Road (41 to 3 Oaks)	✓	✓	✓	✓	New 10' Shared Use Path - Asphalt
Broadway (41 to Sandy)	✓				Sidewalk
3 Oaks Parkway (Coconut to City Boundary)			✓		Sidewalk repair due to tree roots
US 41 (East Side – Covered Wagon to Williams)		✓		✓	Sidewalk significantly under water most of rainy season

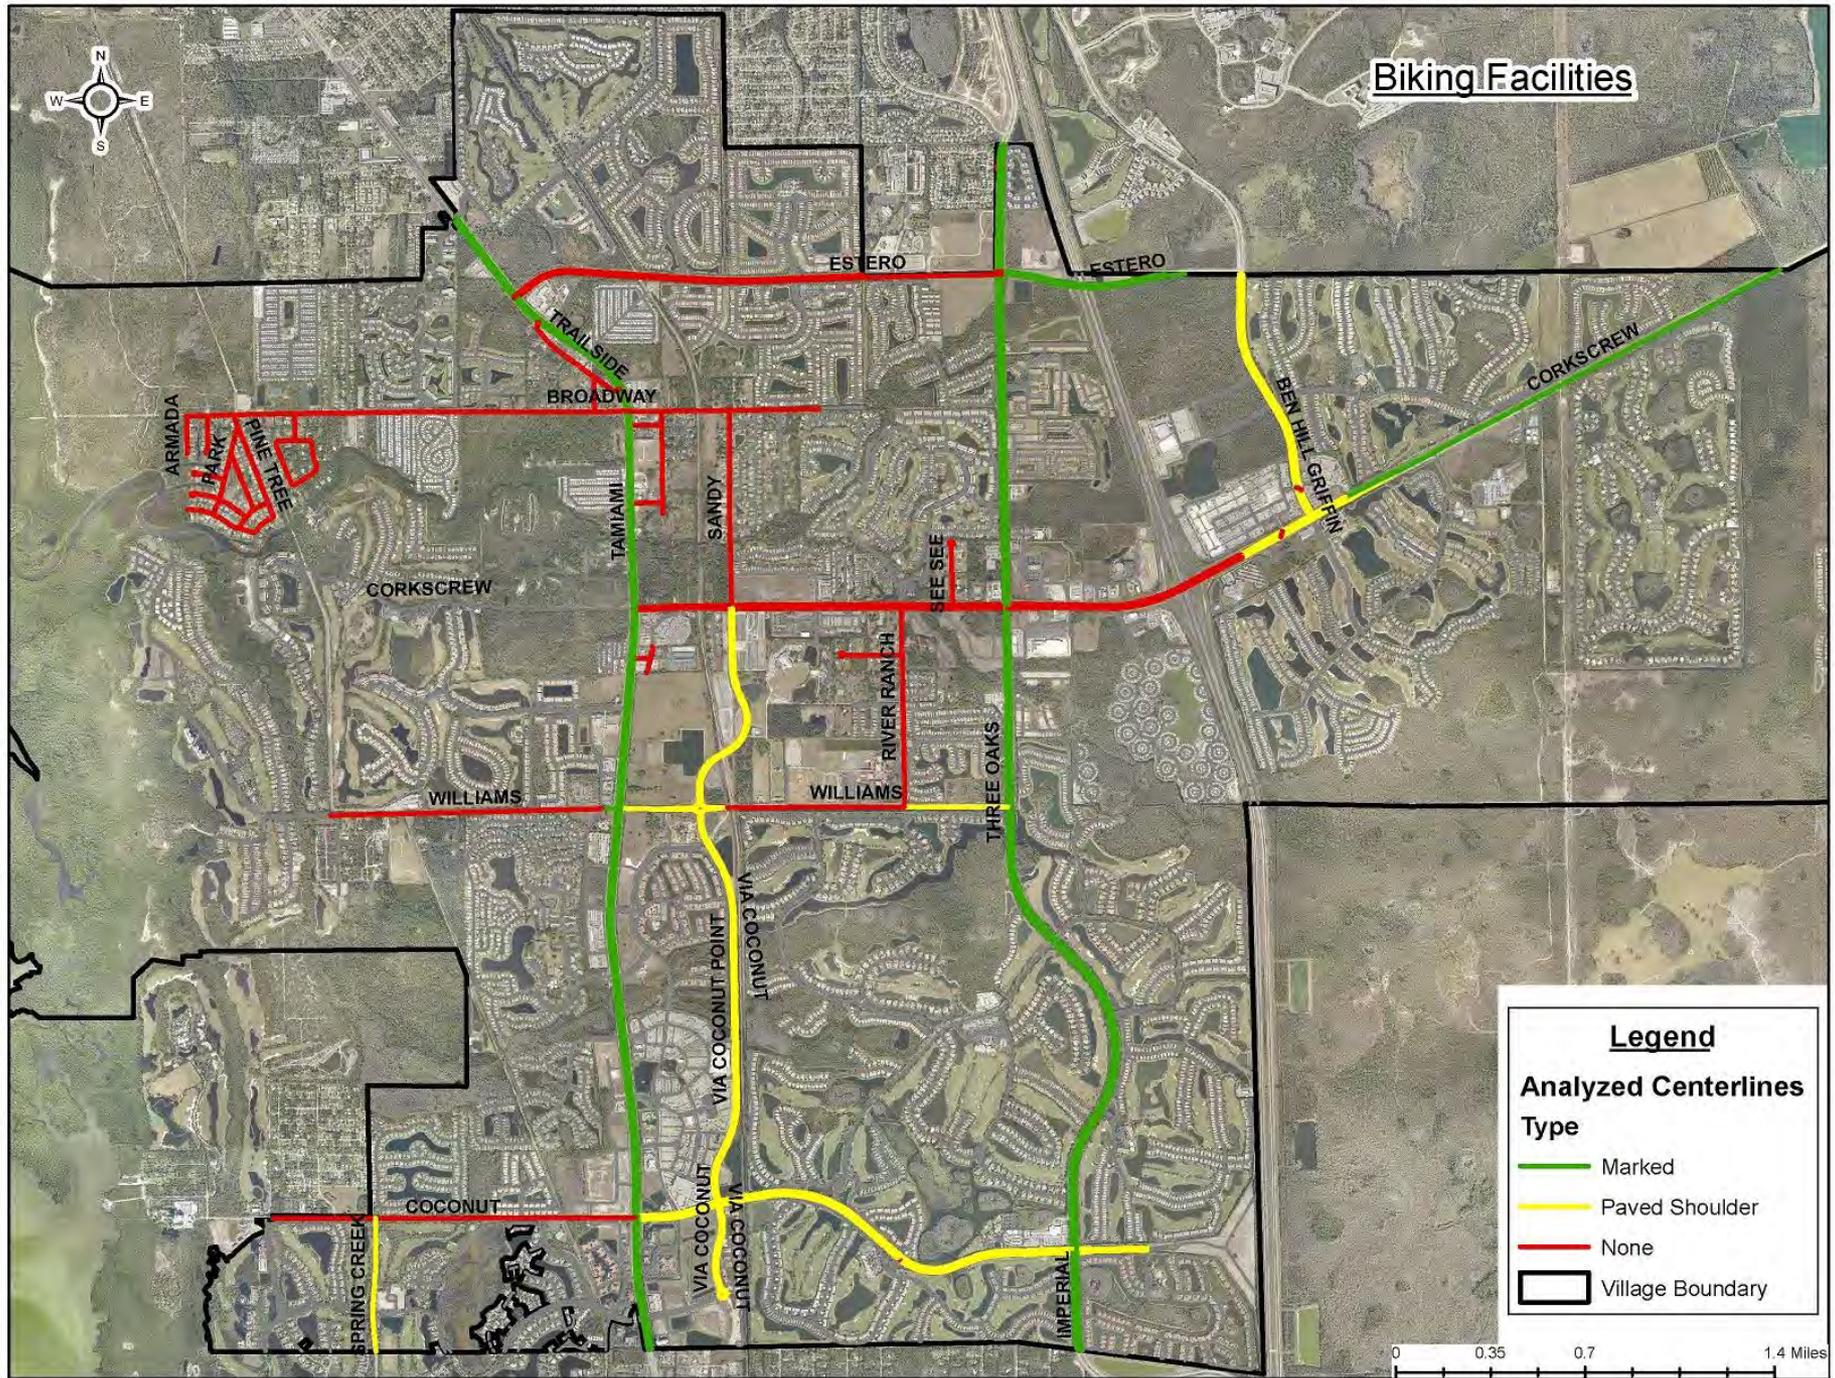
Biking Facilities

Road / Street	Criteria				Recommendation
	Connect	Usage	Safety	Access	
Estero Parkway (41 to 3 Oaks)	✓	✓	✓	✓	New 10' Shared Use Path Buffered / Marked Lanes
River Ranch Road (Corkscrew to Williams)	✓	✓	✓	✓	New Bike Lanes
Estero Community Park (Corkscrew Existing Entrance)	✓			✓	Bike Lane
Williams Road (River Ranch to Via Coconut Point)	✓	✓	✓	✓	Bike Lanes
Broadway (Estero Bay Preserve State Park to 41)	✓			✓	Paved Shoulder
Sandy Lane (Broadway to Corkscrew)	✓		✓	✓	Paved Shoulder
Corkscrew Road (41 to Miromar Mall Area)	✓	✓	✓	✓	New 10' Shared Use Path
3 Oaks Parkway (South of Estero Parkway to Village Boundary)			✓		Consider buffered bike lanes & lane diets
Village Center		✓		✓	Consider slow streets / sharrows
