ESTERO INFRASTRUCTURE INVENTORY

JANUARY 2016

PREPARED FOR THE
VILLAGE OF ESTERO, FL

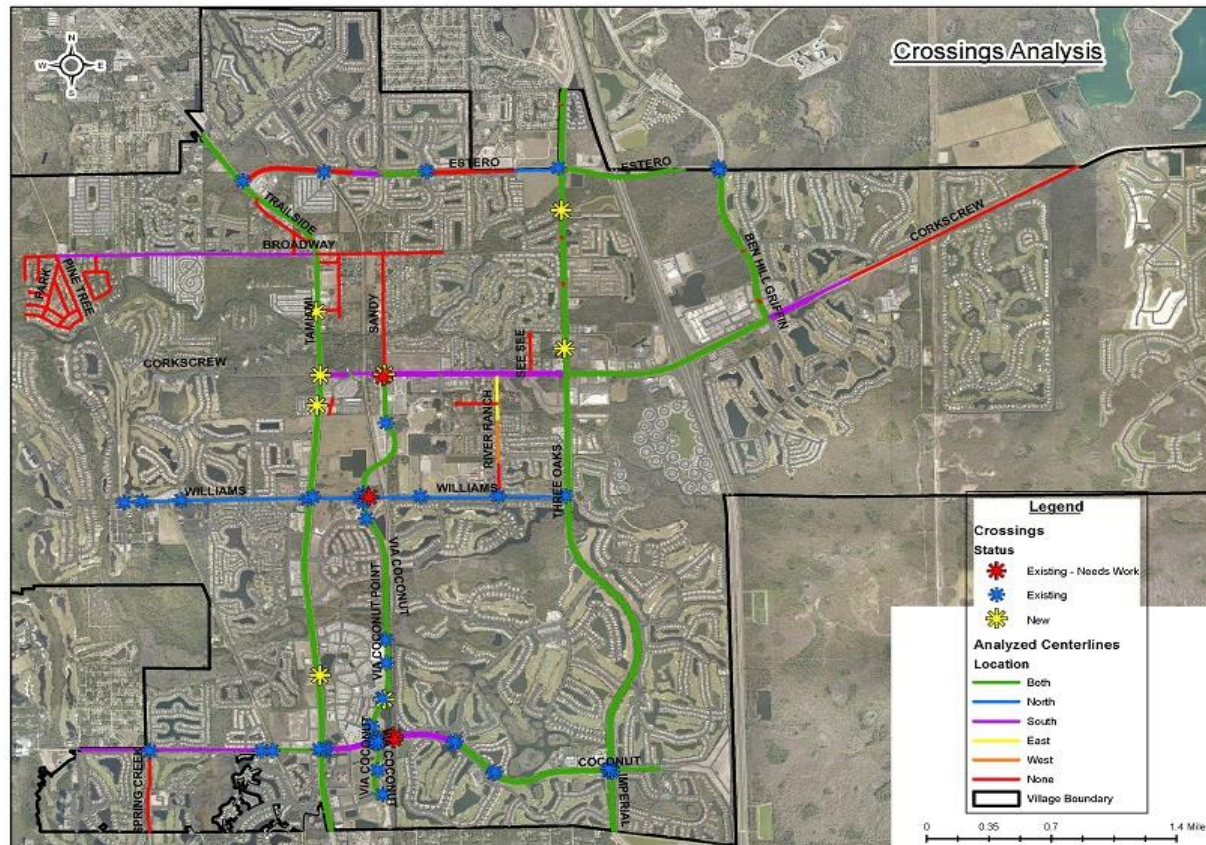
Figure 13: Sidewalks & Intersections & Crossings

The map that appears in Figure 13 shows the location of existing sidewalks and sidewalk gaps. The most significant are gaps that appear on Estero Parkway from US 41 to 3 Oaks Parkway (west of the Don Eslick Bridge). Many of the participants in the recommendations conference considered Estero Parkway to be a significant opportunity to showcase the Village's efforts to be a walkable and bikable community. This was due, in part to the opportunities for connections to

In addition, there are many gaps on River Ranch Road near Estero High School that should be addressed. These gaps are significant because the sidewalks are primarily on one side but switch sides periodically. This presents unsafe walking conditions for students and families as it forces pedestrians to cross multiple times if they intend to use the sidewalk.

In addition to the sidewalks, the Team mapped many of the intersections in Estero. Intersections are particularly important from a safety standpoint because they represent conflicts between pedestrians / bicyclists and automobiles. The primary issue with the existing intersections in the Estero community is their speed. This analysis and the recommendations found four intersections that were problematic. These are indicated on the map (see Figure 13) as red asterisks. They are also listed below in Table 6.

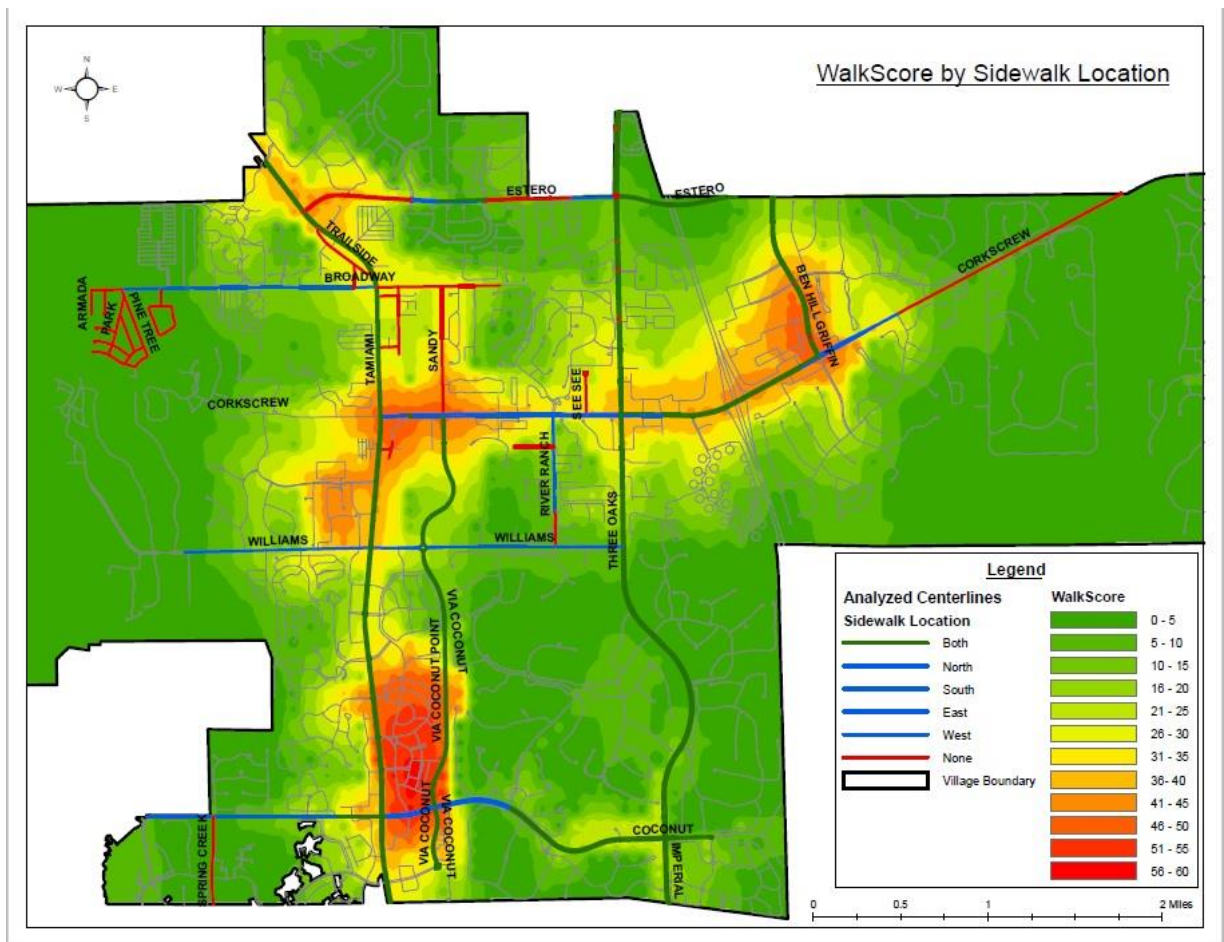
Figure 16: Walk Score with Estero Sidewalk Location Layer

Further analysis is available with the Walk Score Heat Map that shows the existing sidewalk infrastructure layered over the Walk Score Heat Map that appears below in Figure 16.¹³ This analysis shows that several areas with higher amenities lack basic sidewalk infrastructure or only have a sidewalk on one side.

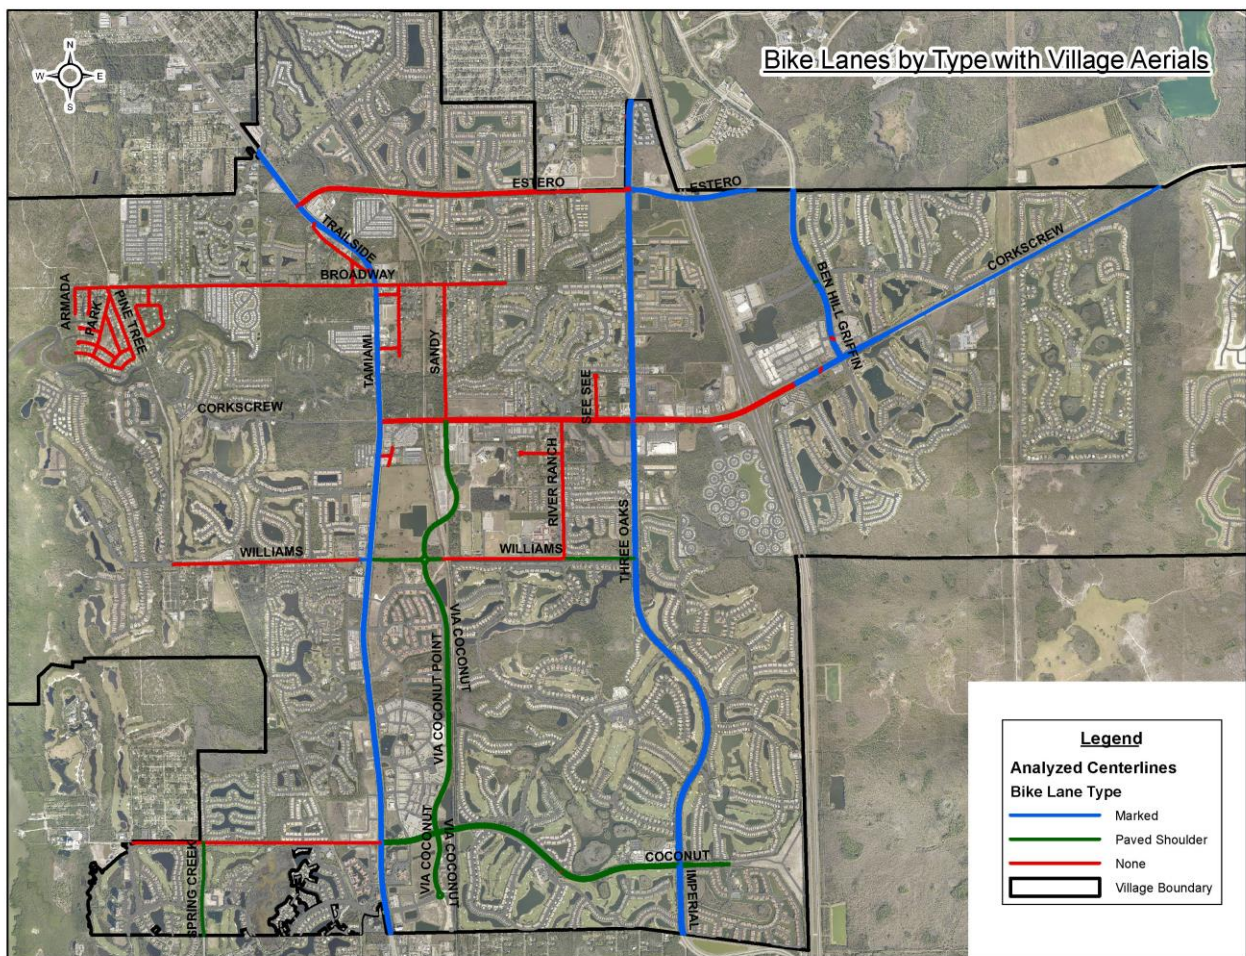
Figure 18: Estero Biking Facilities

As shown on Figure 18, there are many gaps in the biking facilities in the Village. There are a variety of benefits of fixing these gaps, including increased safety, usage, and reduction of vehicle miles traveled. In addition, there are connectivity benefits that could increase livability.

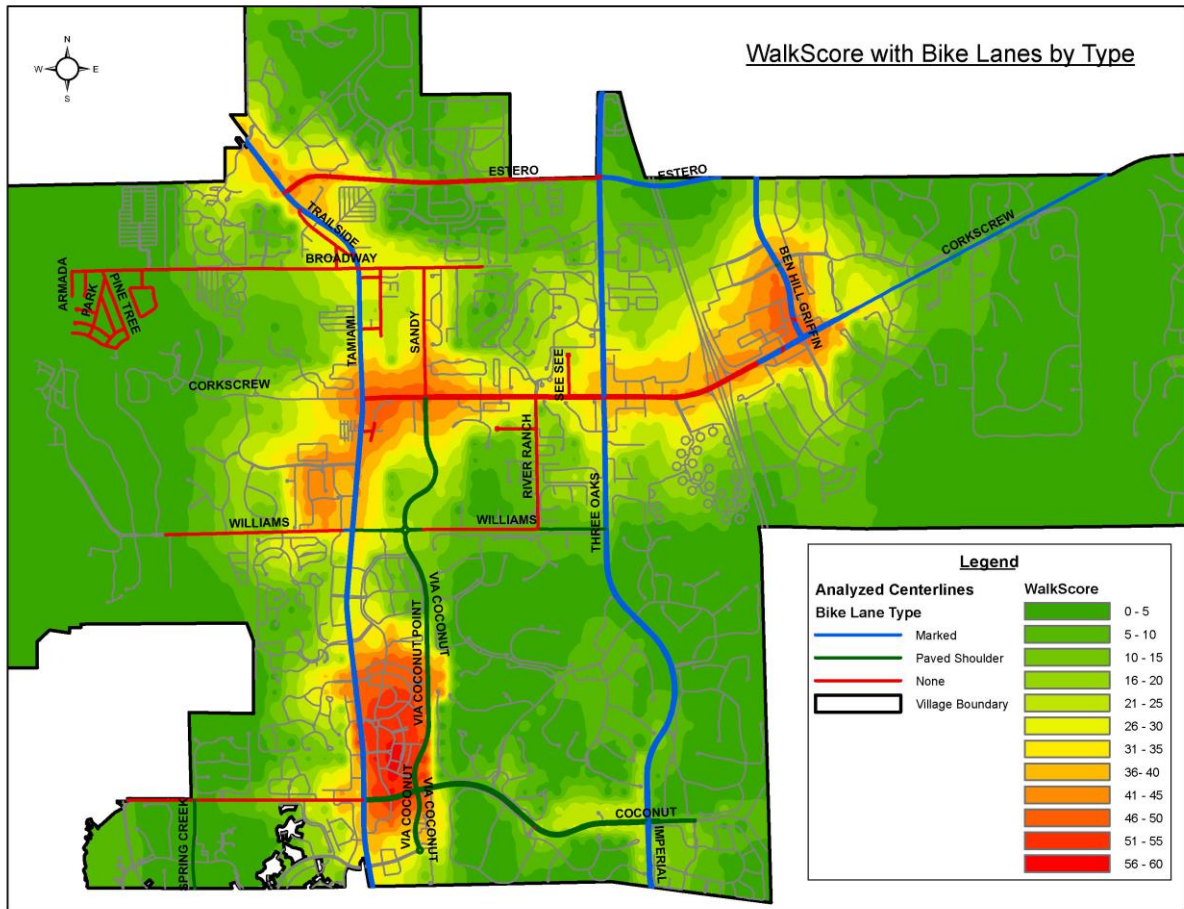
Figure 19: Walk Score by Bike Lane Type

Similar to the discussion related to the Walk Score and side walk analysis, the FGCU Team also analyzed the implications of the proximity of amenities for the bicycling infrastructure. Figure 19 below shows the Walk Score Heat Map with the bicycling facilities layer. The analysis of this map supports the recommendation for additional biking facilities along Corkscrew west of Ben Hill Griffin and Estero Parkway west of the Don Eslick Bridge.
