**The Village of Estero
9401 Corkscrew Palms Circle
Estero, FL 33928**

DATE: May 26, 2020
SOLICITATION NO.: RFB 2020-06

SUBJECT: ADDENDUM NUMBER: Two (2)

REFERENCE: Estero on the River Structure Demolition

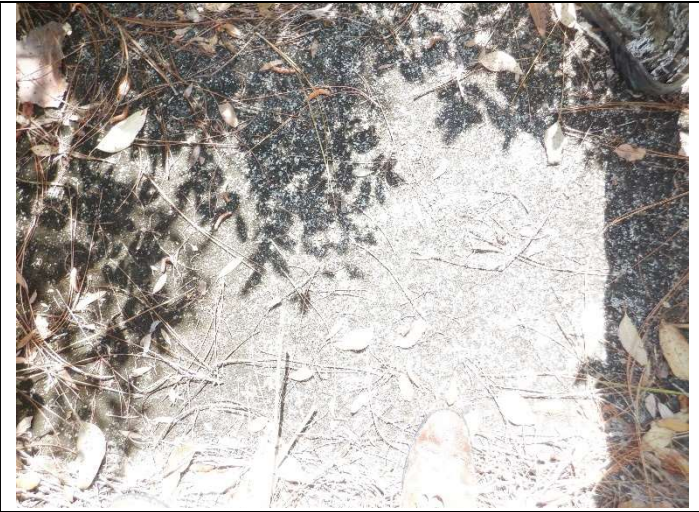
HM-L: Concrete Slab, Gray

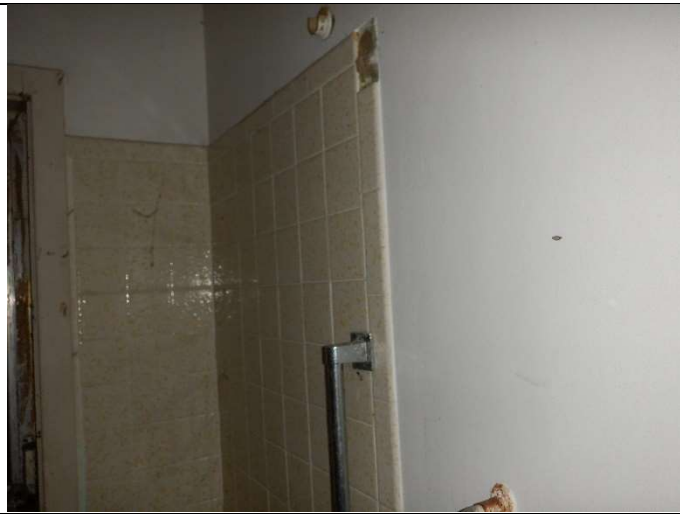
HM-R: Shower Tile/Grout/ Mastic, White
