Village of Estero Area-Wide TRAFFIC STUDY

August 14, 2017

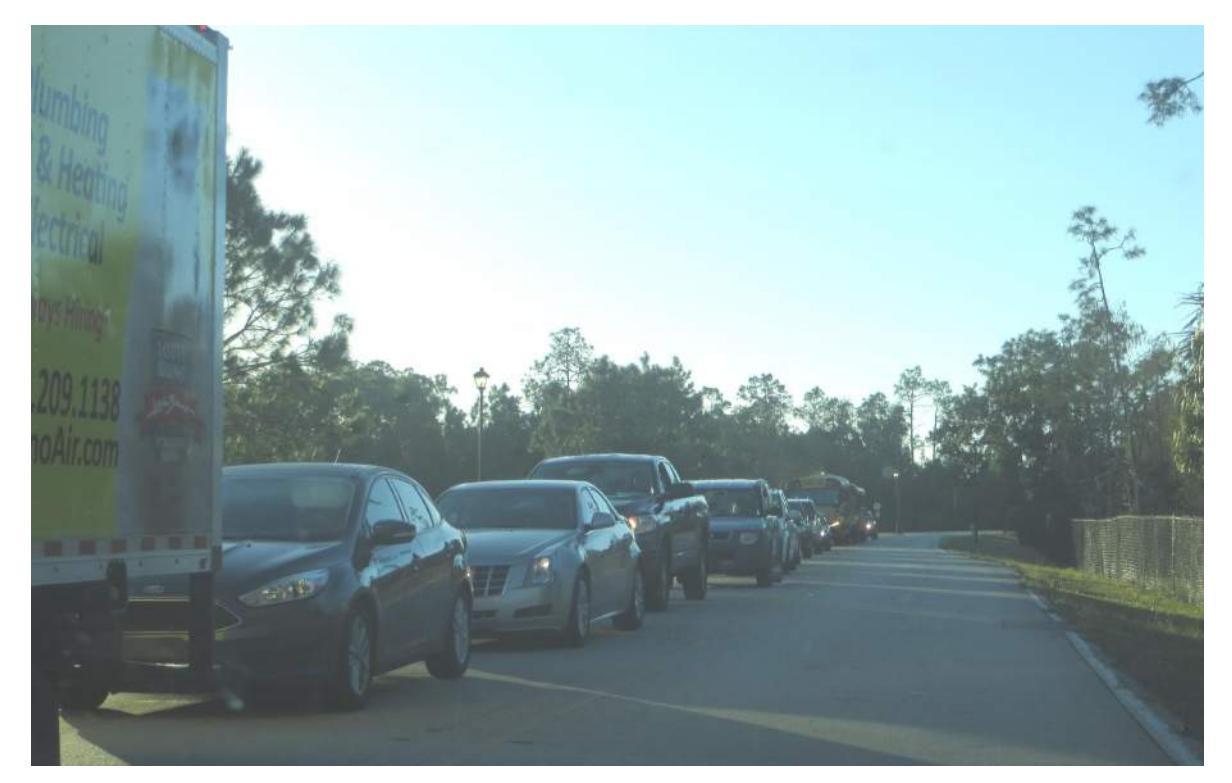
Northbound Queue at the Intersection of Corkscrew Road & Stoneybrook Golf Drive

Pinewoods Elementary School is located along Stoneybrook Golf Drive, and access to the school is provided indirectly via Corkscrew Road. During the a.m. peak-hours, a significant northbound queue (comprised of traffic leaving the school, Stoneybrook Golf Course, and the gated neighborhood) was observed from the intersection of Corkscrew Road & Stoneybrook Golf Drive to the entrance to Pinewoods Elementary School. It was observed that the traffic signal at the intersection of Corkscrew Road & Stoneybrook Golf Drive allowed most of the northbound queue to clear within one cycle. The higher delay times experienced by the vehicles exiting the northbound approach could be mitigated with signal re-timing. This could allow more green time to be allocated to Stoneybrook Golf Drive during school peak periods and should be based upon the schedule for Pinewoods Elementary School. This would require coordination with Lee County DOT.

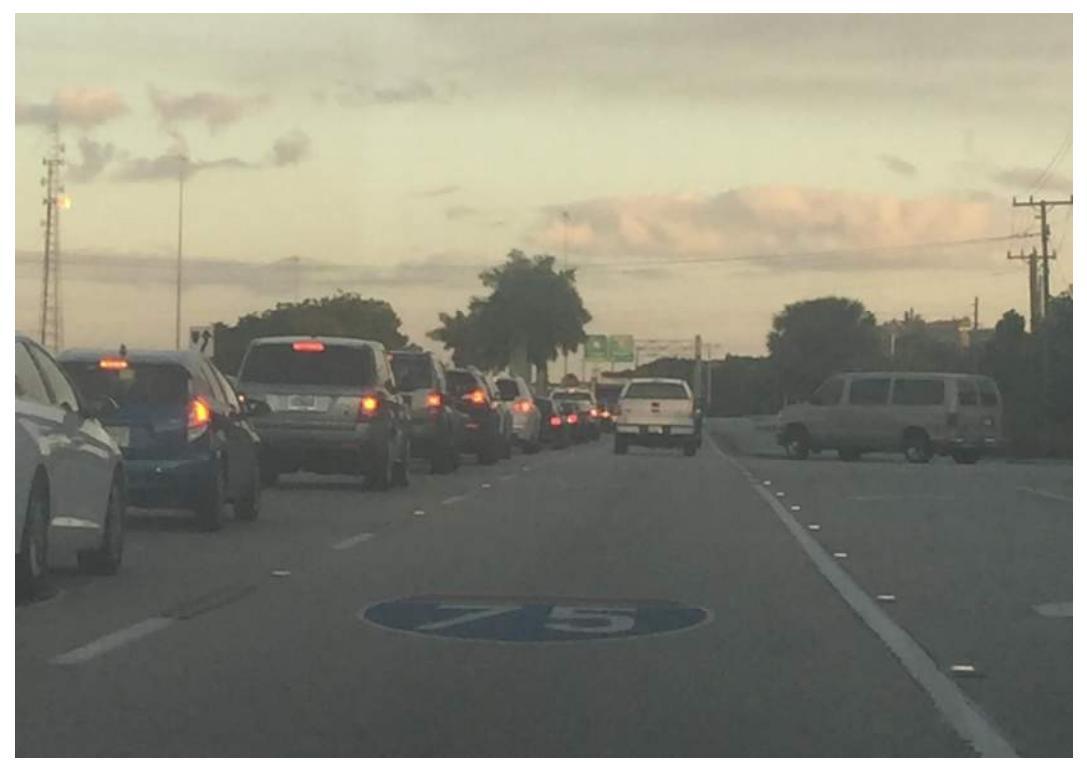
Eastbound Queue observed at the I-75 Ramps & Corkscrew Road during the P.M. Peak-Hour

Intersection queuing issues, especially for the eastbound left-turn, were observed to impact upstream intersections along Corkscrew Road. During the p.m. peak-hour, the queue for the I-75 ramps along Corkscrew Road was observed to extend past Corkscrew Woodlands Boulevard. The queue impacted the intersection of Corkscrew Road & Corkscrew Woodlands Boulevard. Several vehicles were also observed trying to make a westbound U-turn at the intersection of Corkscrew Road & Corkscrew Woodlands Boulevard in order to join the queue for the I-75 ramps.

The I-75/Corkscrew Road Interchange technical memorandum describes the proposed improvements including dual eastbound left-turn lanes onto the I-75 ramps. The intersection was analyzed in future conditions with the optimization of the signal timing and the proposed FDOT geometric improvements as they are scheduled for design in 2017 and construction in 2019.

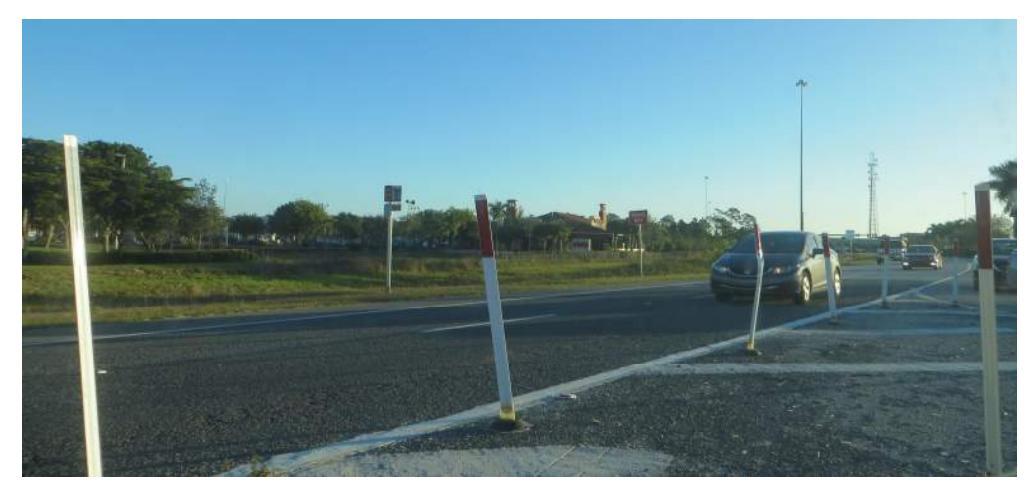
Merging Westbound onto Corkscrew Road

The intersection of Corkscrew Road & Corkscrew Woodlands Boulevard currently allows for a northbound left-turn movement and provides a storage area delineated by the barriers shown in the image on the next page. The sight line when merging onto Corkscrew Road is difficult as drivers must look over their shoulders in order to merge onto Corkscrew Road. It is recommended to make interim safety improvements to this intersection with a focus on the egress and ingress movements on Corkscrew Road.

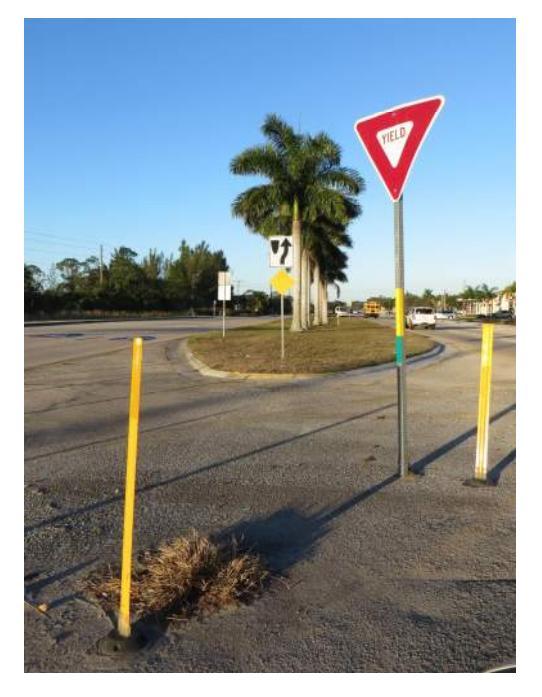
Intersection of Corkscrew Road & Corkscrew Woodlands Boulevard

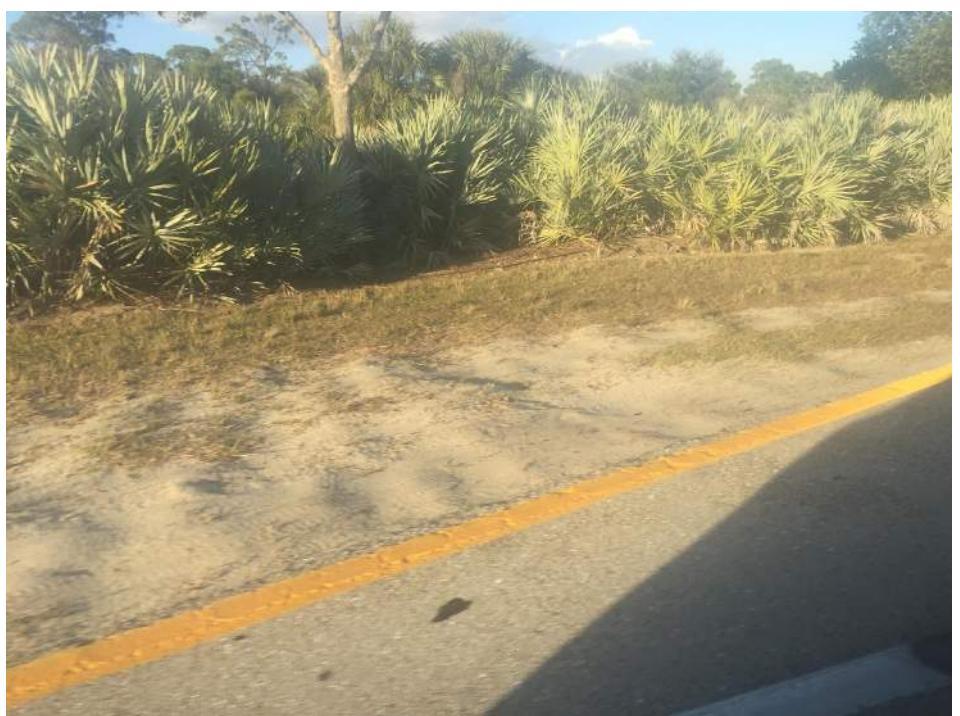
Eastbound Left-Turn Lane at the Intersection of Corkscrew Road & Three Oaks Parkway

The dual eastbound left-turn lanes at the intersection are each approximately 600 feet. During the p.m. peak-hour, the eastbound left-turn lane was blocked by the eastbound through queue. Vehicles were observed to drive on the grass along the side of the road, prior to the beginning of the turn lane, in order to enter the turn lane.

Since the intersection operates with a protected eastbound left-turn lane, it is recommended to extend the eastbound left-turn lane to allow for more vehicles to enter the lane on a paved roadway segment. It is also recommended to explore the option of adding a second northbound right-turn lane. The 95th percentile queue length in Synchro indicates the queue is anticipated to extend beyond the existing 475-foot northbound right-turn lane.

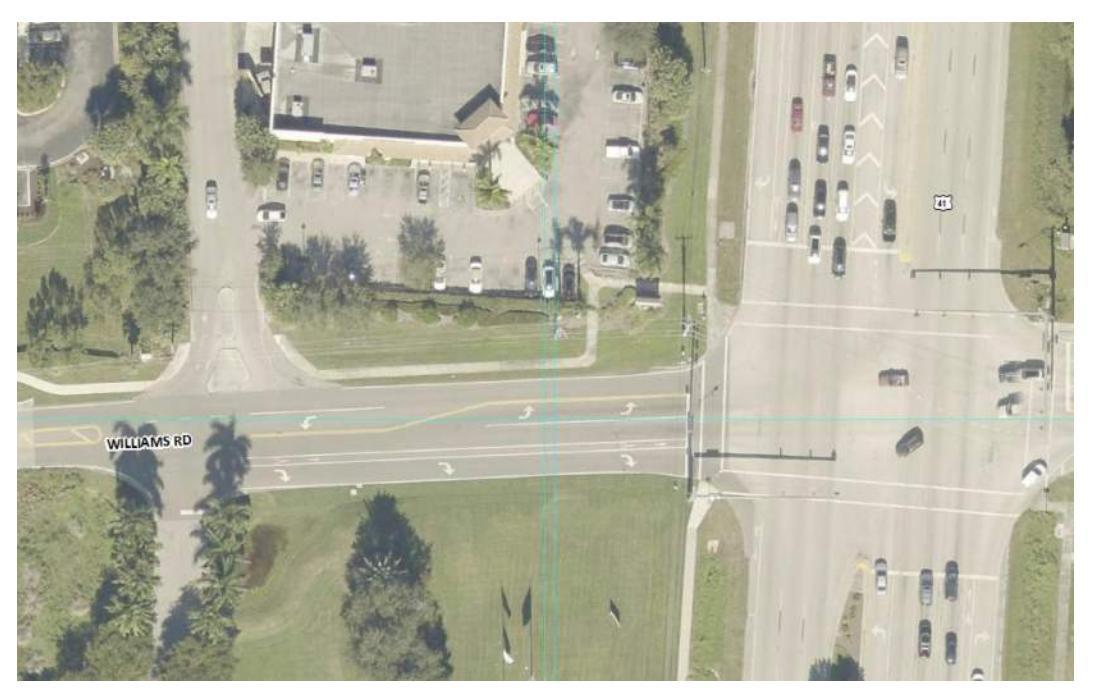
Additionally, it is recommended to coordinate with FDOT to close the westbound left-turn of the driveway opening on Williams Road (approximately 200 feet to the west of the signalized intersection of US 41 & Williams Road) indicated in the aerial below.

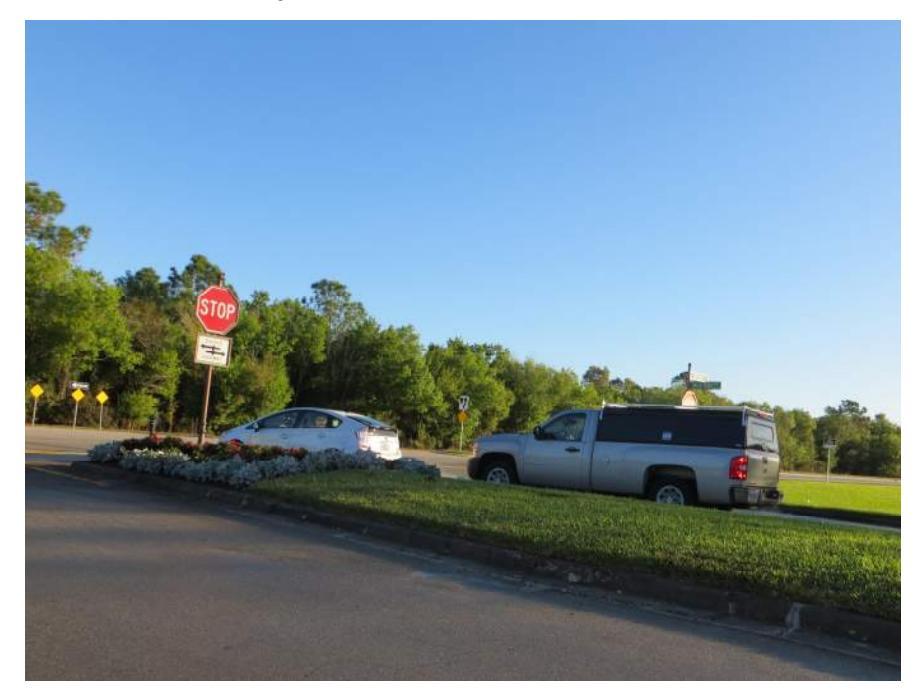
Northbound Traffic at Intersection Of Corkscrew Road & Bella Terra Boulevard

Due to the higher traffic volumes along US 41 and Corkscrew Road, the neighborhood access points that operate at stop-controlled intersections must wait for adequate gaps. While the queues were not observed to be significant at the minor street access points at the time of the site observations, increases to traffic volumes along both US 41 and Corkscrew Road are anticipated to increase these delays.

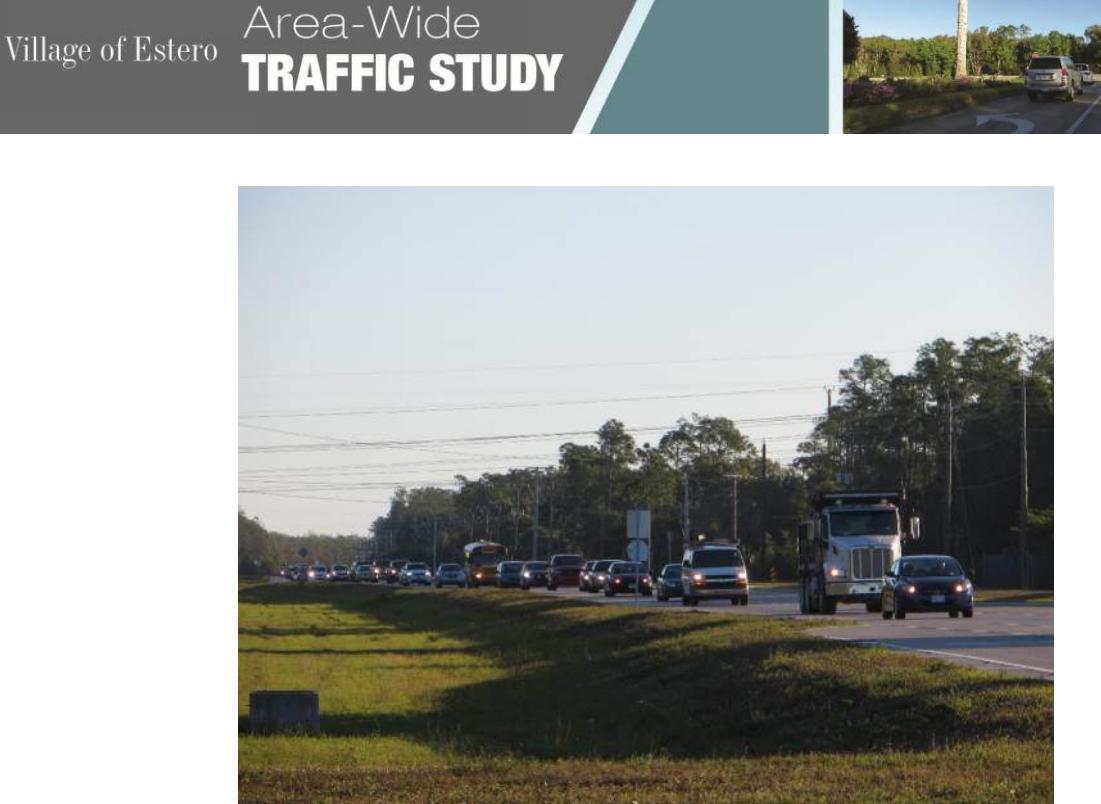
Westbound Traffic on Corkscrew Road

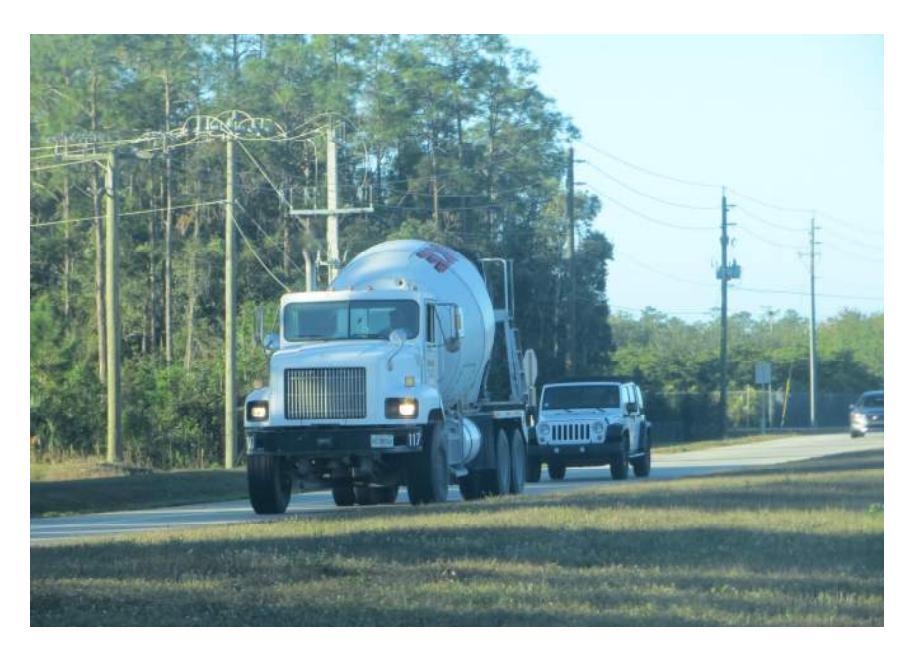
Heavy Vehicle Traffic Eastbound on Corkscrew Road

A high volume of truck traffic was observed during the a.m. peak-hour period along Corkscrew Road travelling eastbound. Based upon discussions with The Village of Estero staff, a portion of these heavy vehicles are related to mining operations in areas east of The Village. The heavy vehicles traveling along Corkscrew Road were traveling in the opposite direction of the a.m. peak-hour traffic. At the intersection of Corkscrew Road & Bella Terra Boulevard the heavy vehicles were 24% of all eastbound traffic during the a.m. peak-hour (7:00 a.m. to 8:00 a.m.). Observations were only performed during the a.m. peak-hour and p.m. peak-hour. The heavy vehicles were not observed in as high volumes traveling westbound during the p.m. peak-hour.

A high volume of loaded heavy vehicles may result in faster degradation of the roadway and may require more frequent roadway maintenance. Additionally, a high volume of truck traffic also can impact the speeds along the two-lane roadway of Corkscrew Road. Safety concerns should also be considered with a higher volume of heavy vehicles near residential areas.

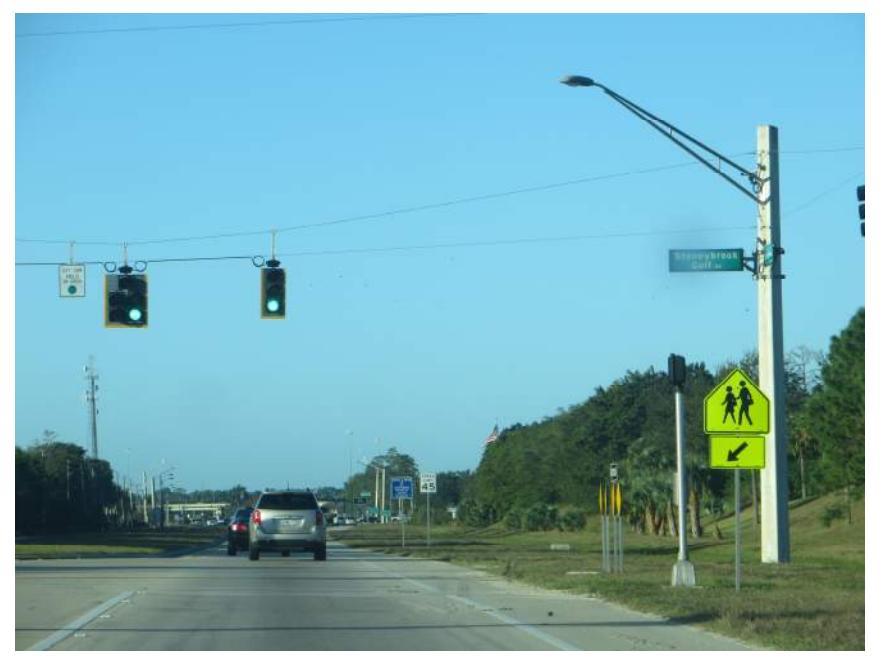
Signal at the Intersection of Corkscrew Road & Stoneybrook Golf Drive

The current signal timing along Corkscrew Road allowed for a progression of vehicles from the intersection of US 41 & Corkscrew Road to the intersection of Corkscrew Road & Stoneybrook Golf Drive. The offsets and signal timing allowed for vehicles, particularly during the p.m. peakhour in the eastbound direction, to travel throughout the corridor with minimal delays at the signalized intersections. Therefore, it is recommended to continue to monitor the intersections along Corkscrew Road and maintain the timing to allow for this progression.

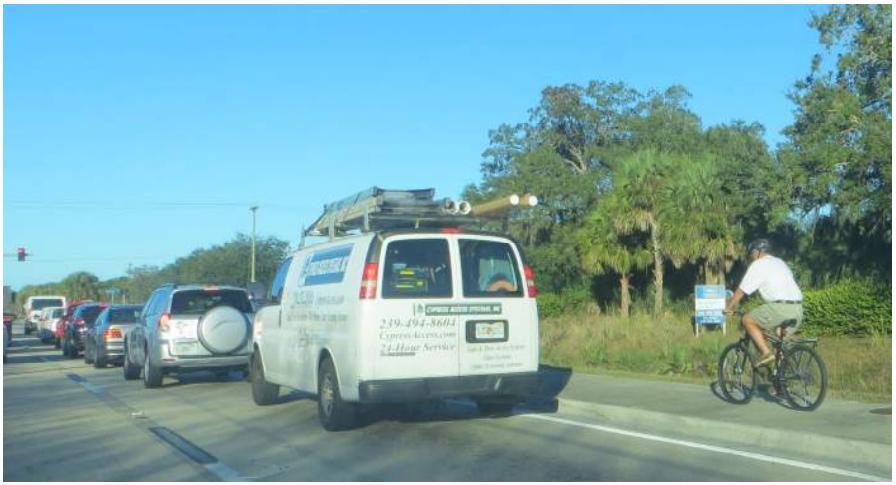
Cyclist on the Sidewalk Approaching the Intersection of Corkscrew Road & Three Oaks Parkway

Three Oaks Parkway, within the study area, also contains a striped bicycle lane and cyclists were observed to use the bicycle facilities and sidewalk during the site observations.

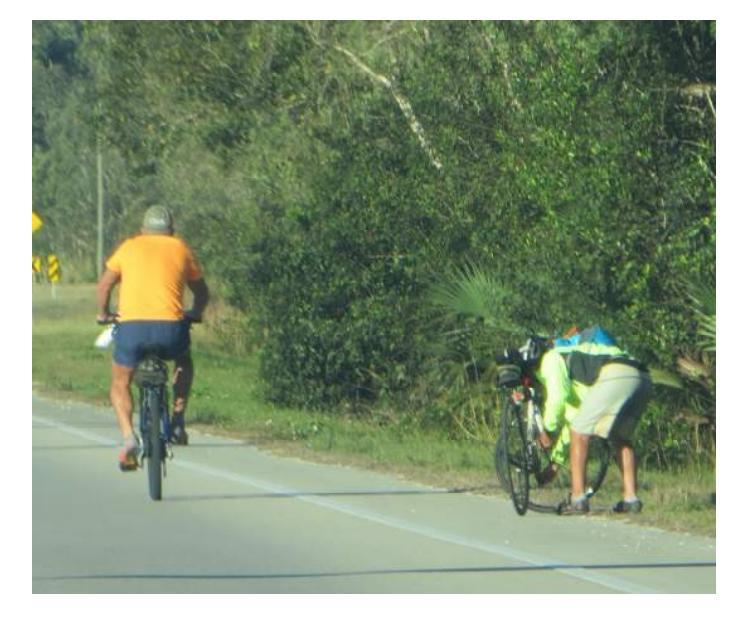
Cyclists on Corkscrew Road West of Bella Terra Boulevard

Cyclists were observed along Corkscrew Road and Three Oaks Parkway. Within the study area, Corkscrew Road, from Corkscrew Woodlands Boulevard to Bella Terra Boulevard, contains a striped bicycle lane. Future roadway improvements from the intersection of US 41 & Corkscrew Road to Corkscrew Road & Corkscrew Woodlands Boulevard are recommended to consider the addition of bicycle lanes. The MPO is currently in the process of developing a Bicycle and Pedestrian Master Plan.

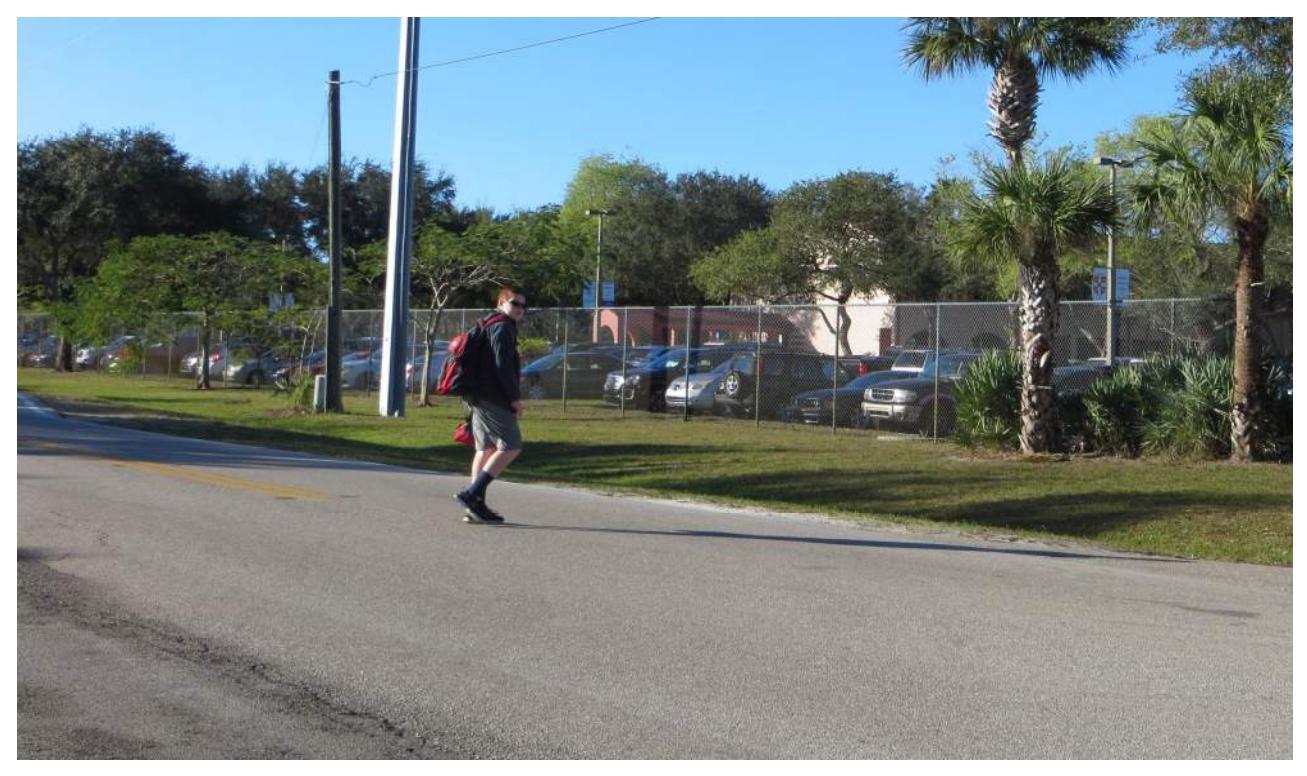
Student Crossing River Ranch Road

It is recommended to provide crosswalks and sidewalks along River Ranch Road, adjacent to the Estero High School. For example, the picture below shows a student who was observed crossing the roadway (without a crosswalk during the p.m. peak-hour). It is recommended to discuss with the school district, the need for crosswalks and sidewalks adjacent to the school.
