Village of Estero Stormwater Master Plan

October, 2018

Stormwater Master Plan

Volume 1

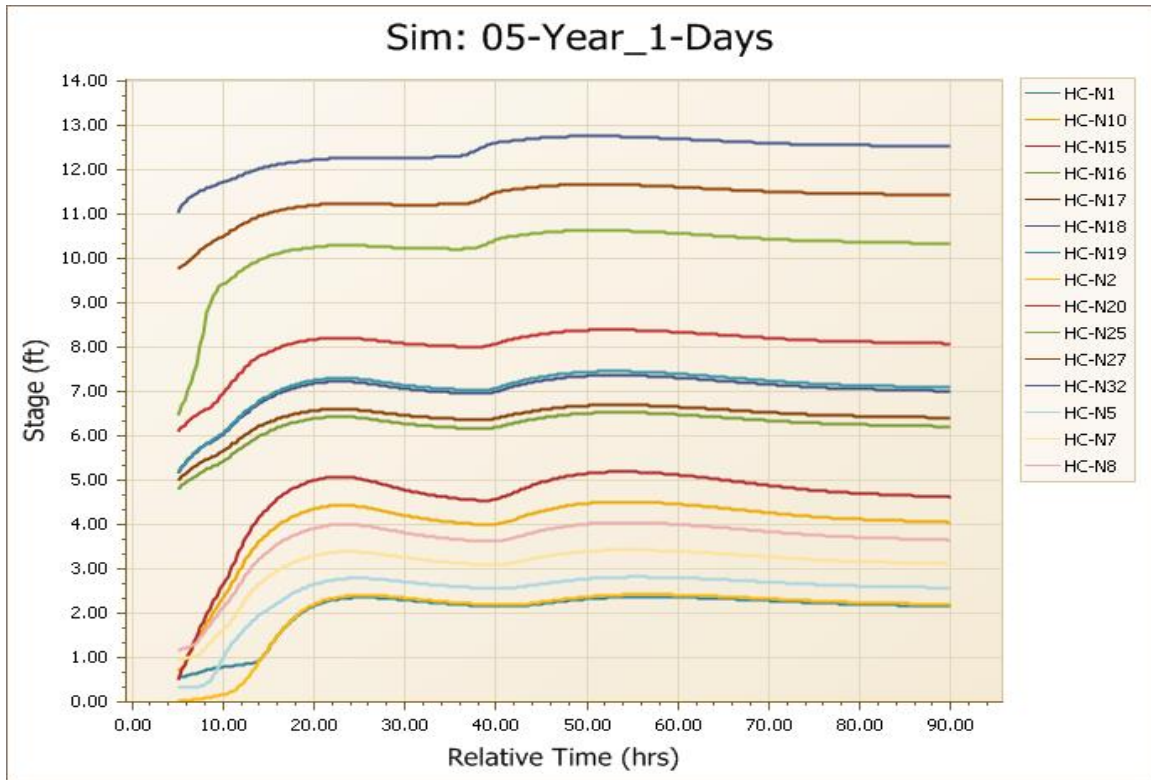
**Figure 3-10: Halfway Creek Section 1 -
5-Year, 1-Day Stage Time Series**

- o ***To lessen the hydraulic jump within the large conservation/wetland area located between West Bay Club and FPL crossing, conduct routine/regular maintenance to reduce roughness factor within flow area.***
- o ***Work with the West Bay Club community on a regular maintenance program for the upstream portions of Halfway Creek located within their property.***

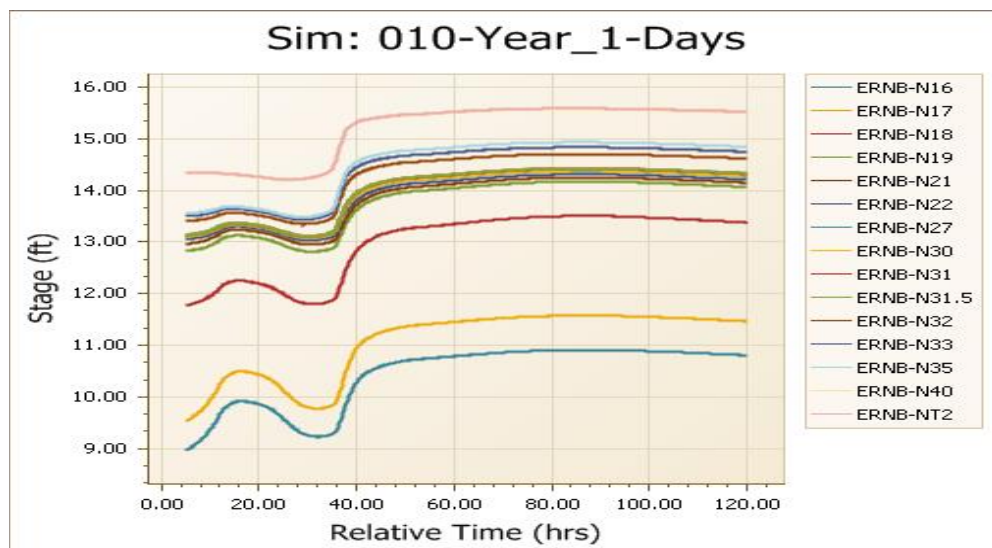
Figure 3-30: North Branch Section 2 - 10-Year, 1-Day Stage Time Series

- ***To lessen the hydraulic jumps within the section of the branch that travels between Villages at Country Creek and Rookery Drive, conduct improvements to the channel cross-section to achieve a more gradual slope from north to south and conduct routine maintenance to remove vegetation debris and exotics.***

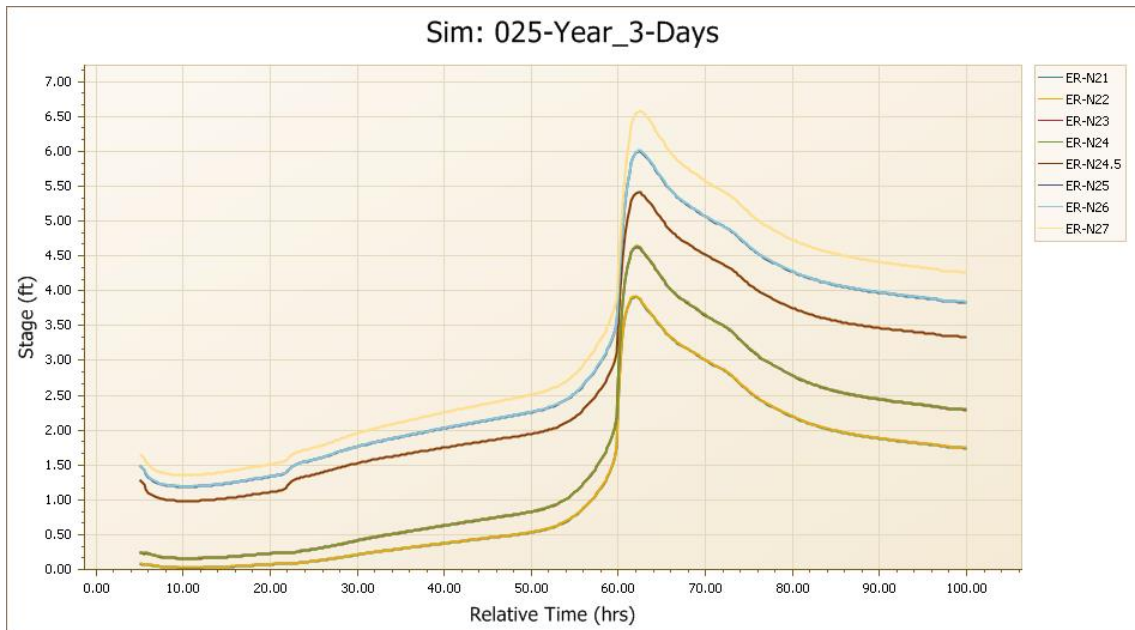
Figure 3-45: Estero River Section 2 - 25-Year, 3-Day Stage Time Series

- o ***For the section of the River located upstream of the railroad crossing up to the downstream side of Sandy Lane, it is recommended that the channel be modified to be more consistent in size, bottom width and side slopes.***

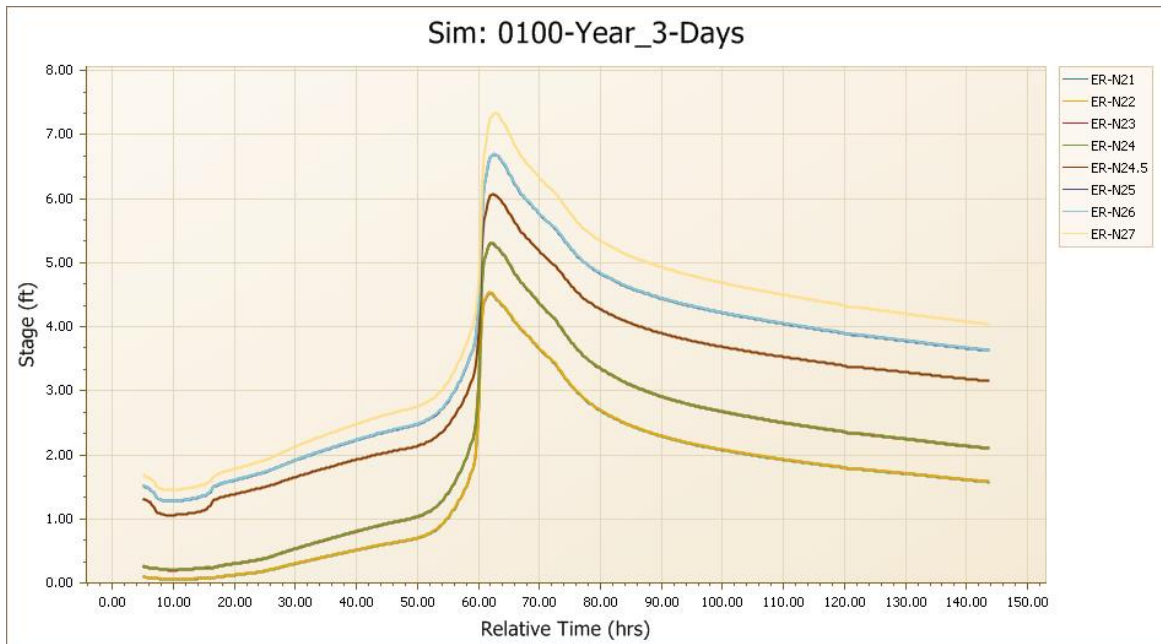
Figure 3-57: Estero River Section 2 - 100-Year, 3-Day Stage Time Series

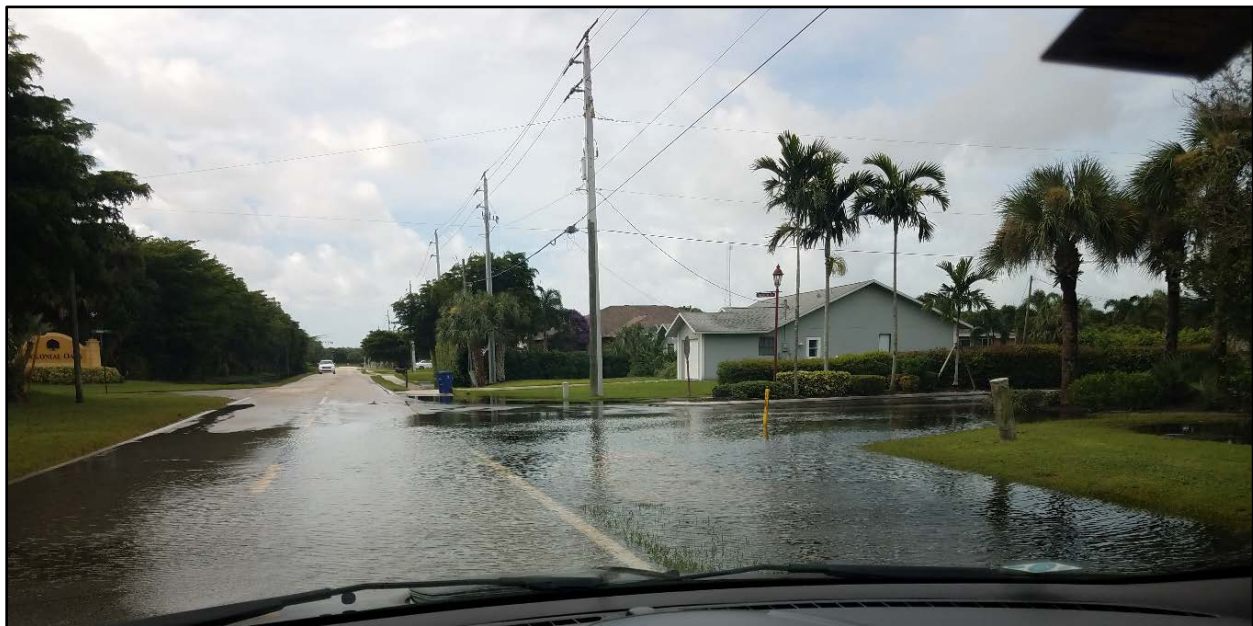
**Figure 4-1: River Ranch Road and Block Lane, Looking South
(August 28, 2017)**

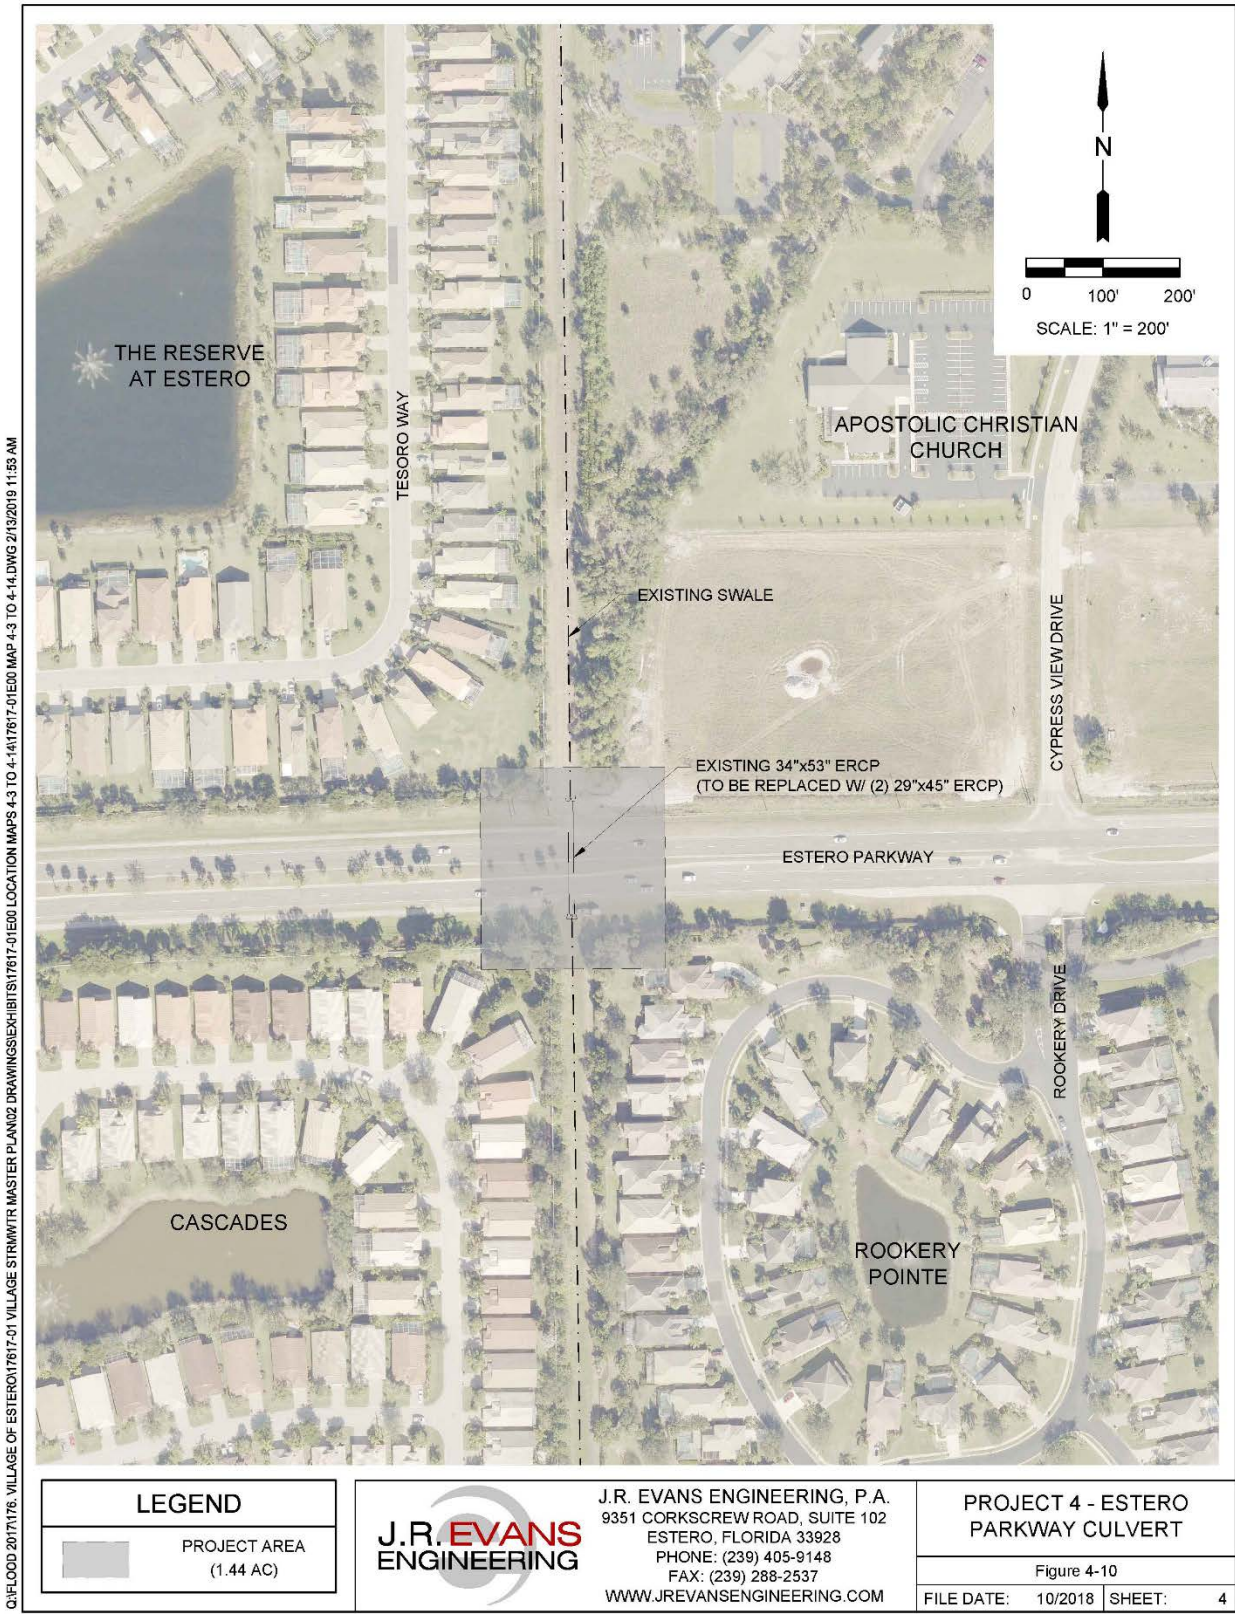
Figure 4-10: Project Four - Estero Pkwy Culvert Replacement

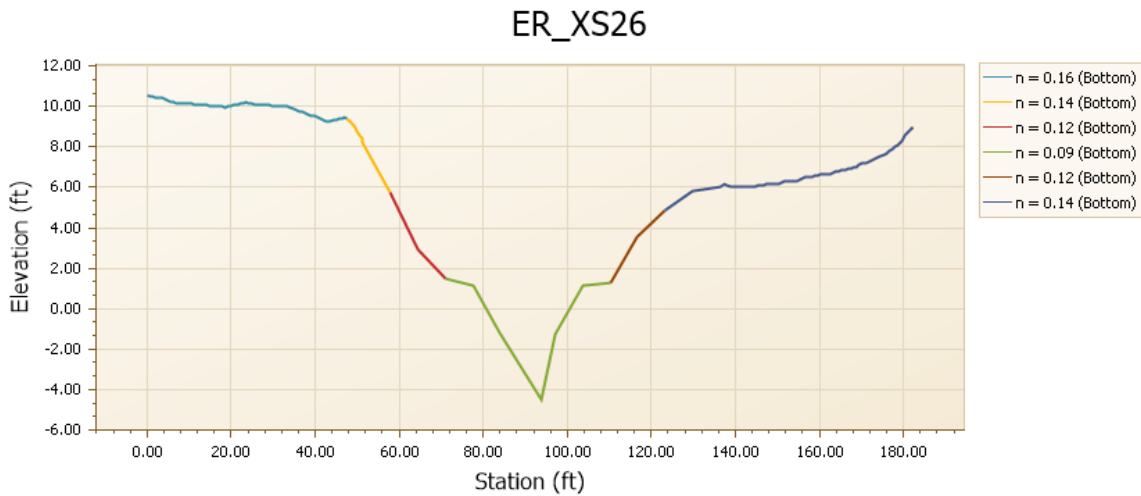
PROPOSED CHANNEL CROSS-SECTION ER-XS26

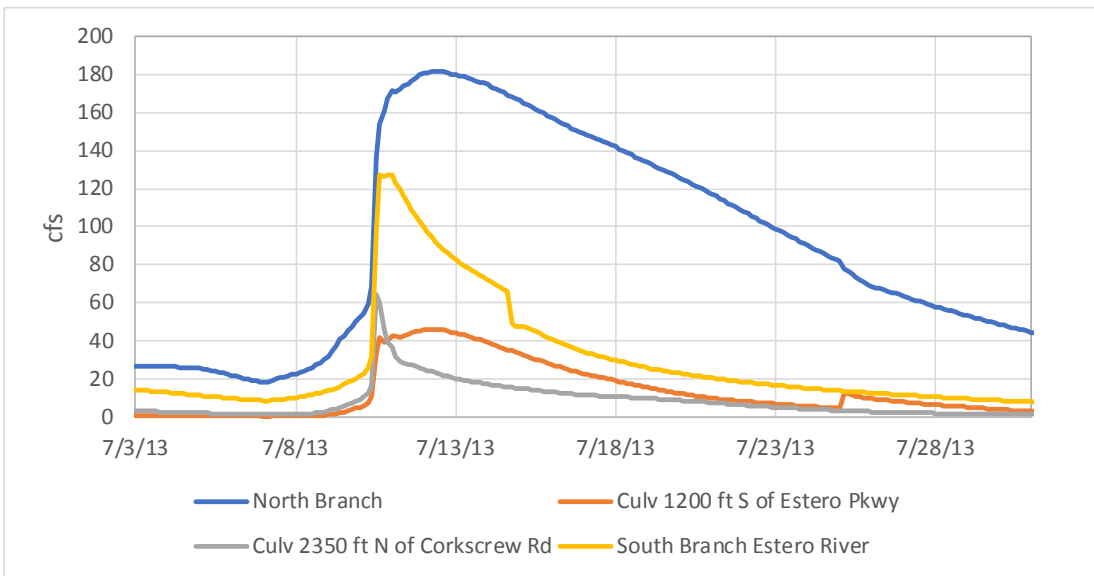
Figure 25 - 25-Year Boundary Condition Flows for North and South Branch Estero River
