Village of Estero Stormwater Master Plan

J.R. **EVANS**
ENGINEERING

Stormwater Master Plan

Volume 1

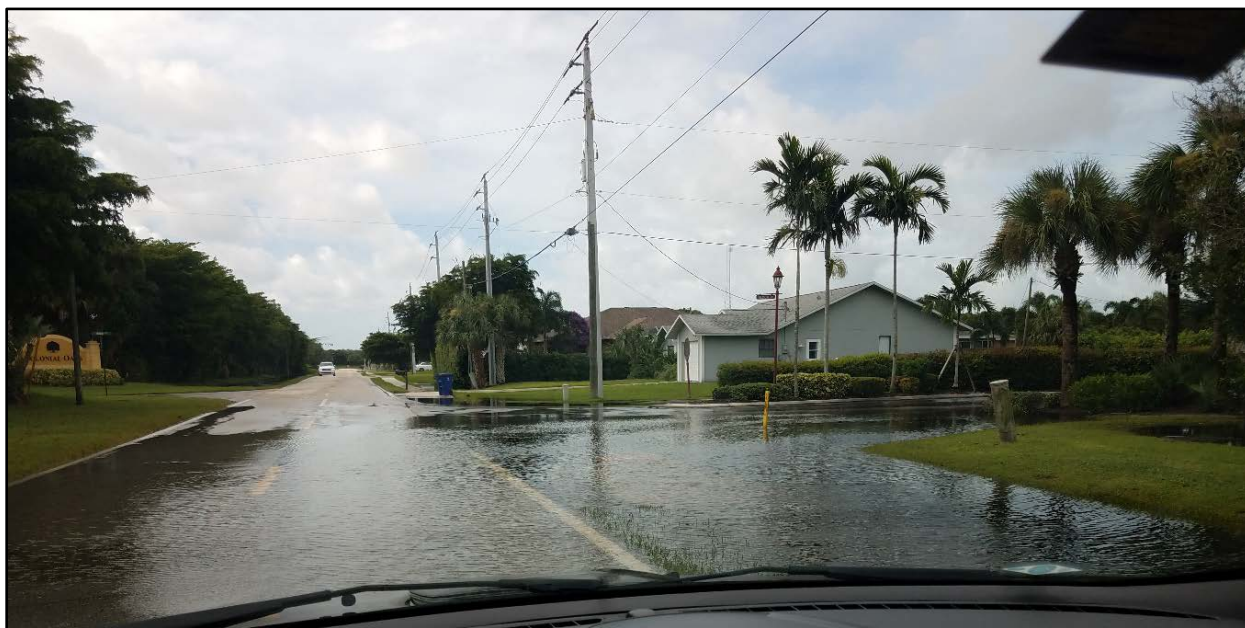
**Figure 4-1: River Ranch Road and Block Lane, Looking South
(August 28, 2017)**

Specifically, for the Estero River South Branch watershed, the area of concern and of frequent flooding is located around the intersection of River Ranch Road and Block Lane. In past rainfall events, it has been documented that the existing roadside drainage swale/pipe network along River Ranch Road inefficiently handles the surface water flows and results in flooding of the intersection with Block Lane and other connecting internal roadways. These roadways lead to residential properties and are utilized to get to the major arterial roadways, such as Corkscrew Road and Three Oaks Parkway. The following pictures were taken after the August 2017 rainfall event and depicts the level of flooding in this area:
