**VILLAGE OF ESTERO, FLORIDA**

**RESOLUTION NO. 2020 - 01**

**A RESOLUTION OF THE VILLAGE COUNCIL OF THE  
VILLAGE OF ESTERO, FLORIDA, ADOPTING THE  
VILLAGE OF ESTERO STORMWATER MASTER PLAN;  
AND PROVIDING AN EFFECTIVE DATE.**

**Section 1.** The Village Council hereby adopts the Village of Estero Stormwater Master Plan dated October, 2018 as guidance for future development and maintenance of stormwater management facilities in the Village.

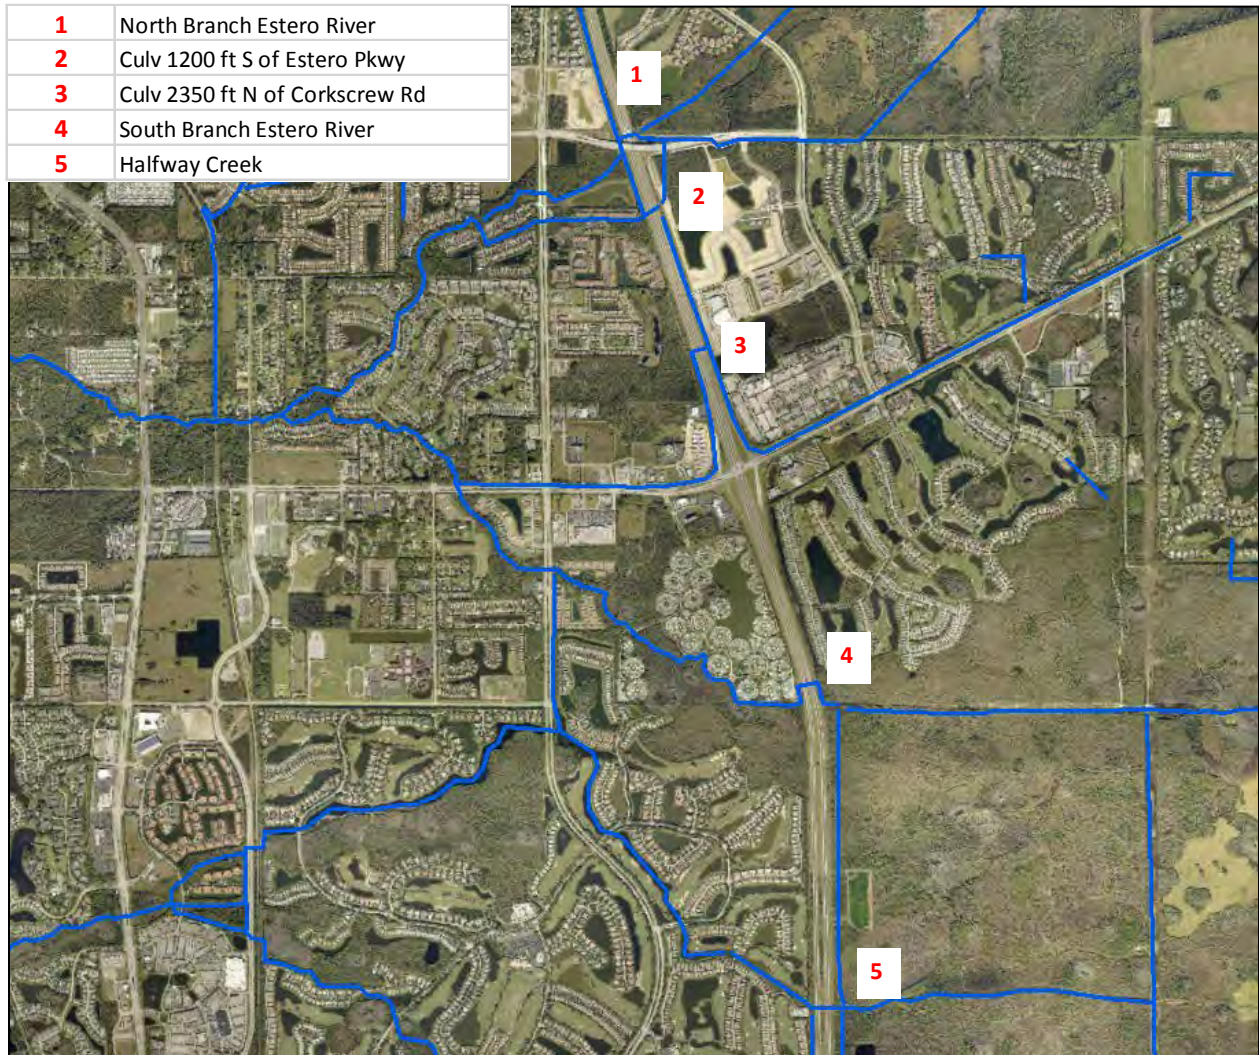
Figure 2-4: Location of Boundary Conditions Used from MIKE SHE Model

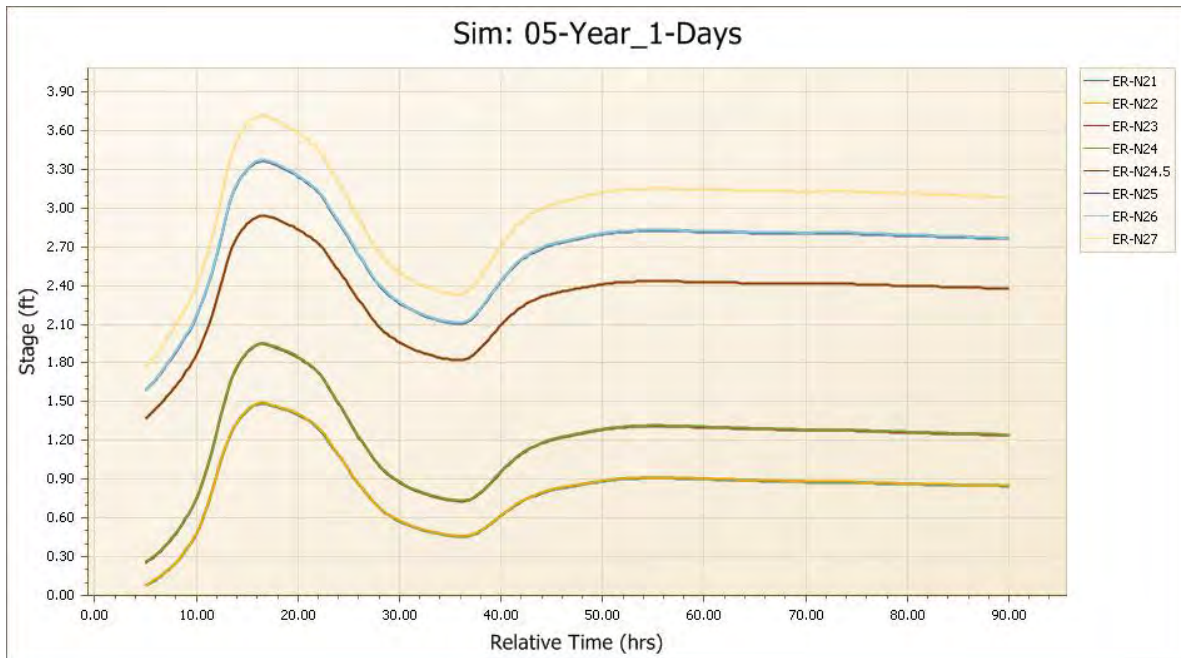
**Figure 3-21: Estero River Section 2 - 5-Year, 1-Day Stage Time Series**

- o ***To reduce the hydraulic jump located between the railroad crossing and the Sandy Lane crossing, it is recommended that the River channel be modified with a more consistent cross-section, including wider bottom and milder side slopes.***

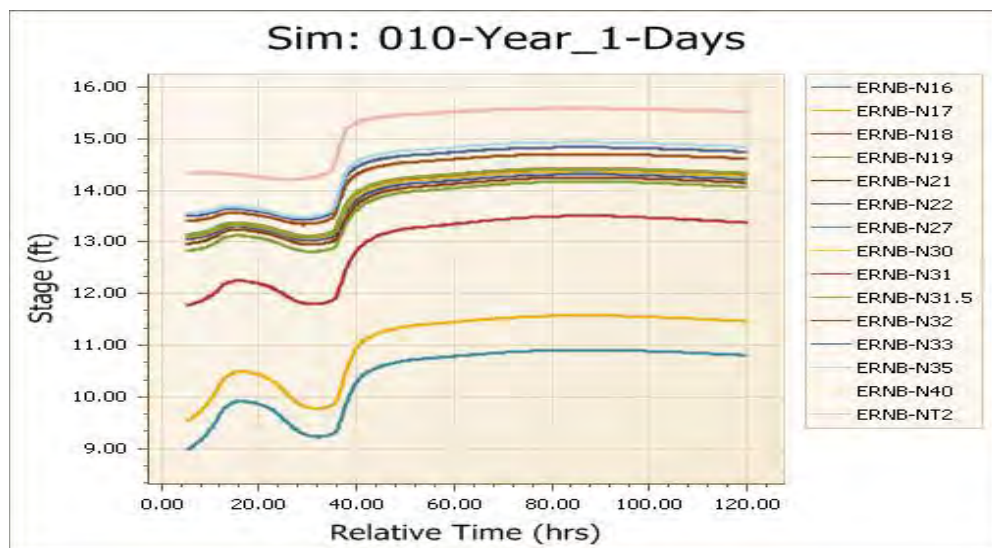
**Figure 3-30: North Branch Section 2 - 10-Year, 1-Day Stage Time Series**

- **To lessen the hydraulic jumps within the section of the branch that travels between Villages at Country Creek and Rookery Drive, conduct improvements to the channel cross-section to achieve a more gradual slope from north to south and conduct routine maintenance to remove vegetation debris and exotics.**

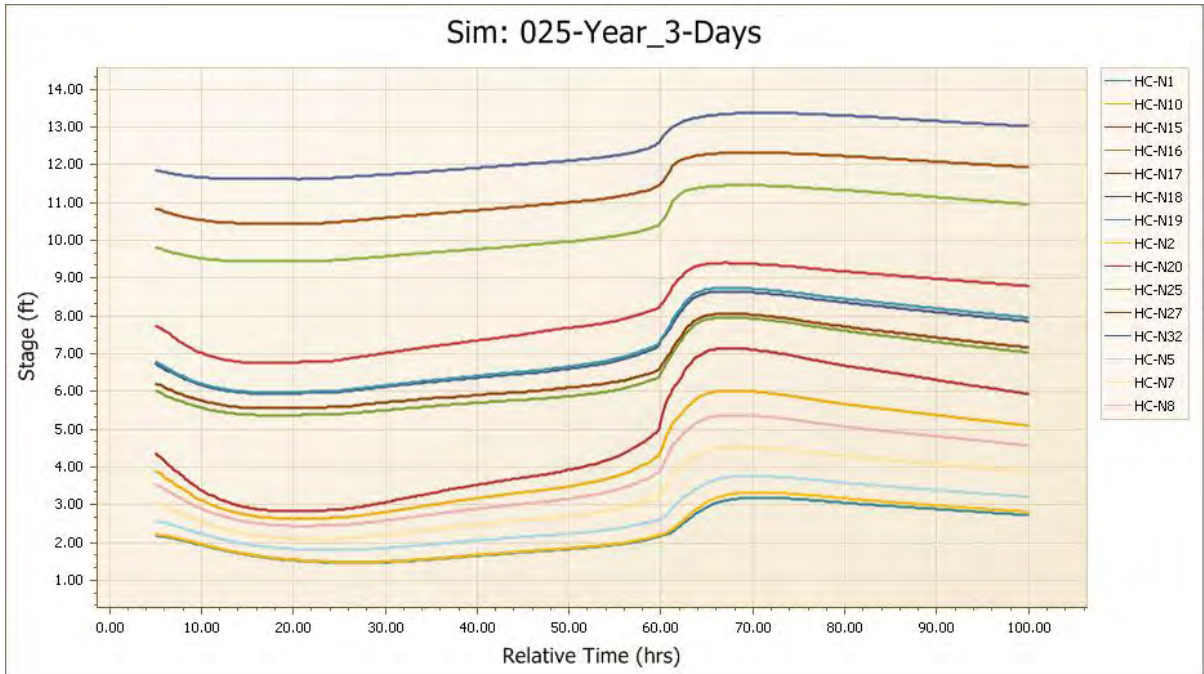
**Figure 3-34: Halfway Creek Section 1 -  
25-Year, 3-Day Stage Time Series**

- o **Conduct Routine/regular maintenance of large conservation/wetland area located between West Bay Club and FPL crossing to reduce roughness factor within flow area.**
- o **Work with the West Bay Club community on a regular maintenance program for the upstream portions of Halfway Creek located within their property.**

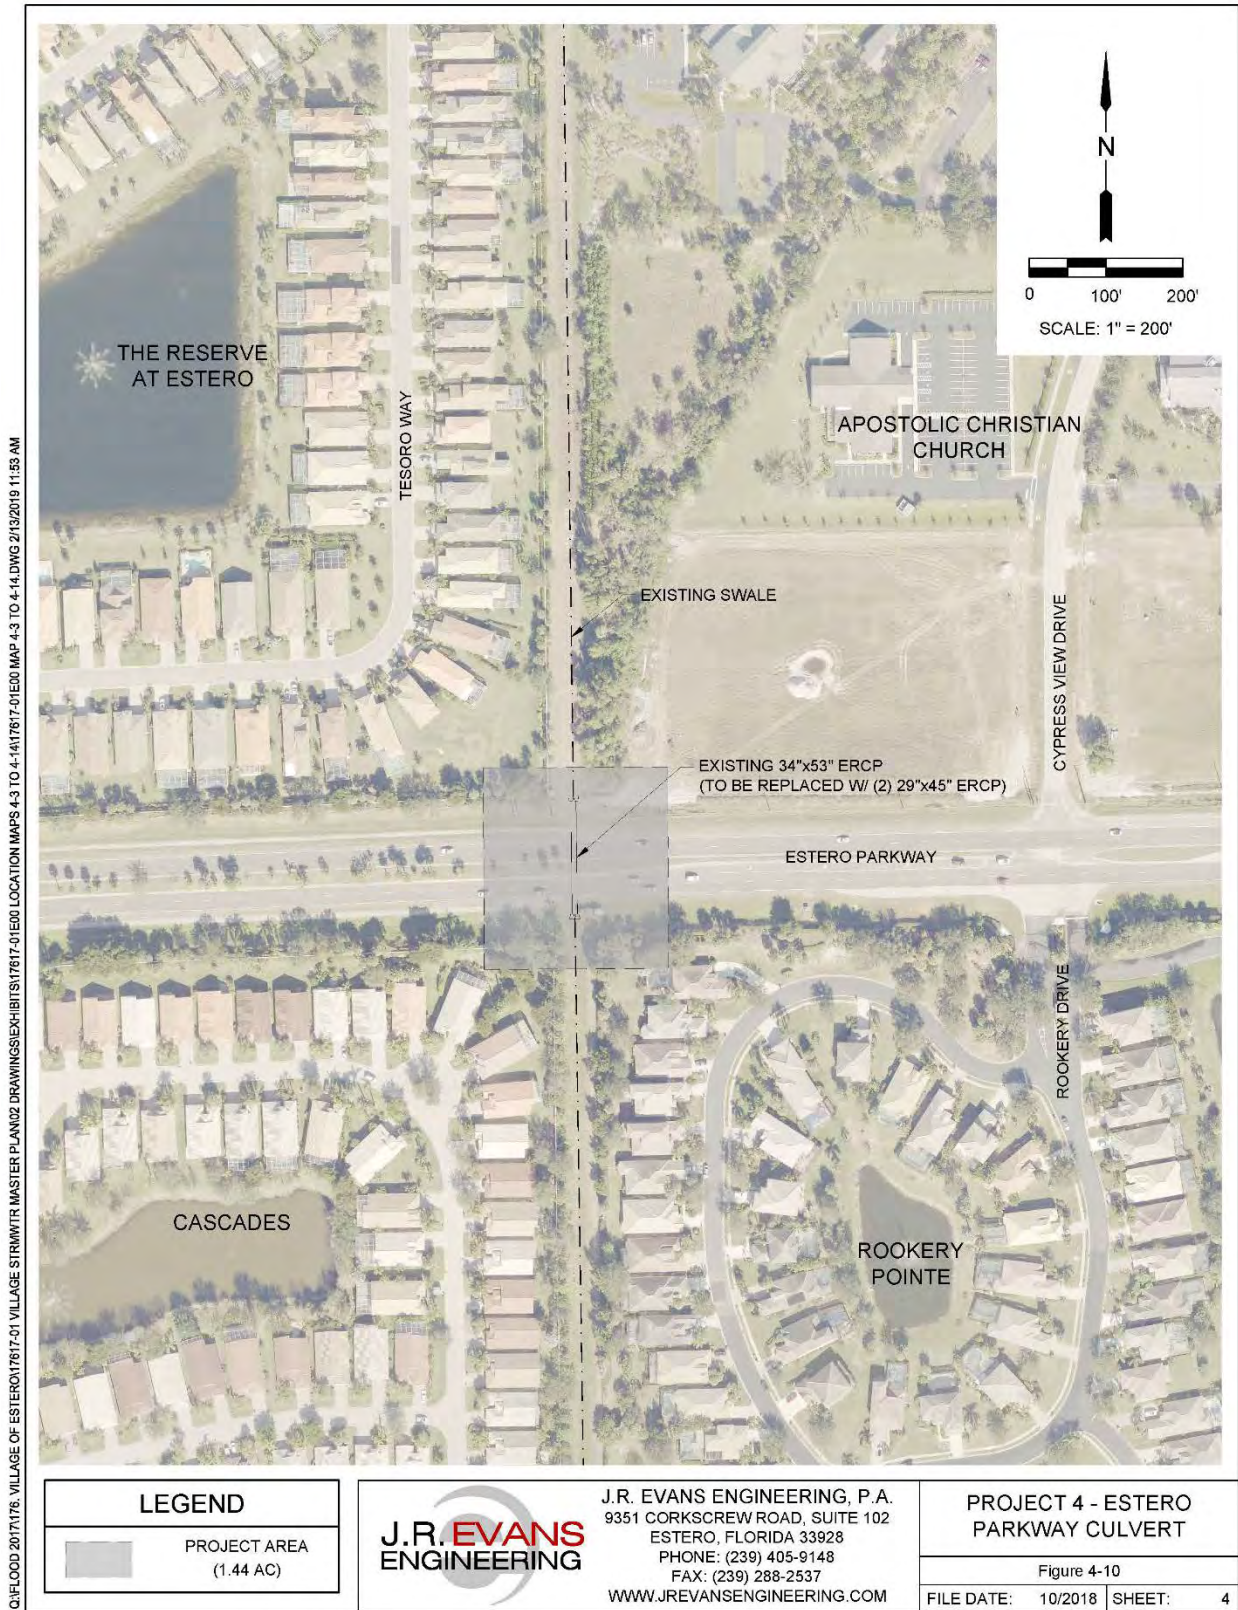
**Figure 4-10: Project Four - Estero Pkwy Culvert Replacement**

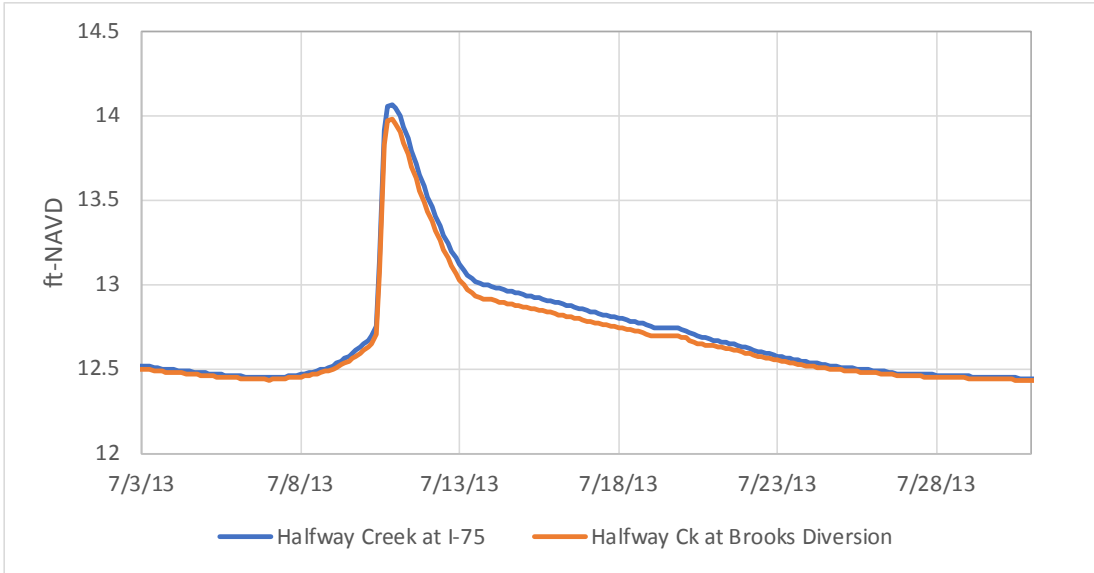
Figure 26 - 25-Year Stages for Halfway Creek at I-75 and Headwater of the Brooks Diversion
