**The Village of Estero
9401 Corkscrew Palms Circle
Estero, FL 33928**

DATE: May 26, 2020
SOLICITATION NO.: RFB 2020-06

SUBJECT: ADDENDUM NUMBER: Two (2)

REFERENCE: Estero on the River Structure Demolition

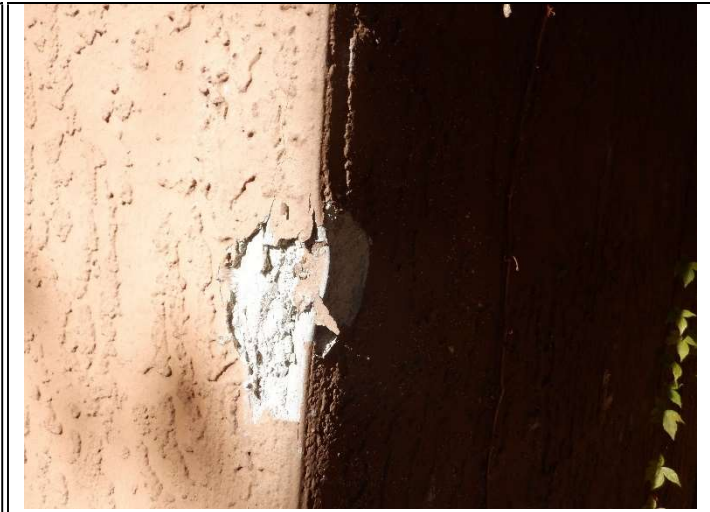
HM-A: Exterior Stucco, Gray

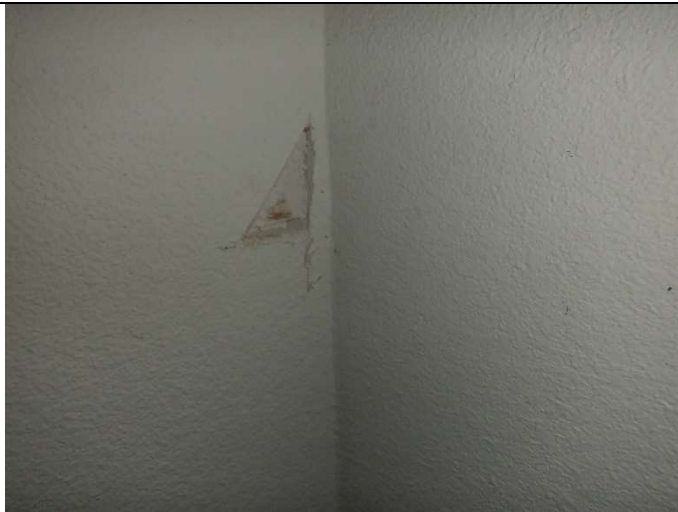
HM-B: Drywall/Joint Compound, White

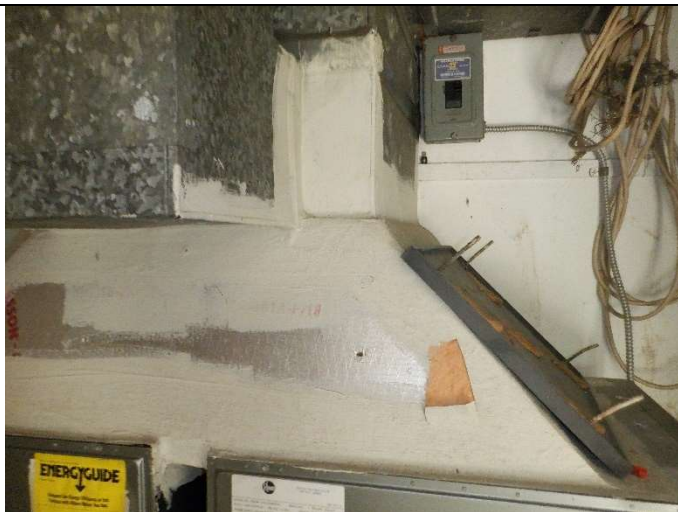
HM-D: Duct Mastic, White

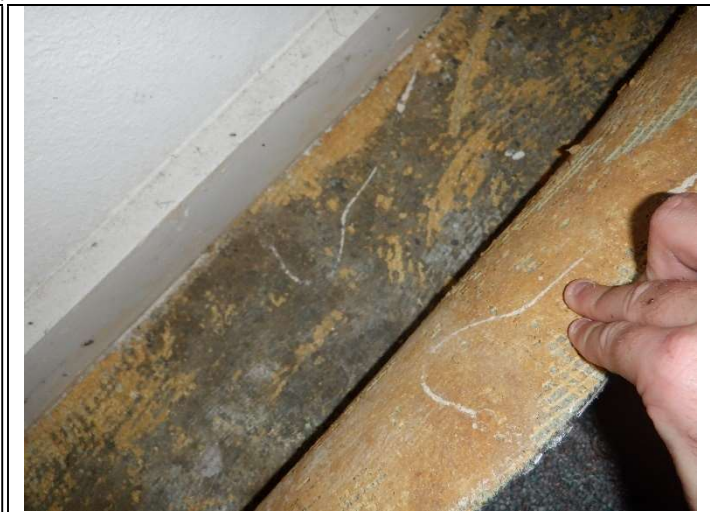
HM-E: Carpet Mastic, Tan

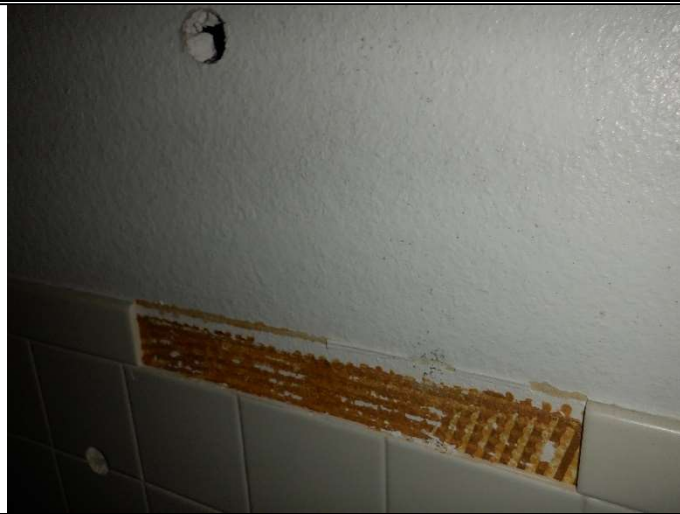
HM-F: 4" Ceramic Tile/Grout/Mastic, White

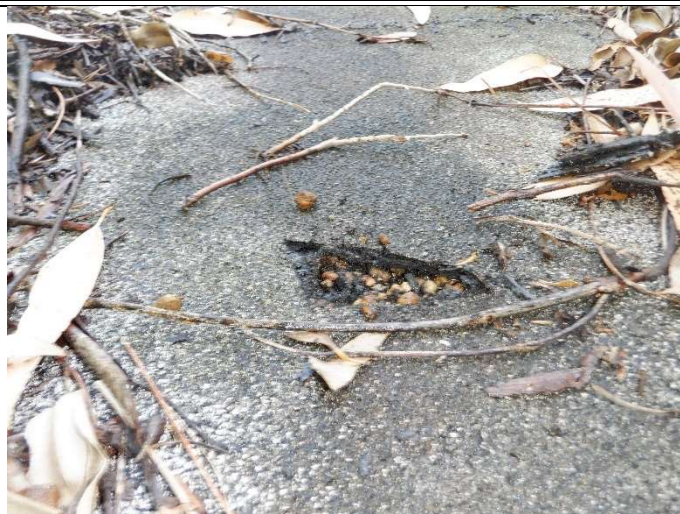
HM-J: Rolled Roofing/Tar, Black

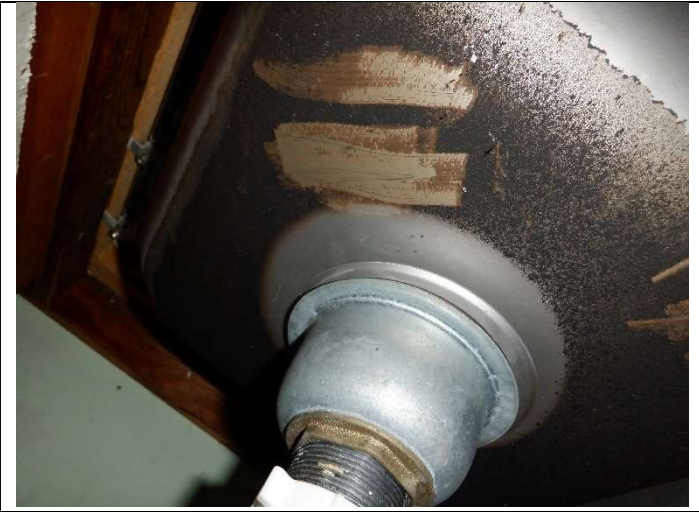
HM-M: Sink Insulation, Black

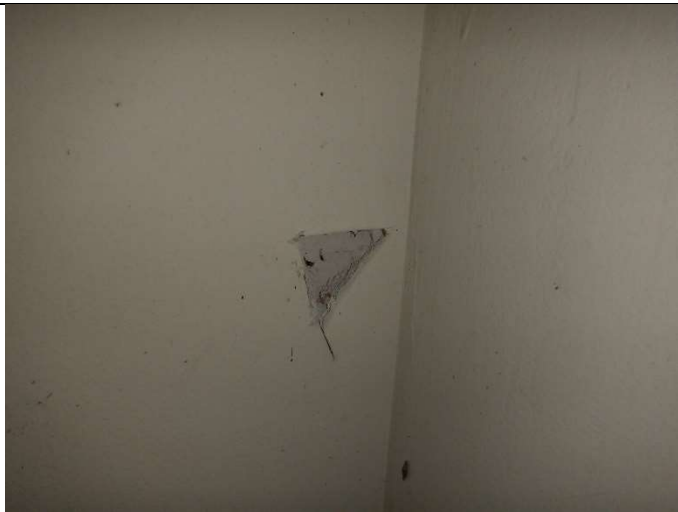
HM-N: Drywall/Joint Compound, White

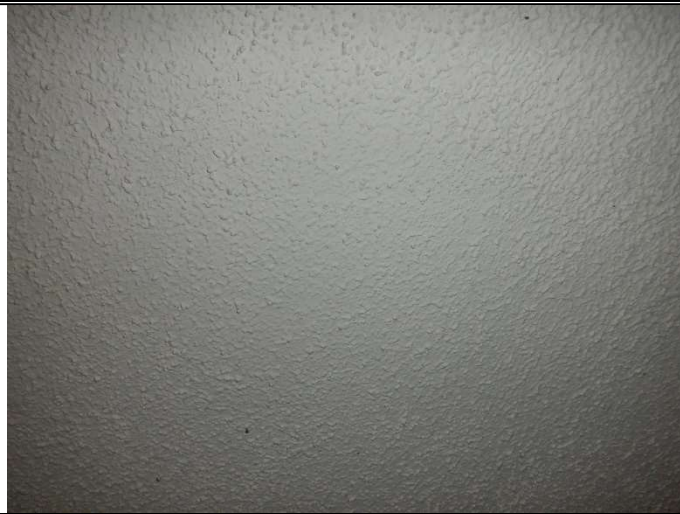
HM-P: Ceiling Texture, White

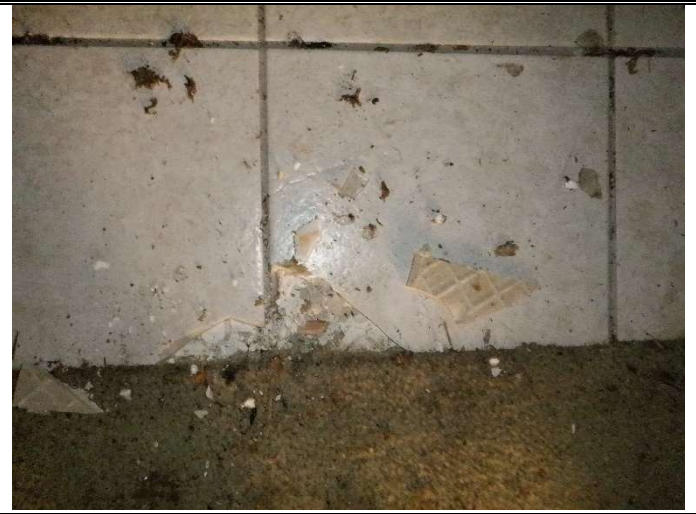
HM-Q: 12" Ceramic Tile/Grout/Thin Set, White

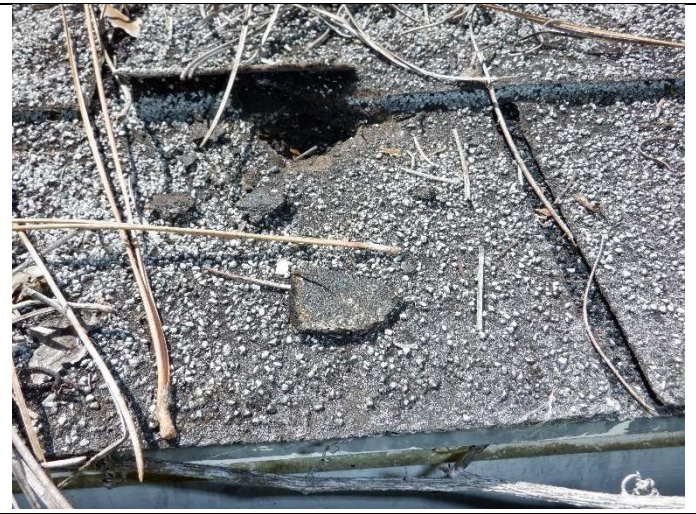
HM-S: Asphalt Shingle, Black

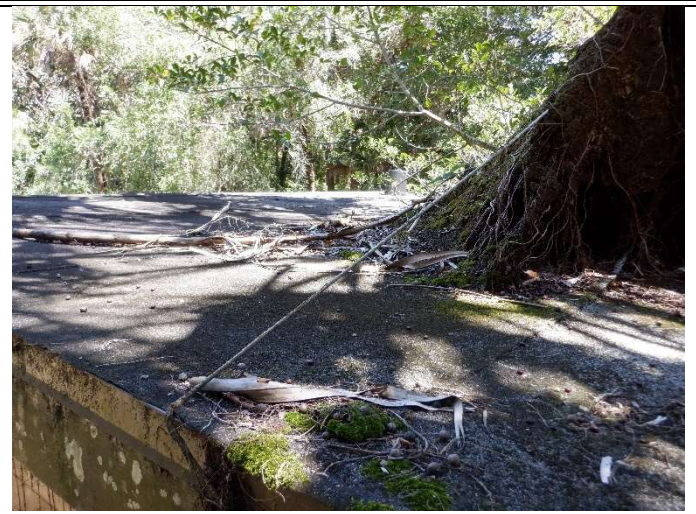
HM-T: Rolled Roofing/Felt Paper, Black

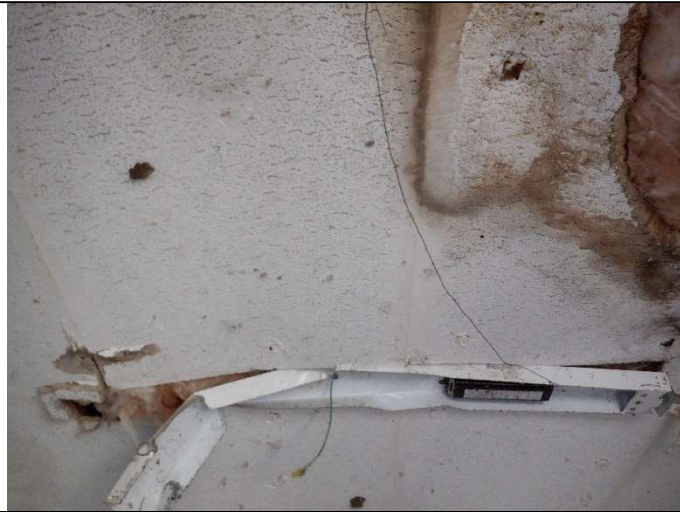
HM-U: Ceiling Tile, White

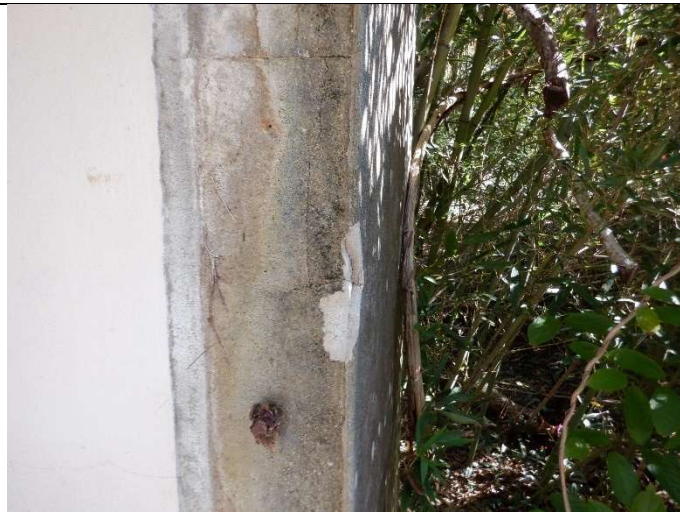
HM-W: Exterior Plaster, Gray

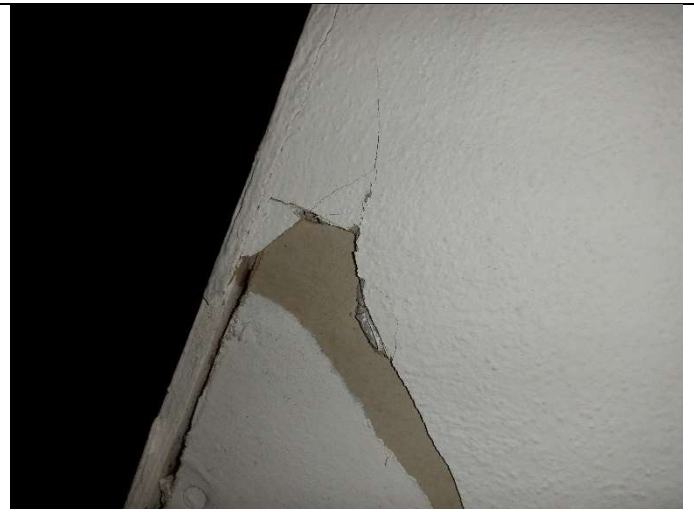
HM-X: Interior Plaster, Gray

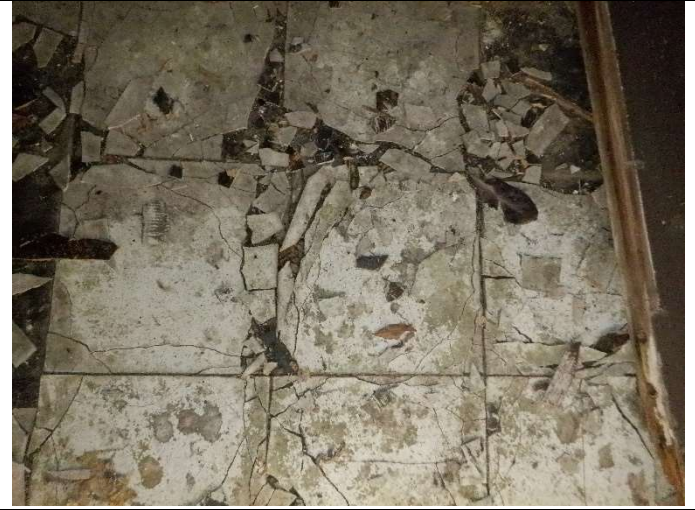
HM-Y: 9" x 9" Vinyl Floor Tile, Gray

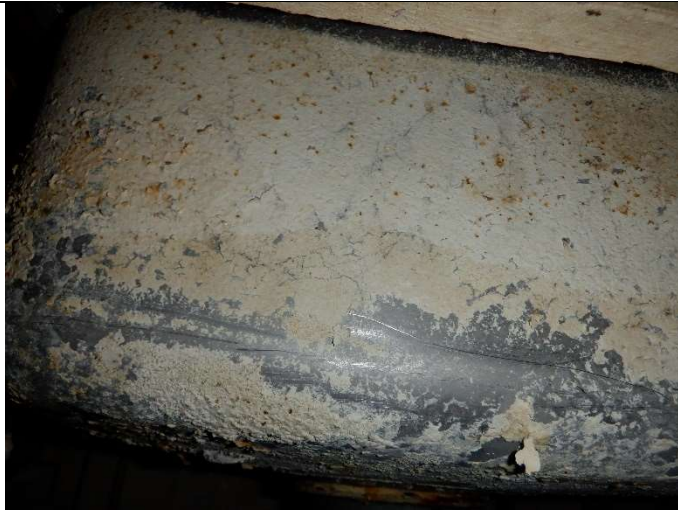
HM-Z: Sink Insulation, White

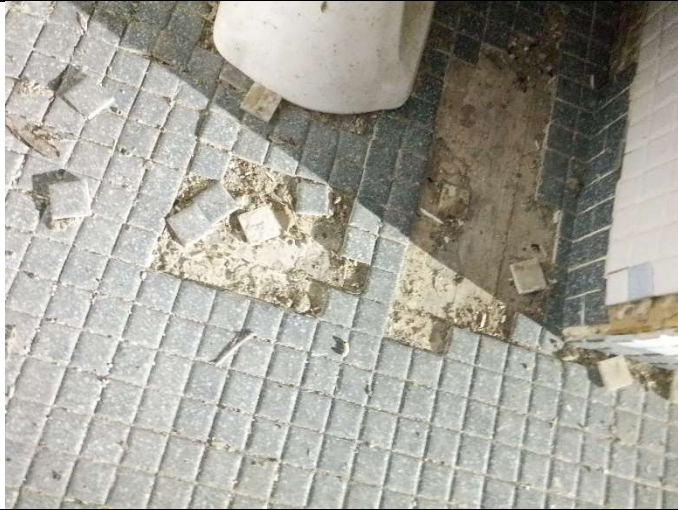
HM-BB: 1" Ceramic Tile/Grout/Mastic, Blue

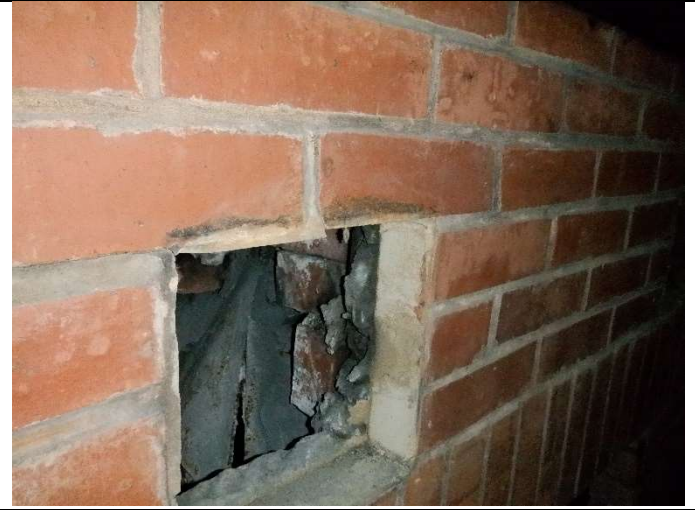
HM-CC: Mortar, Gray

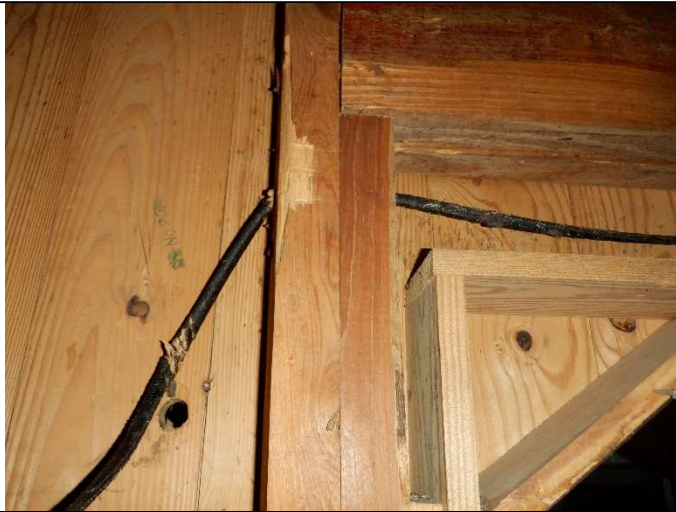
HM-DD: Wire Insulation, Black

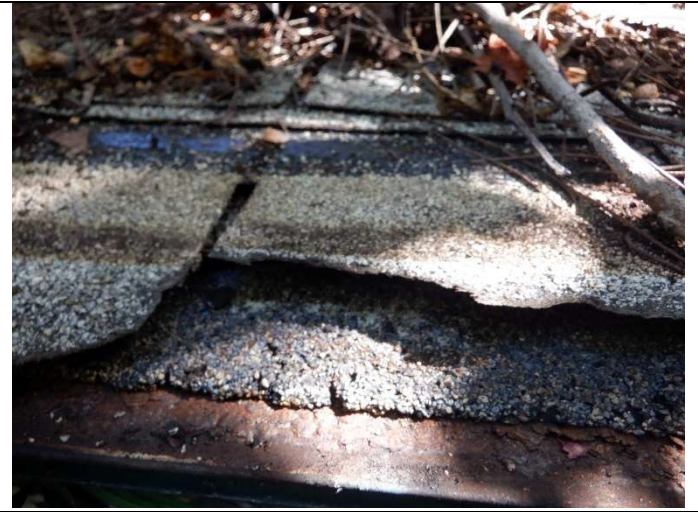
HM-EE: Asphalt Shingle, Black

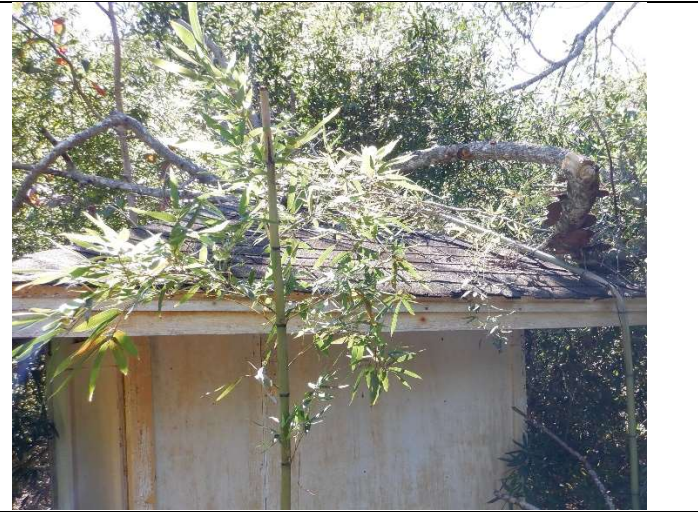
HM-FF: Asphalt Shingle/Felt, Black

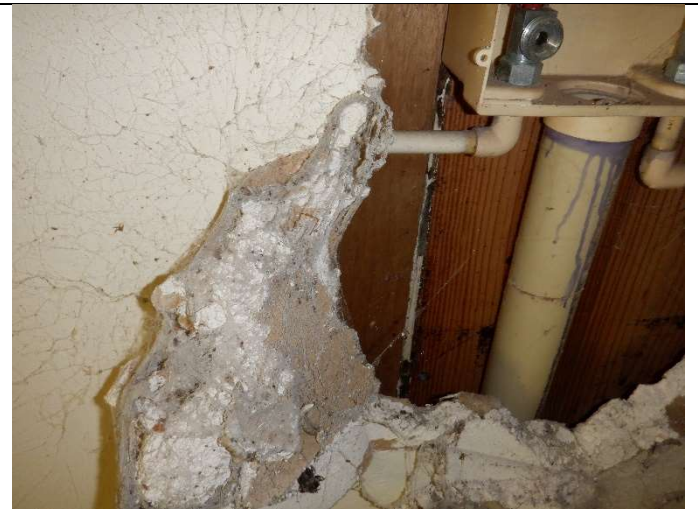
HM-GG: Drywall/Joint Compound, White

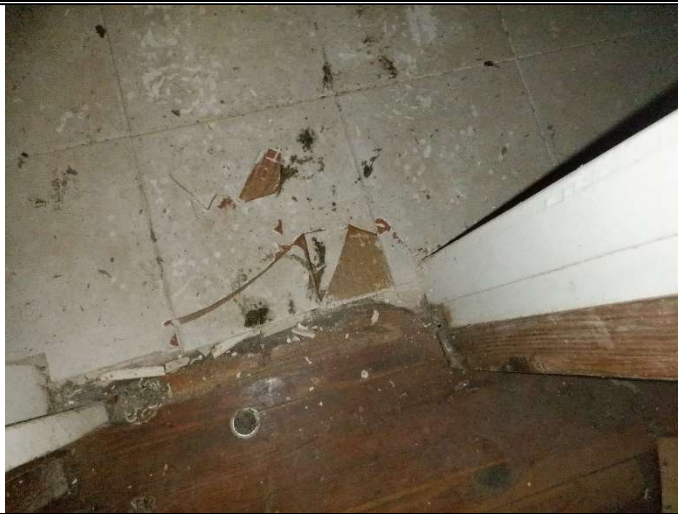
HM-HH: 12" Ceramic Tile/ Grout/Thin Set, Gray

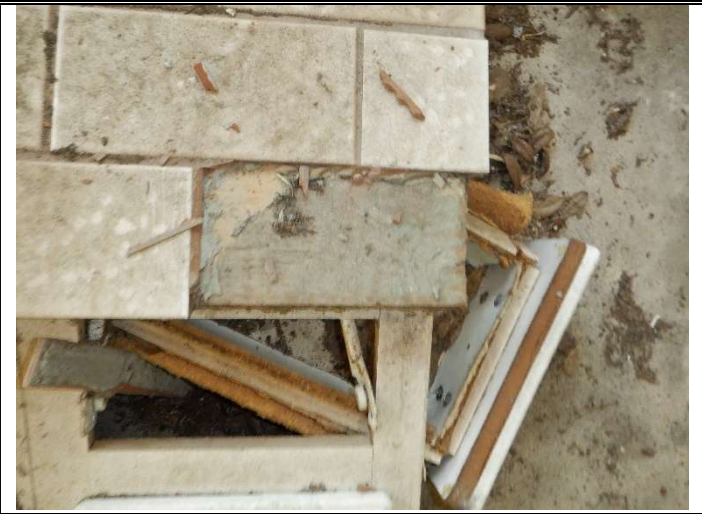
HM-II: Brick/Ceramic, Gray

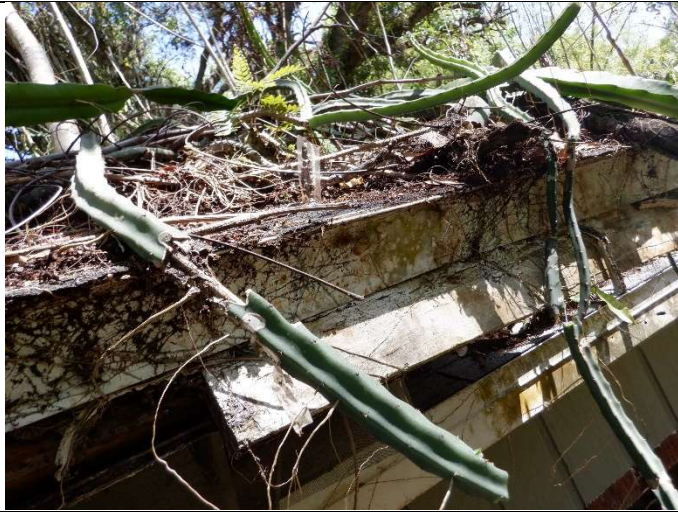
HM-JJ: Asphalt Shingle, Black

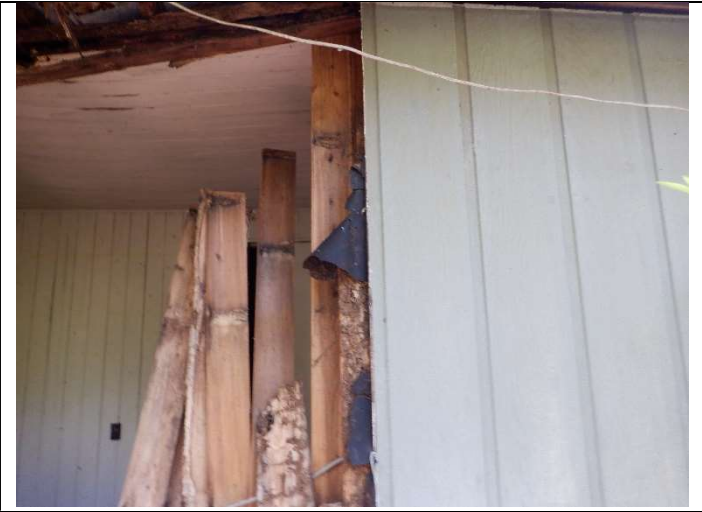
HM-KK: Felt Paper, Black

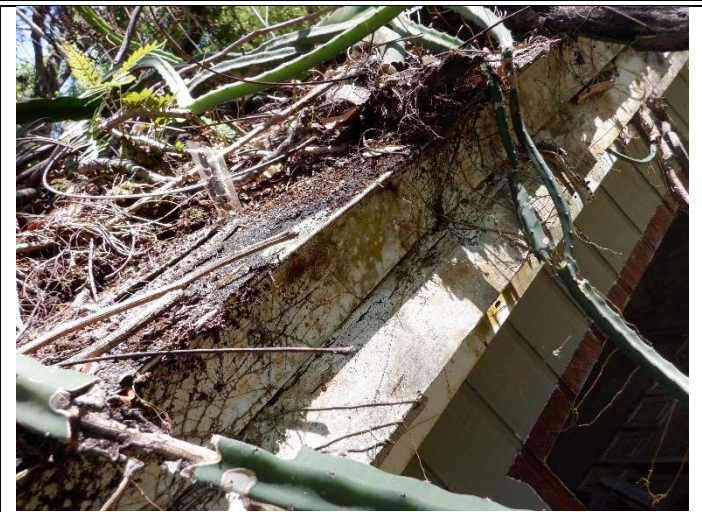
HM-MM: Asphalt Shingle/Felt Paper, Black

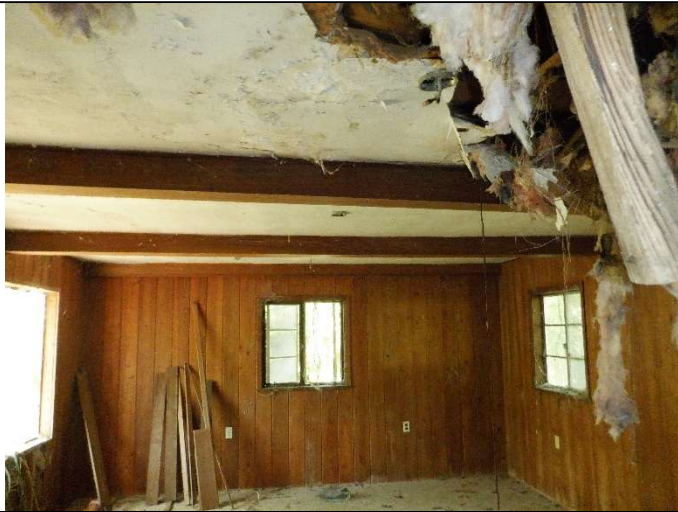
HM-NN: Textured Drywall/Joint Compound, White

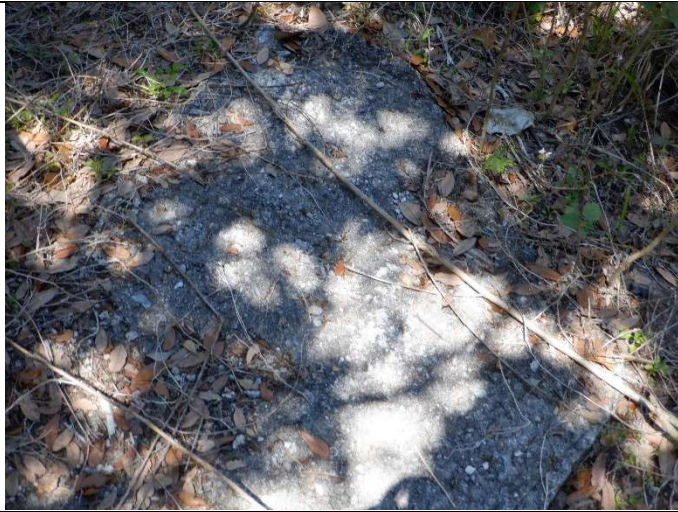
HM-OO: Concrete Slab, Gray

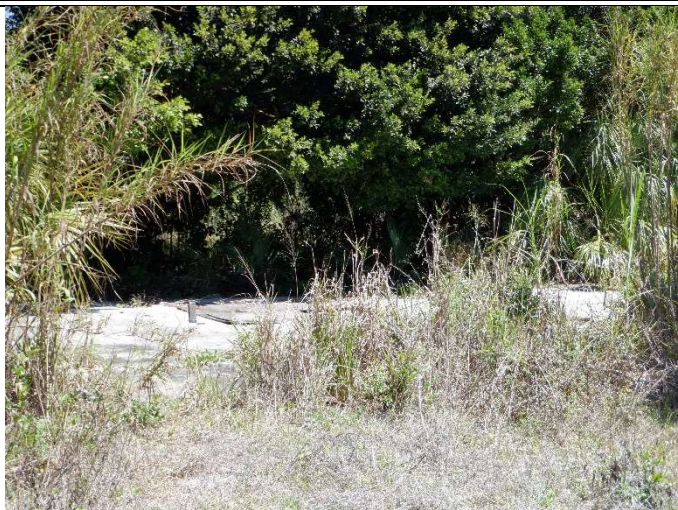
HM-PP: Concrete Slab, Gray
